# City of Gloucester Comprehensive River and Stream Habitat Restoration Report

2003

Tim Purinton

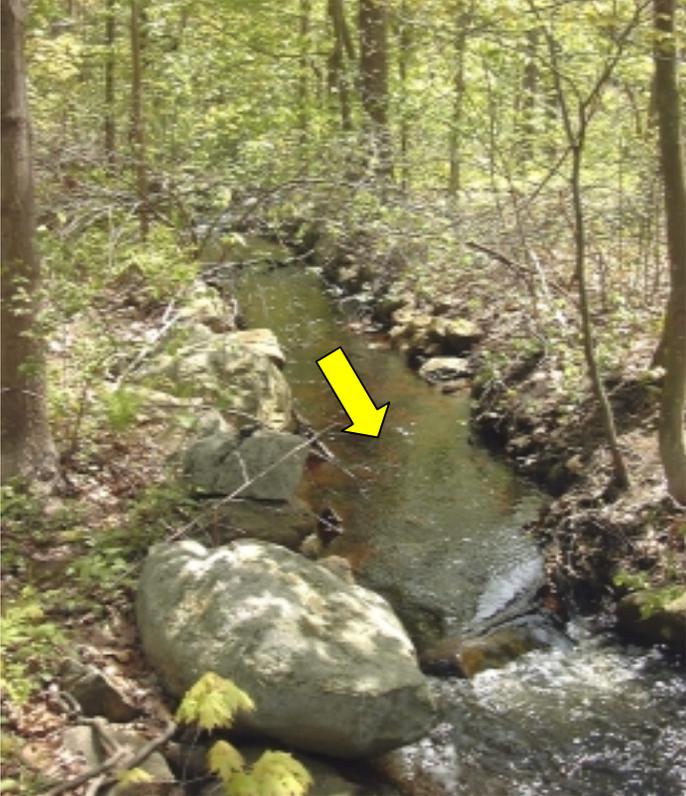
Below channel wetland stream conditions								
Area would provide sufficient depth for alewife passage								
Banks are loose stone								
If alewife passage is a goal this area may not need to change								
<b>Sketch</b>

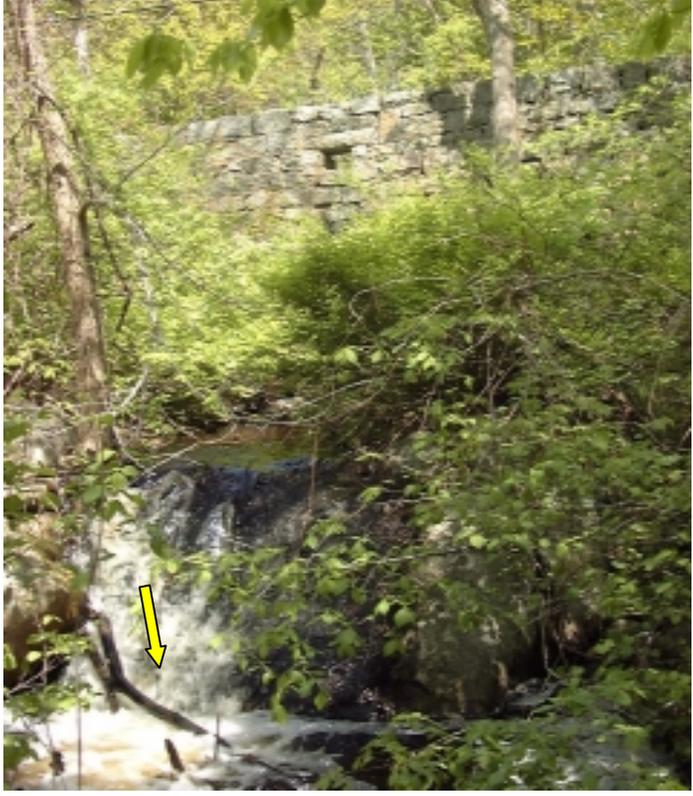
Quad	Site #	Watershed	Wetland Type	Restoration Code	Target Species	Access/Road	Ownership	Waypoint
Q-1	9	Walker Creek Trib	Shrub Swamp	FR, CU	Riverine/Catadromous	Sumner St.	Unknown	10
<b>Notes</b>				<b>Photo</b>				
Large elevation drop from across the street

Road appears to be an old mill foundation								
Elevated box culvert creates waterfall								
Large stone in stream retards flow								
Plunge pools are present								
Upstream water flows through flat drop culvert								
Granite box culvert								
<b>Sketch</b>				A.

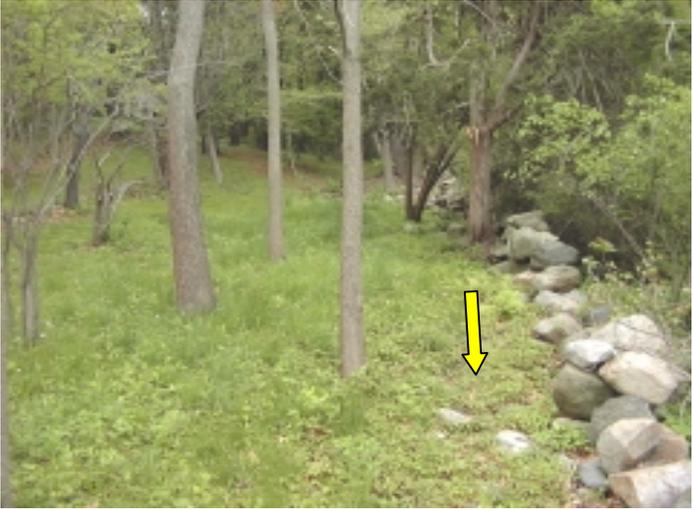
Quad	Site #	Watershed	Wetland Type	Restoration Code	Target Species	Access/Road	Ownership	Waypoint
Q-1	12	Walker Creek Trib.	Shallow Marsh Meadow/Wooded Swamp Deciduous	CU, BE, BMP	Catadromous	Sumner St.	Public/Private	14
<b>Notes</b>				<b>A.</b>				
Upstream horizontal drop culvert

Downstream waterfall								
Upstream stream buffer reduced by cutting								
Stonewall criss crosses stream, upstream								
Drop culvert on upstream								
Transition zone between salt and fresh								
<b>Sketch</b>				<b>B.</b>

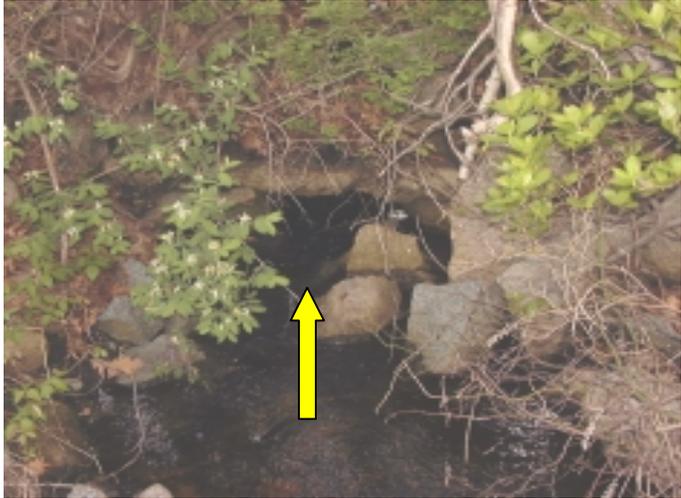
Quad	Site #	Watershed	Wetland Type	Restoration Code	Target Species	Access/Road	Ownership	GPS - ID
Q-1	36	Sleepy Hollow Pond	Salt Marsh/Brackish Marsh	FL, CU, BMP	Anadromous	Atlantic St.	Public	37
<b>Notes</b>				<b>A.</b>				
Granite culvert, slumped and in poor repair

Low flow may reduce alewife passage								
Culvert improvements could be done in conjunction with stormwater improvements								
Erosion along roadway, sedimentation and siltation noted								
Approximately 2'x2' box culvert (upstream)								
Downstream side almost completely blocked								
Downstream stream channel may need to be improved for fish passage								
<b>Sketch</b>				<b>B.</b>

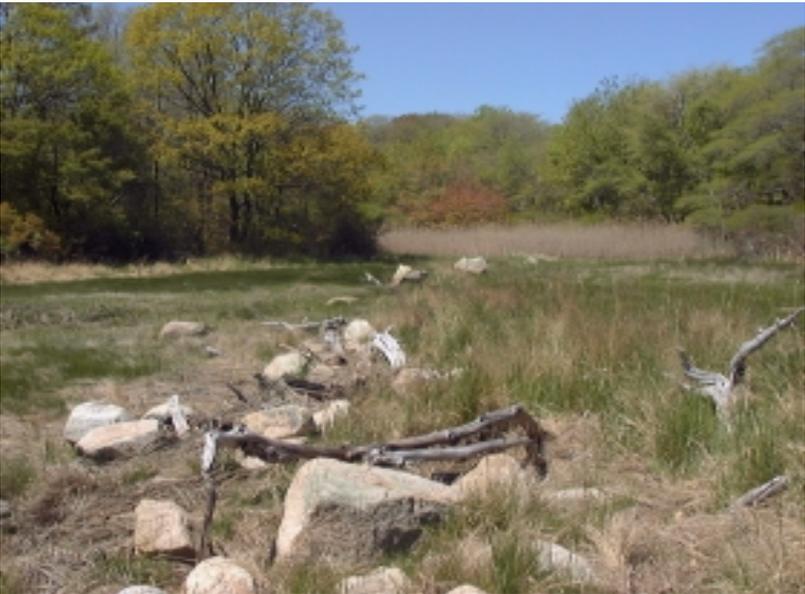
Quad	Site #	Watershed	Wetland Type	Restoration Code	Target Species	Access/Road	Ownership	Waypoint
Q-1	46	Jones/Annisquam Riv.	Salt Marsh	FR, IM	Estuarine	Atlantic St.	Unknown	49
<b>Notes</b>				<b>Photo</b>				
Old pier or foundation on the salt marsh				A.				
Pier extends to <i>Phragmites australis</i> patch

75 to 100' of loose stone								
Fairly easy to remove with limited disturbance								
Near transition zone upland/wetland								
<b>Sketch</b>

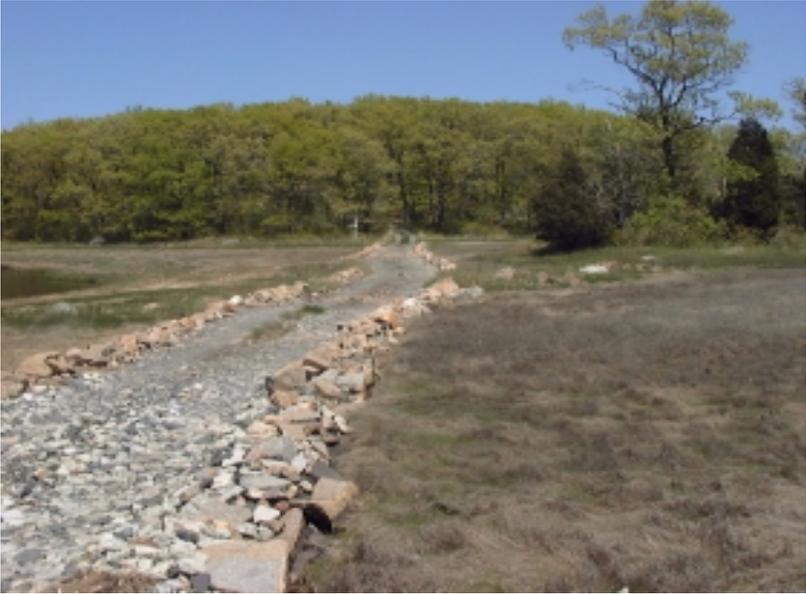
Quad	Site #	Watershed	Wetland Type	Restoration Code	Target Species	Access/Road	Ownership	Waypoint
Q-1	50	Jones River	Salt Marsh	FR, CU	Estuarine	Long Wharf	Private	53
<b>Notes</b>				<b>Photo</b>				
Causeway does not allow natural sheet flow across marsh				A.				
A series of small culverts may improve tidal flushing

No invasive impacts from fill or tidal alteration noted								
Causeway is slumped to allow some storm flow								
<b>Sketch</b>

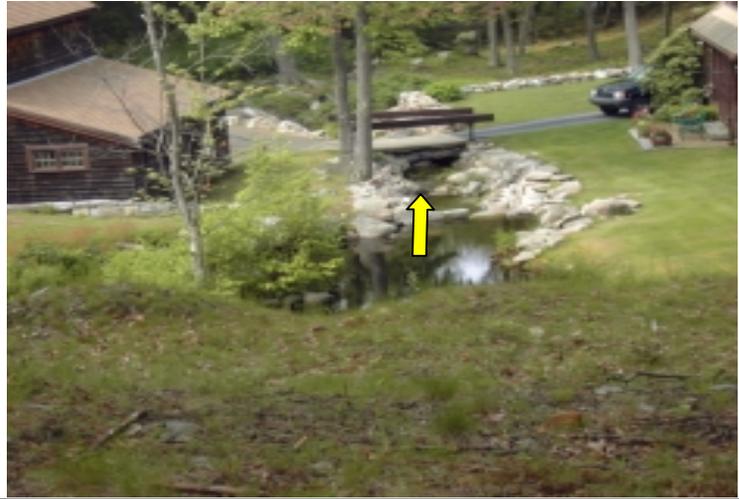
Upstream culvert not found, completely collapsed								
Downstream landowners have mowed to stream edge and channelized the stream								
Larger buffer recommended downstream								
<b>Sketch</b>

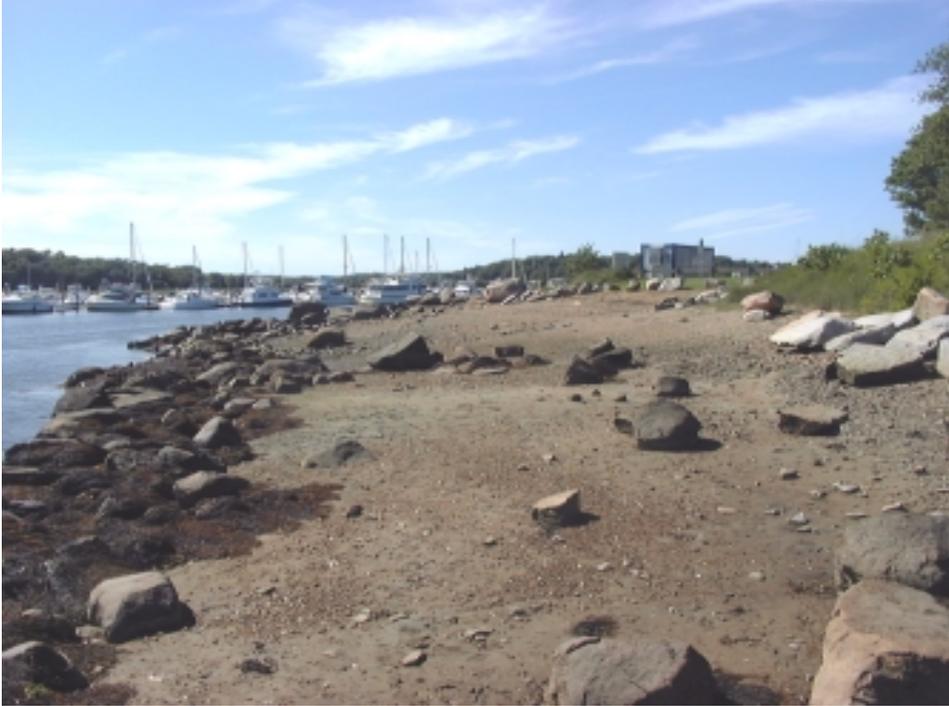
Area not a productive viable mudflat								
Degraded zone could have soil amendments and elevation change to support vegetation								
Area subject to wave action due to high boat traffic								
Approx. 200' in length and 75' wide								
<b>Sketch</b>

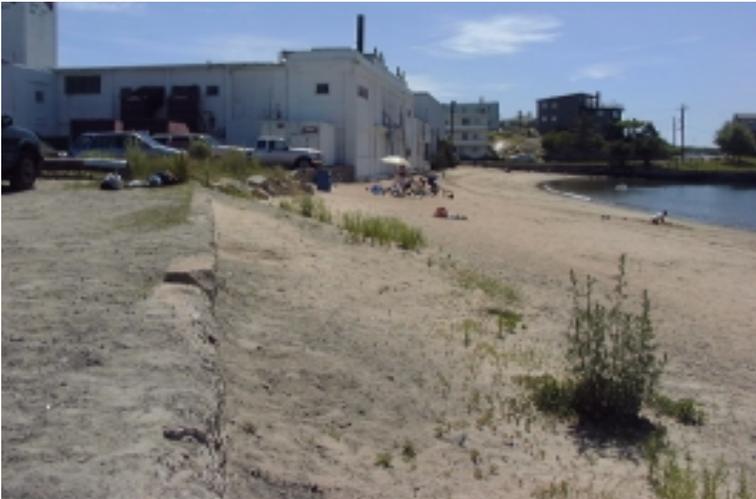
Coastal bank highly degraded, no vegetative buffer								
Planting plan could be developed								
Area has intensive use may be difficult to improve conditions								
No buffer between warehouses and beach								
<b>Sketch</b>				<b>B.</b>

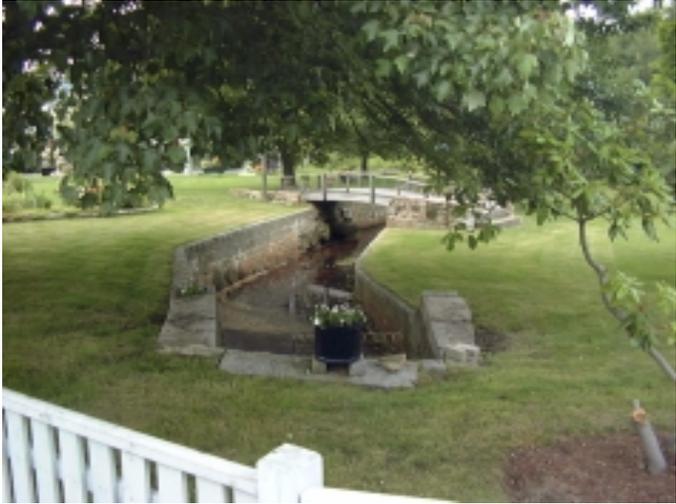
Stone retaining walls replace natural stream banks								
No vegetated buffer along stream edge								
<b>Sketch</b>

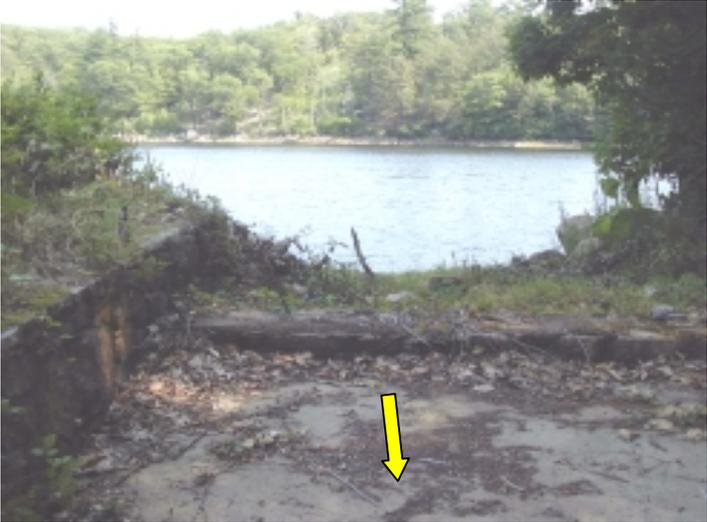
Spillway may be too steep for fish ladder								
Political issue of water supply reservoir as alewife spawning area								
Shoreline of Wallace Pond fairly undisturbed								
<b>Sketch</b>				<b>B.</b>

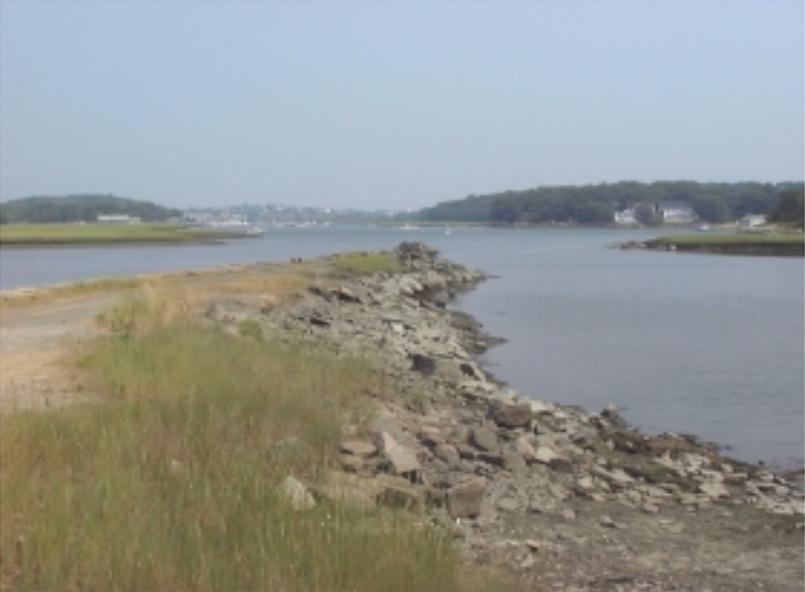
Minimal disturbance								
Pier replaces mudflat								
Pier could be partially removed to allow for more wetland resource creation								
Pier owned by Essex County Greenbelt Assoc.								
<b>Sketch</b>
