# City of Gloucester Comprehensive River and Stream Habitat Restoration Report

2003

Tim Purinton

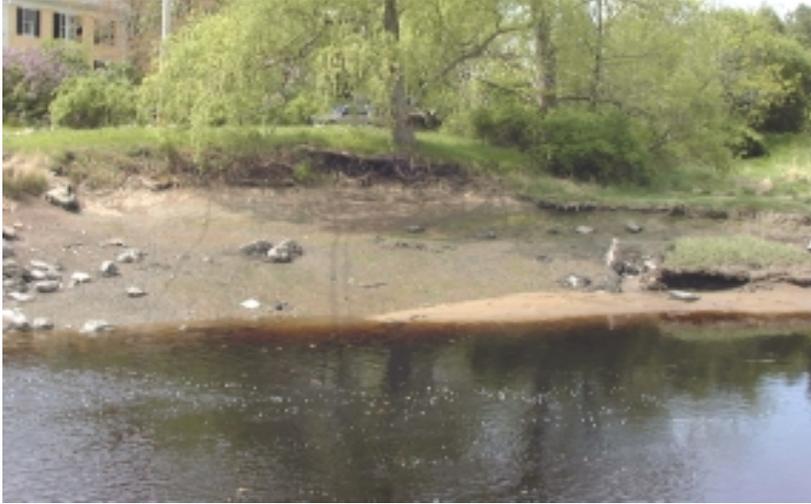
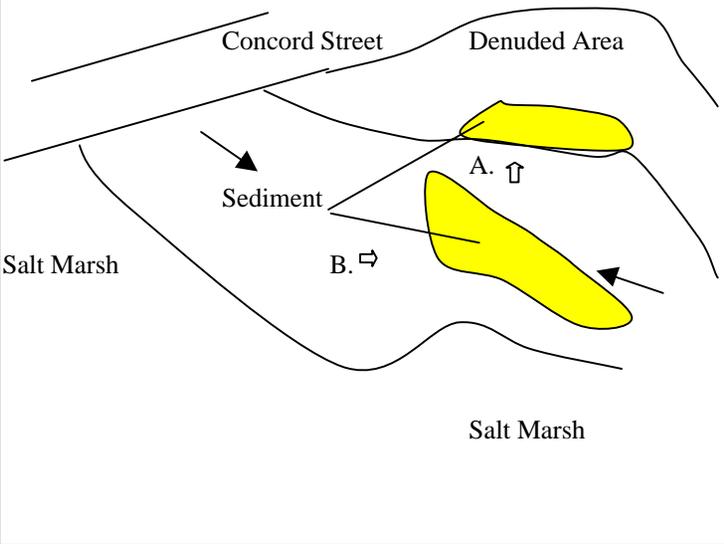
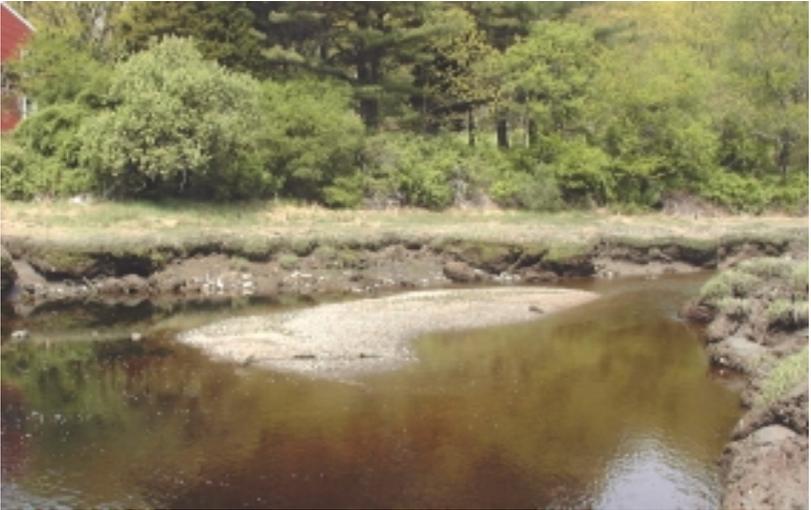
Quad	Site #	Watershed	Wetland Type	Restoration Code	Target Species	Access/Road	Ownership	Waypoint
Q-1	1	Walker Creek	Saltmarsh/Tidal Flat	FR, BMP	Estuarine	Concord St.	Unknown	1, 2
<b>Notes</b>				<b>Photo</b>				
Spoils due to stormwater - sediment buildup				<b>A.</b>

Sand pile adjacent to road deposited from swale cut in bank								
Years of accumulated sediment								
Little corresponding shellfish life associated with spoil piles								
No stormwater infrastructure along Concord Street								
Sediment exposed at low tide only								
In stream gravel bar, edge of bar is sand								
Denudation of bank may be due to human use								
Upstream bridge may affect area of impact

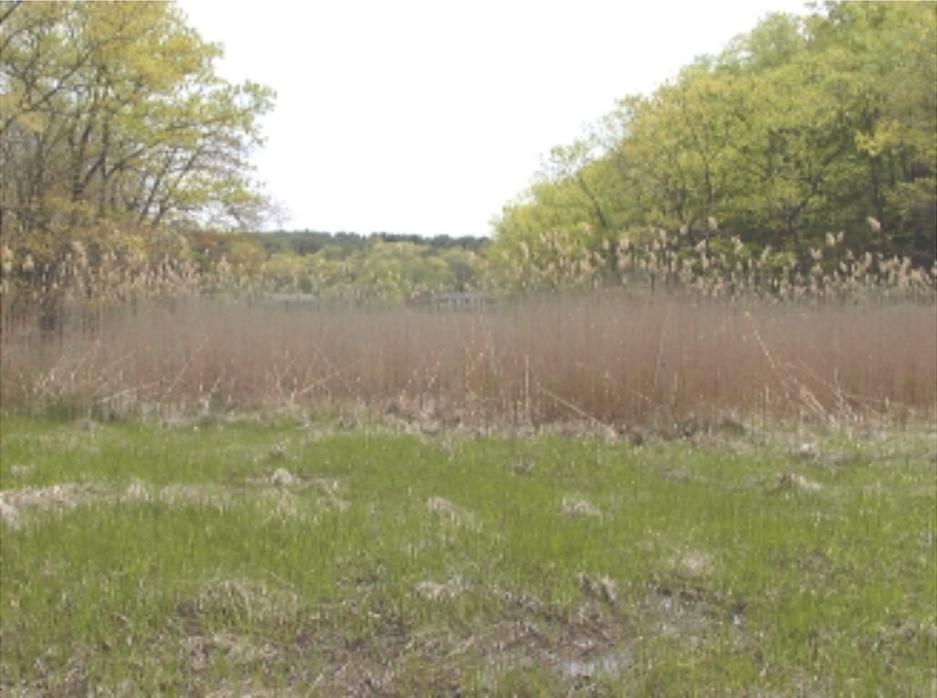
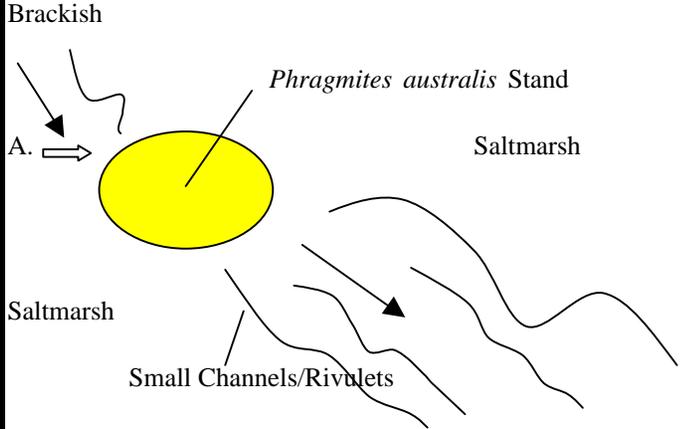
Quad	Site #	Watershed	Wetland Type	Restoration Code	Target Species	Access/Road	Ownership	Waypoint
Q-1	2	Walker Creek Trib.	Brackish Marsh	IM	Estuarine	None	Unknown	3
<b>Notes</b>				<b>Photo</b>				
Transition zone area (salt to fresh water)				A.				
No clear channel definition adjacent to <i>Phragmites</i> growth area

Watershed has a slight elevation drop								
Little natural disturbance								
As one moves up watershed more of a defined stream channel								
Phragmites stand approx. 30'x 30'

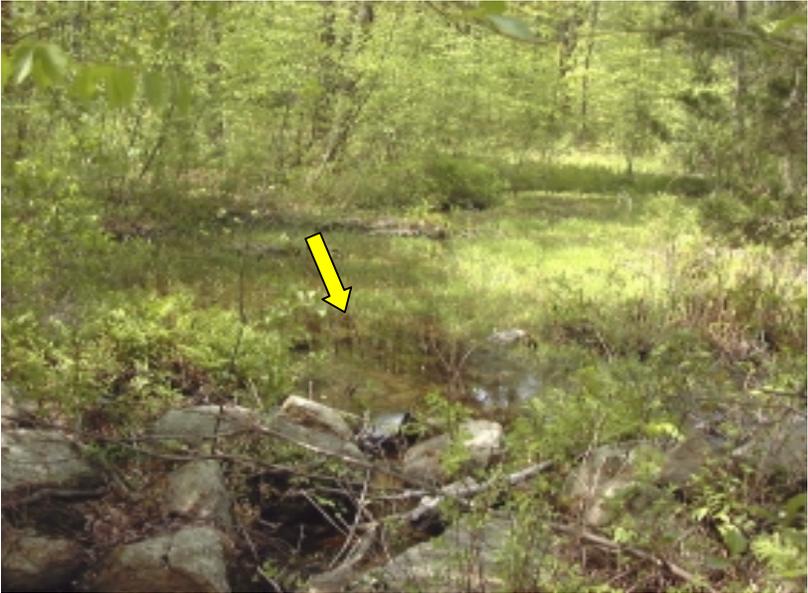
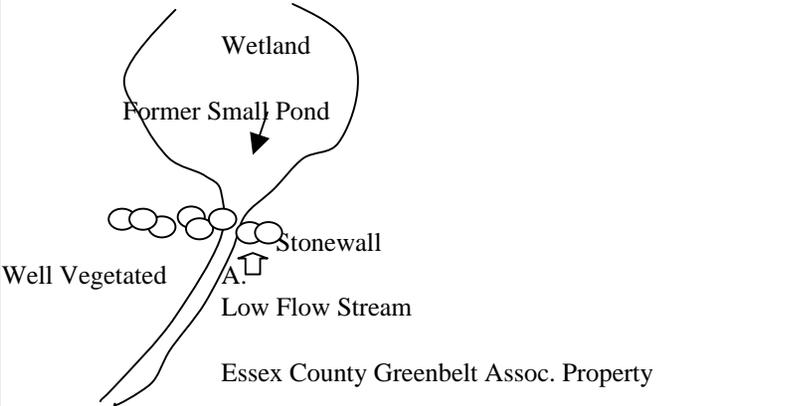
Quad	Site #	Watershed	Wetland Type	Restoration Code	Target Species	Access/Road	Ownership	Waypoint
Q-1	3	Walker Creek Trib.	Deep Marsh/Wooded Swamp Deciduous	FR	Riverine	None	Private	4
<b>Notes</b>				<b>Photo</b>				
Homeowner seems to have attempted to create a pond				<b>A.</b>

HDPE liner present								
Small stone dam								
75 yards behind private residence								
Property abuts and impacts Essex County Greenbelt Assoc. property								
Pond filling in - reverting to an emergent swamp								
Seems to have been some canopy removal

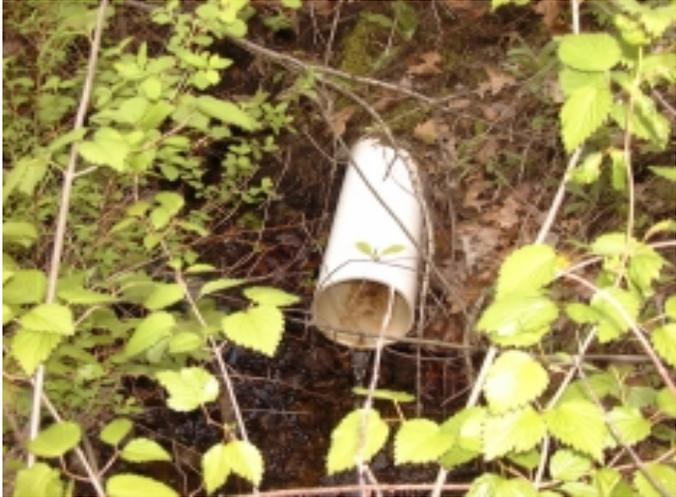
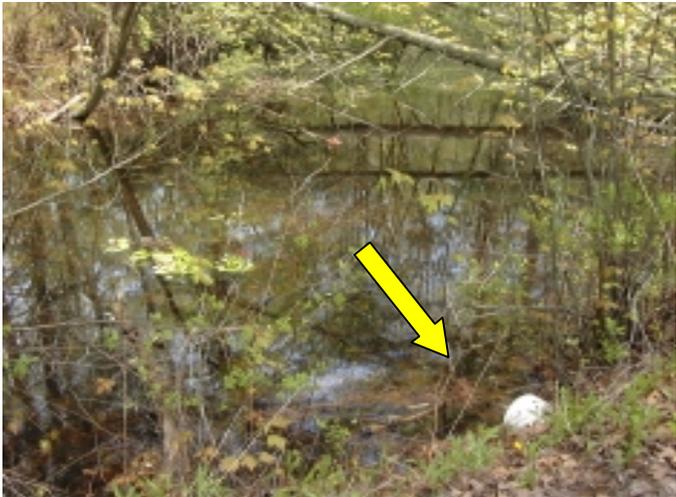
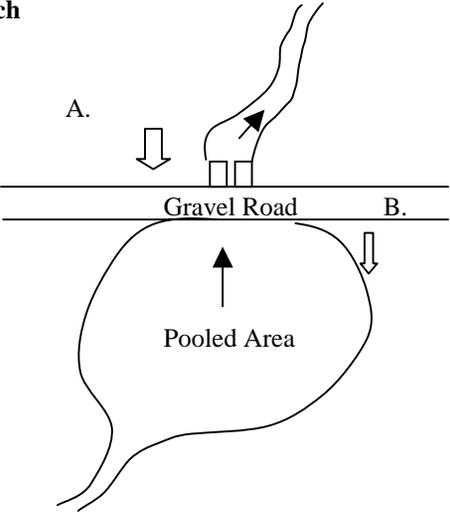
Quad	Site #	Watershed	Wetland Type	Restoration Code	Target Species	Access/Road	Ownership	Waypoint
Q-1	4	Ebben Creek Trib.	Deep Marsh/Wooded Swamp Deciduous	CU	Riverine	Unnamed	Private	5
<b>Notes</b>				<b>Photo</b>				
Stream flows under road, towards Essex not Walker Creek				A.

Two small 12" culverts								
Small culverts as well as driveway restrict natural flow								
Upstream - small pool is formed								
Larger culvert would restore more natural flow but may reduce value of vernal pool like restricted area.								
Culvert set high								
Essex County Greenbelt Assoc. land adjacent to culvert								
<b>Sketch</b>				B.

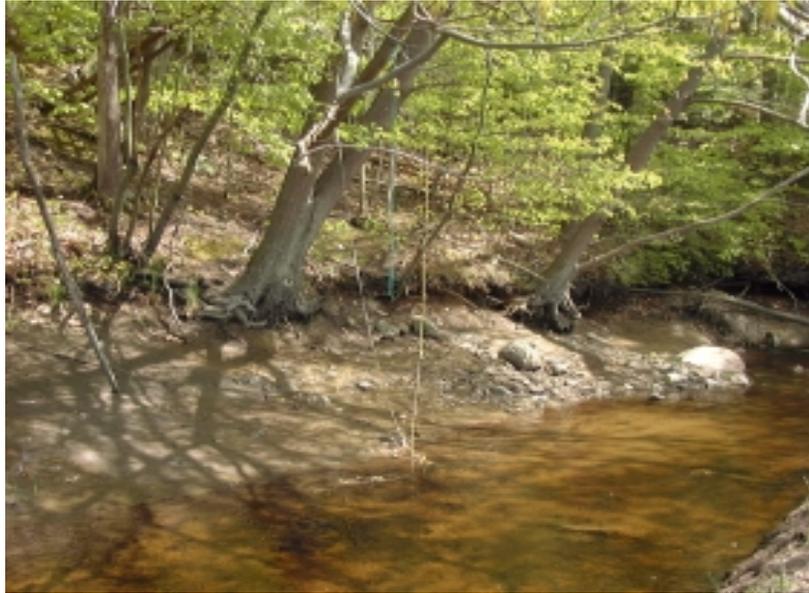
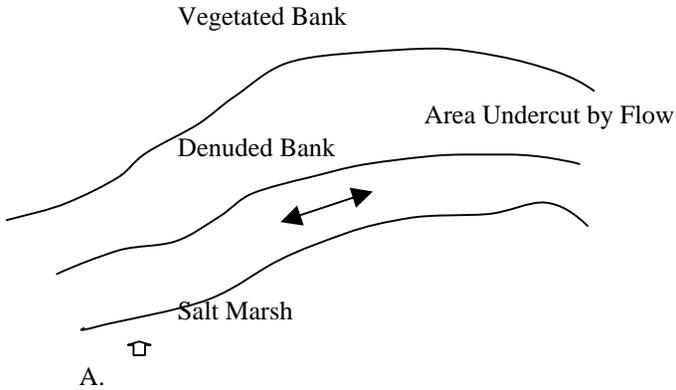
Quad	Site #	Watershed	Wetland Type	Restoration Code	Target Species	Access/Road	Ownership	Waypoint
Q-1	5	Walker Creek	Salt Marsh	BI	Estuarine	Concord St.	Private	6
<b>Notes</b>				<b>Photo</b>				
Appears to be a swimming area				A.				
Bank denuded due to apparent human use

Limited restoration potential if continued use as swimming area								
Some trash could be removed from area								
At transition zone fresh to salt								
Probably within rainbow smelt spawning area								
<b>Sketch</b>

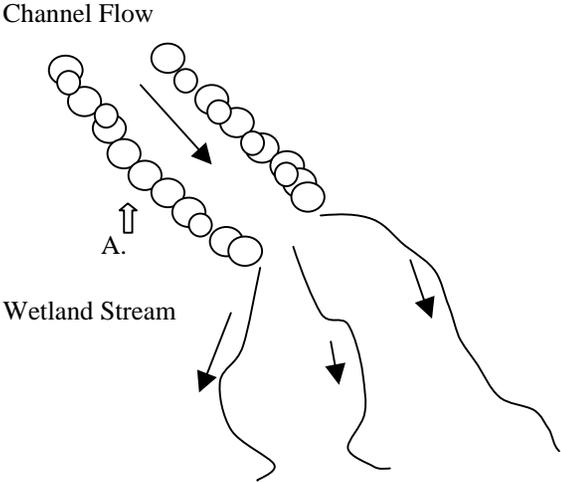
Quad	Site #	Watershed	Wetland Type	Restoration Code	Target Species	Access/Road	Ownership	Waypoint
Q-1	6	Walker Creek	Shrub Swamp	BI	Anadromous/Catadromous	Essex Ave.	Unknown	7
<b>Notes</b>				<b>Photo</b>				
Stream channelized, enhances deep water flow				<b>A.</b>

Below channel wetland stream conditions								
Area would provide sufficient depth for alewife passage								
Banks are loose stone								
If alewife passage is a goal this area may not need to change								
<b>Sketch</b>

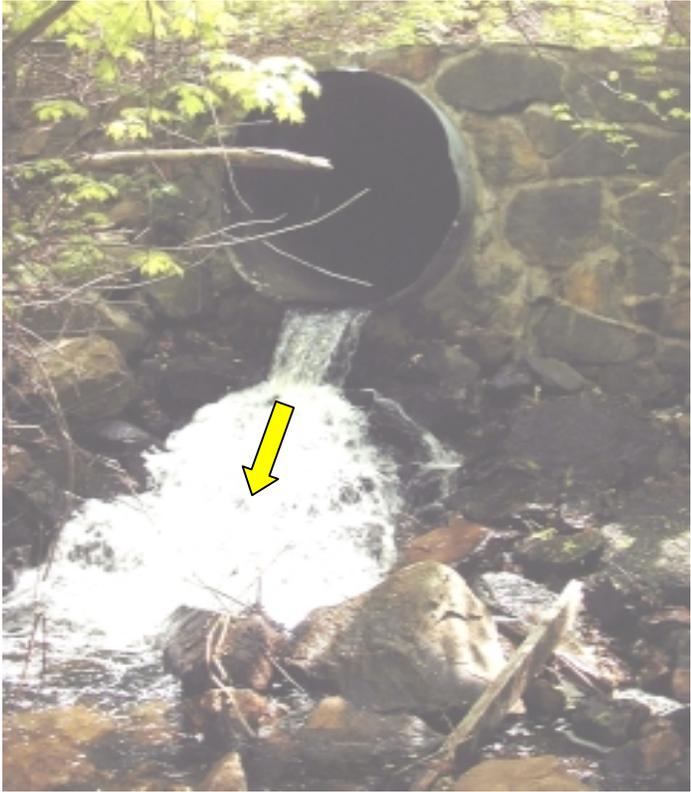
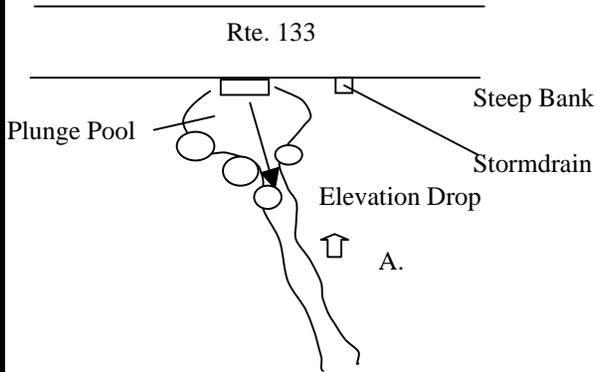
Quad	Site #	Watershed	Wetland Type	Restoration Code	Target Species	Access/Road	Ownership	Waypoint
Q-1	7	Walker Creek	Wooded Swamp Deciduous	CU, RR, BMP, FL	Anadromous/Catadromous	Essex Ave.	Public	8
<b>Notes</b>				<b>Photo</b>				
Culvert set too high for fish passage				A.				
Improvement to eliminate water fall would aid passage potential

Approx. 4' steel culvert								
Plunge pool formed below culvert outlet								
Stormdrain outlet discharges untreated to stream								
Culvert upgrade or fish ladder to existing culvert may solve passage issues								
<b>Sketch</b>

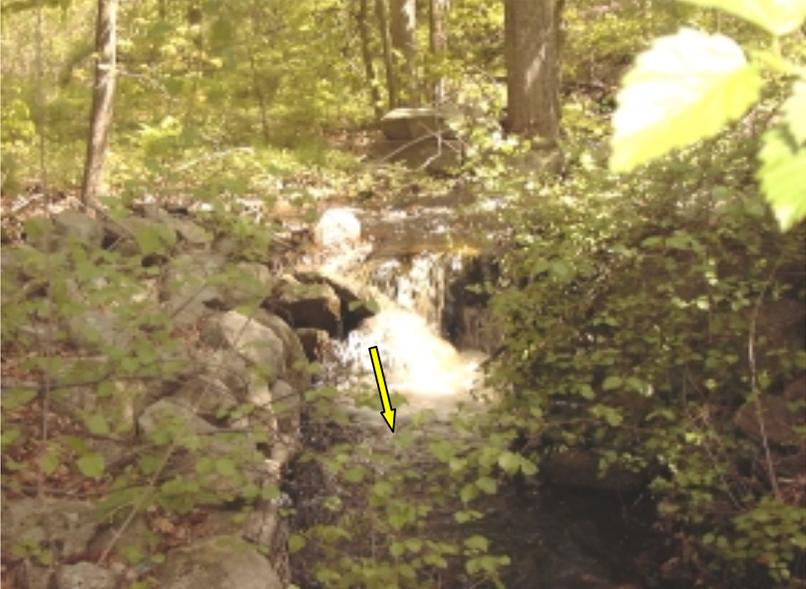
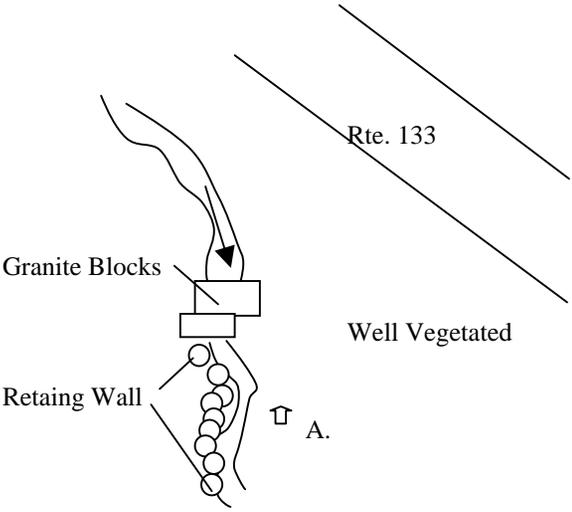
Quad	Site #	Watershed	Wetland Type	Restoration Code	Target Species	Access/Road	Ownership	Waypoint
Q-1	8	Walker Creek Trib.	Wooded Swamp Deciduous	FR	Riverine	Sumner St./Essex Ave.	Private	9
<b>Notes</b>				<b>Photo</b>				
Granite blocks in stream retard water flow				<b>A.</b>

Blocks create small water fall								
Impact to resource area slight due to no anadromous fish usage								
Need to determine impact to eels								
Possibly an old mill site								
Good canopy along stream								
<b>Sketch</b>

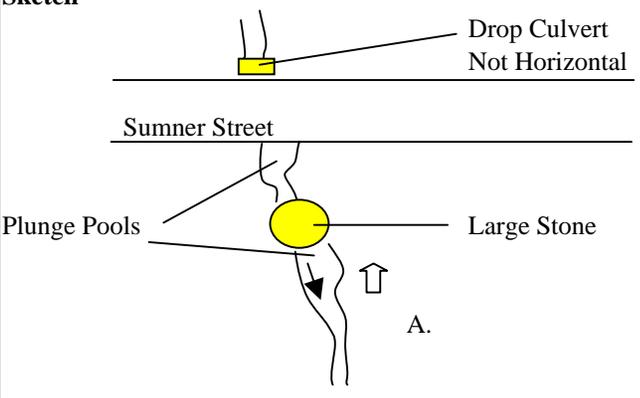
Quad	Site #	Watershed	Wetland Type	Restoration Code	Target Species	Access/Road	Ownership	Waypoint
Q-1	9	Walker Creek Trib	Shrub Swamp	FR, CU	Riverine/Catadromous	Sumner St.	Unknown	10
<b>Notes</b>				<b>Photo</b>				
Large elevation drop from across the street

Road appears to be an old mill foundation								
Elevated box culvert creates waterfall								
Large stone in stream retards flow								
Plunge pools are present								
Upstream water flows through flat drop culvert								
Granite box culvert								
<b>Sketch</b>				A.

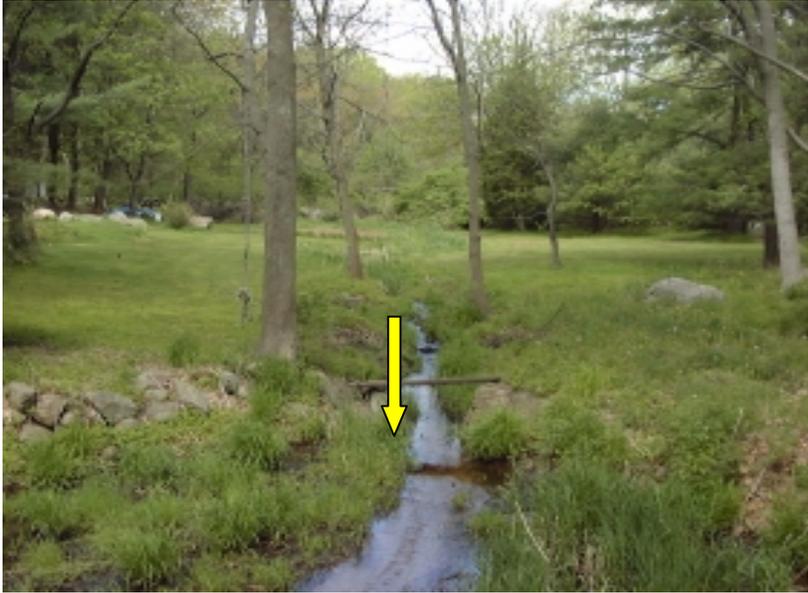
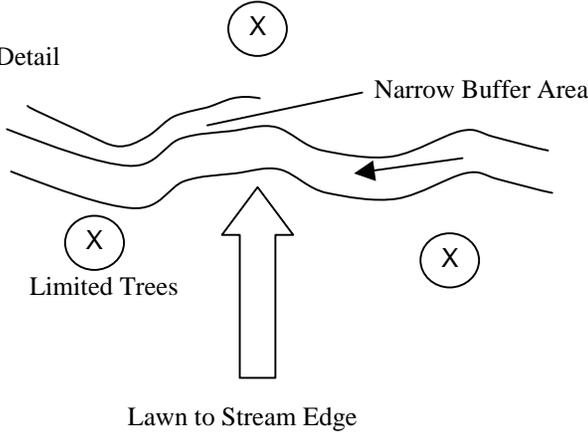
Quad	Site #	Watershed	Wetland Type	Restoration Code	Target Species	Access/Road	Ownership	Waypoint
Q-1	11	Walker Creek Trib.	Shallow Marsh Meadow	BE	Riverine	Lincoln St./Walker St.	Private	12,13
<b>Notes</b>				<b>Photo</b>				
Along stream many areas where lawn comes to stream edge or near stream edge				A.				
Education campaign about importance of natural riparian buffers

Reduced canopy								
Structures and debris to stream edge								
Entire length of creek could be inventoried for buffer enhancement opportunities								
Waypoints indicate upper and lower end of extent of buffer reduction								
Photo taken at Lincoln Street culvert looking upstream								
<b>Sketch</b>								
Typical Detail

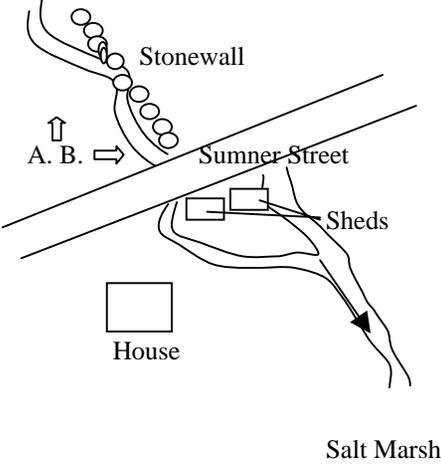
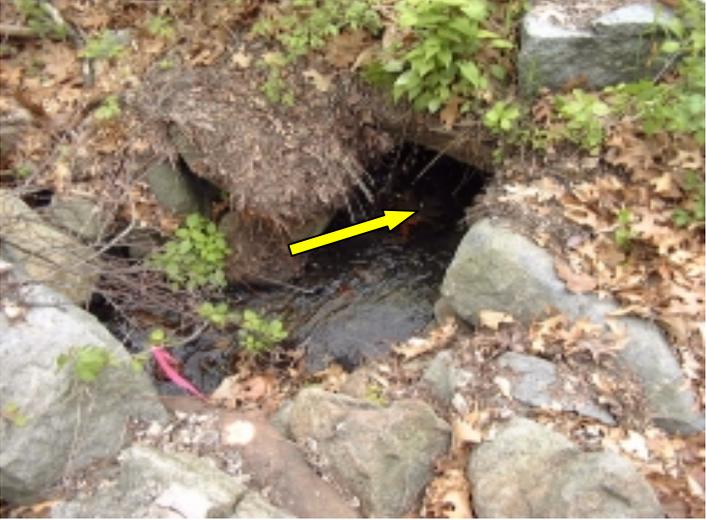
Quad	Site #	Watershed	Wetland Type	Restoration Code	Target Species	Access/Road	Ownership	Waypoint
Q-1	12	Walker Creek Trib.	Shallow Marsh Meadow/Wooded Swamp Deciduous	CU, BE, BMP	Catadromous	Sumner St.	Public/Private	14
<b>Notes</b>				<b>A.</b>				
Upstream horizontal drop culvert

Downstream waterfall								
Upstream stream buffer reduced by cutting								
Stonewall criss crosses stream, upstream								
Drop culvert on upstream								
Transition zone between salt and fresh								
<b>Sketch</b>				<b>B.</b>

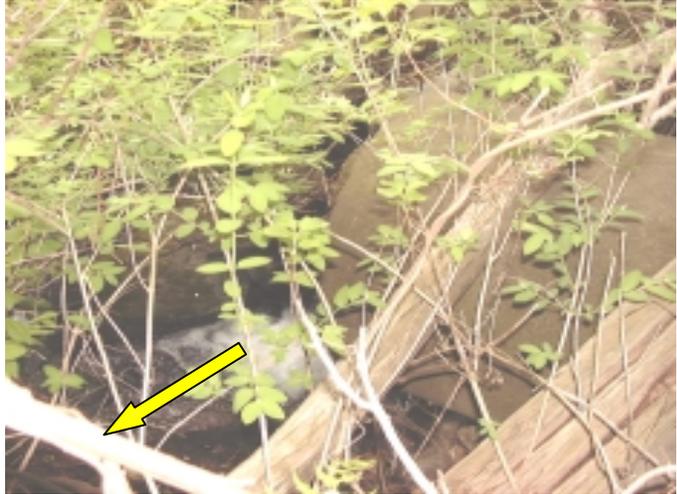
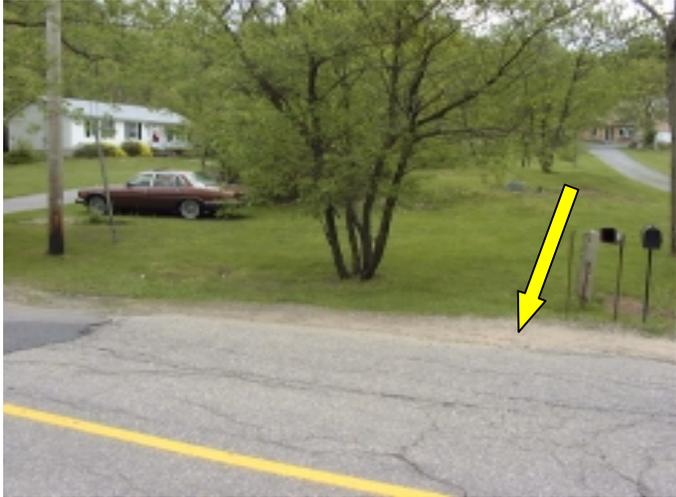
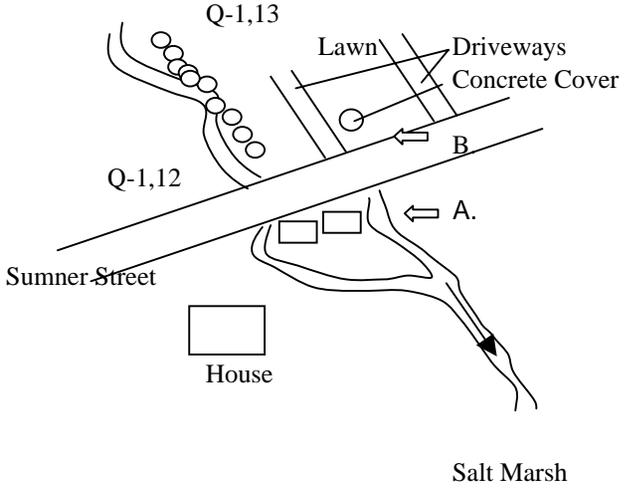
Quad	Site #	Watershed	Wetland Type	Restoration Code	Target Species	Access/Road	Ownership	Waypoint
Q-1	13	Walker Creek Trib.	Shrub Swamp	DL, BMP, CU, BE	Catadromous	Sumner St.	Public/Private	15
<b>Notes</b>				<p>A.</p>

Upstream - no inlet culvert found								
Downstream - waterfall								
Transition zone between salt and fresh								
Site adjacent to Q-1, 12								
Concrete pad may cover stream								
Amount of potential daylight not known, over 100 yards								
Lawn replaces stream								
Flow seen downstream indicates probably intermittent stream or small perennial stream similar to Q-1,12								
Typical steep elevation drop from salt to fresh seen along								
Discharge to north bank of Walker Creek								
Young trees over approximate area of fill (see photo)								
Pond shown on USGS upstream								
<b>Sketch</b>

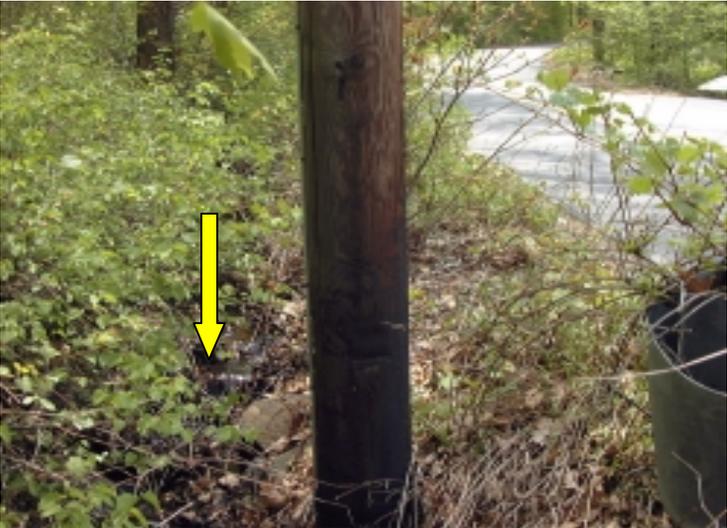
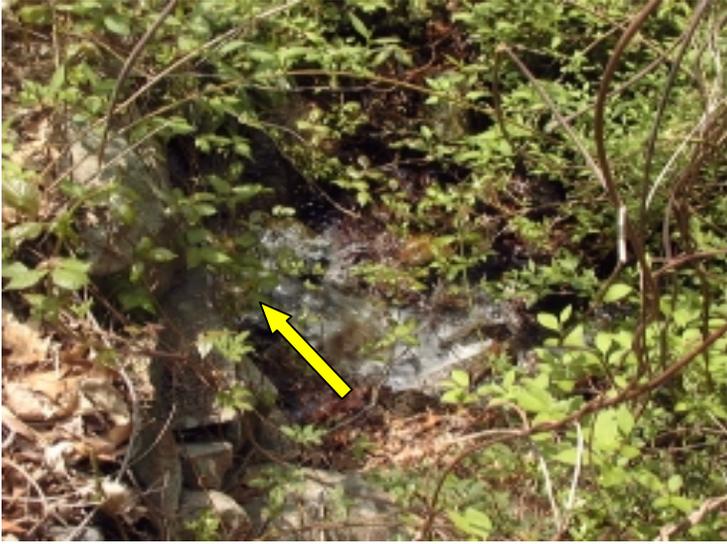
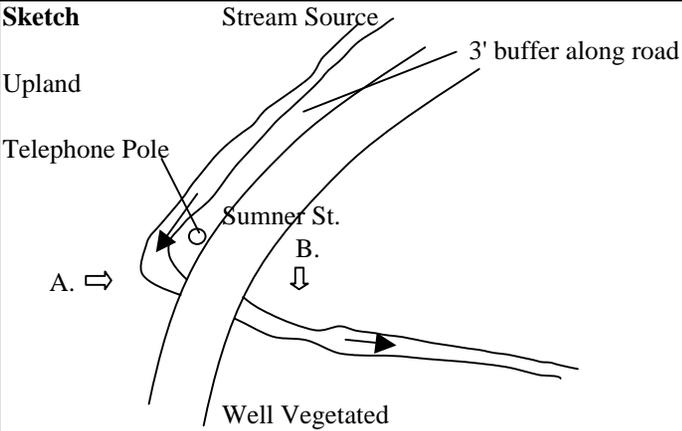
Quad	Site #	Watershed	Wetland Type	Restoration Code	Target Species	Access/Road	Ownership	Waypoint
Q-1	14	Walker Creek Trib.	Shrub Swamp	BMP, BE	Riverine	Sumner St.	Public	16
<b>Notes</b>				A.

Upstream flow along street								
Low flow stream								
Natural stream is probably part of roadside drainage								
Steep drop to Walker Creek								
Could do stormwater enhancement along road								
Limited restoration potential due to proximity to road								
Swale and banks are vegetated								
Culvert outlet - drop flow								
<b>Sketch</b>				B.

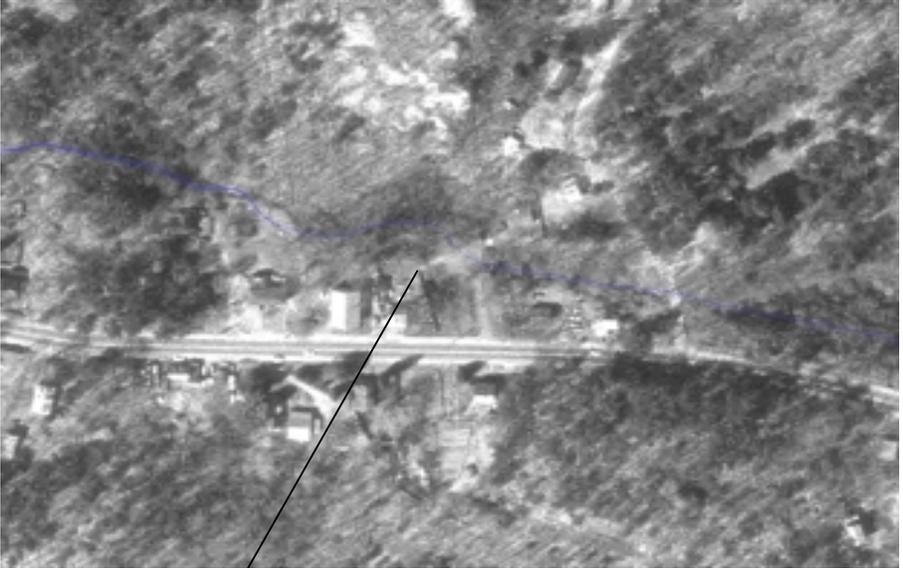
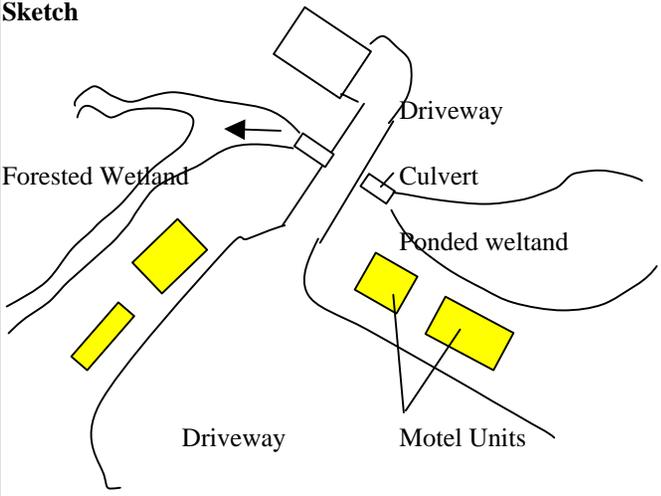
Quad	Site #	Watershed	Wetland Type	Restoration Code	Target Species	Access/Road	Ownership	GPS - ID
Q-1	15	Walker Creek Trib.	Shrub Swamp/Wooded Swamp Deciduous	BE, CU	Riverine	Essex Ave.	Private	17
<b>Notes</b>				<b>Air Photo</b>				
Area altered by close development to stream				<p>A.</p>

<p>Motel Driveway</p>				
Area most likely historic fill								
Stream flows against edge of motel buildings								
Recently installed culvert too small, creates wetland stream above								
Dense residential activity adjacent to stream								
Larger culvert or bridge may reduce upstream wetlands								
<b>Sketch</b>

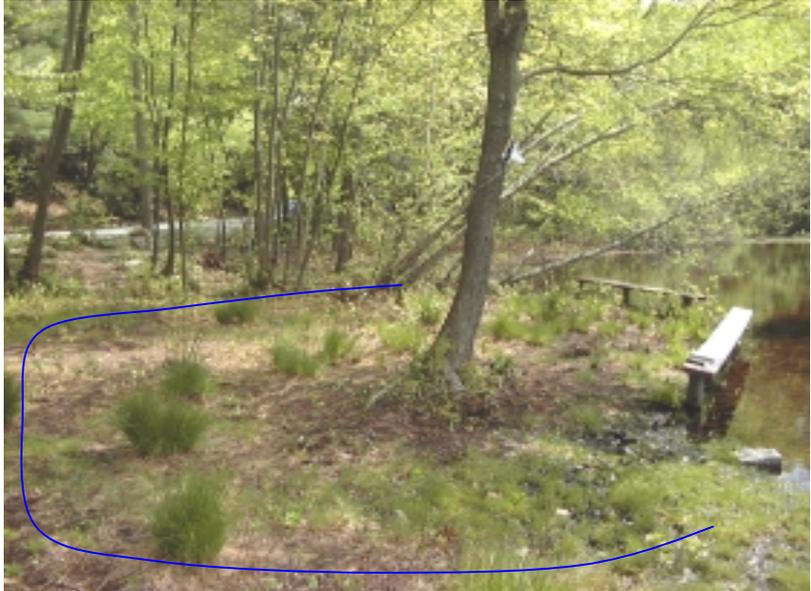
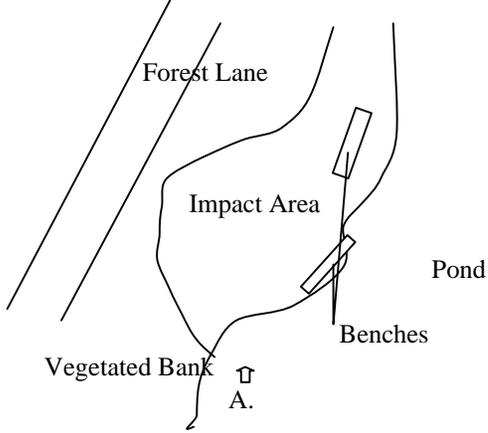
Quad	Site #	Watershed	Wetland Type	Restoration Code	Target Species	Access/Road	Ownership	Waypoint
Q-1	16	Walker Creek	Wooded Swamp Deciduous	BE	Riverine	Forest Lane	Public	18
<b>Notes</b>				<b>Photo</b>				
Impact from human use				<b>A.</b>

Area might be restricted access during growing season								
Soil compaction may exacerbate problems of re-growth								
High visibility potential								
Stewardship of area may be a problem								
<b>Sketch</b>

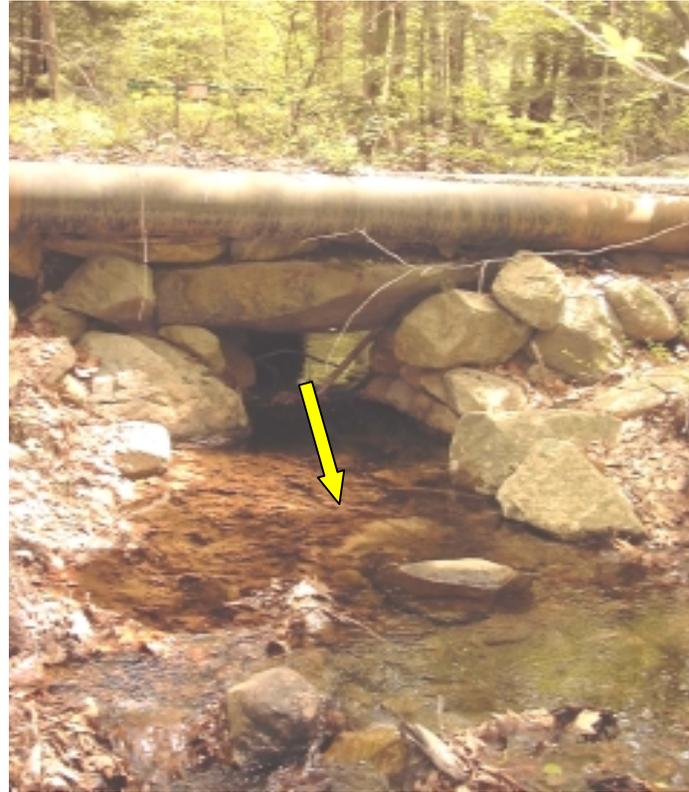
Quad	Site #	Watershed	Wetland Type	Restoration Code	Target Species	Access/Road	Ownership	Waypoint
Q-1	17	Walker Creek	Wooded Swamp Mixed Trees	CU,FR	Riverine	Forest Lane	Unknown	19
<b>Notes</b>				A.				
Bridge may serve private property								
Steal pipes probably do not contain utilities								
Bridge could be improved to reduce potential for stream blockage								
Low priority site								
Stream may have potential for native trout if adequate base flow								
Stream has good canopy								
Alewife run may not likely due to lack of base flow								
<b>Sketch</b>								
<b>Restoration Priority</b>								
<i>General Classification: minor</i>								
<i>Restoration Potential Score: NA</i>

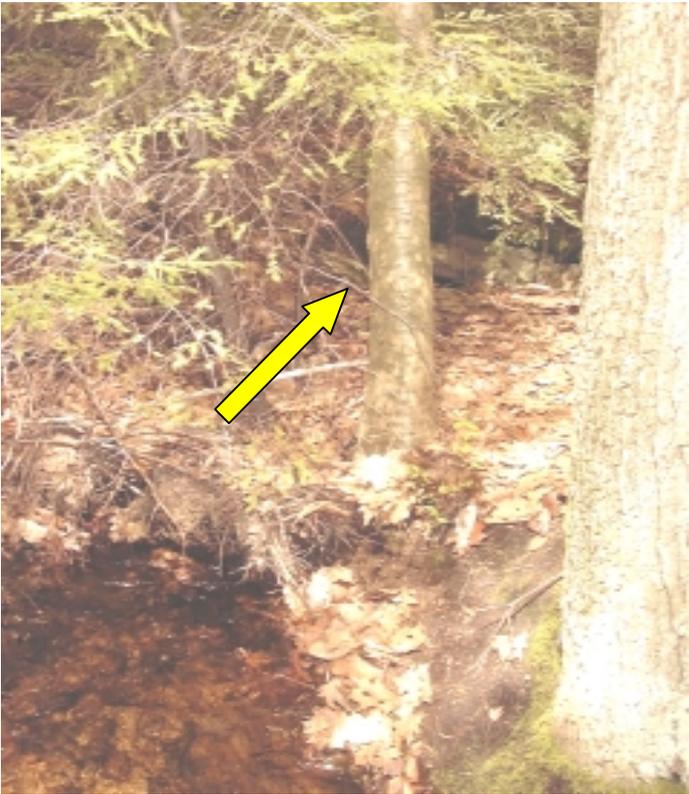
Quad	Site #	Watershed	Wetland Type	Restoration Code	Target Species	Access/Road	Ownership	Waypoint
Q-1	18	Walker Creek	Wooded Swamp Coniferous	DL, TR	Riverine	Forest Lane	Unknown	20
<b>Notes</b>				<b>Photo</b>				
Appears to be an old bridge				A.				
Trees growing on bridge aid overall canopy								
Limited impact								
Water cooling effect do to shelter, may be positive								
Flow not retarded (high flows only)								
<b>Sketch</b>								
<b>Restoration Priority</b>								
<i>General Classification:</i> minor								
<i>Restoration Potential Score:</i> NA

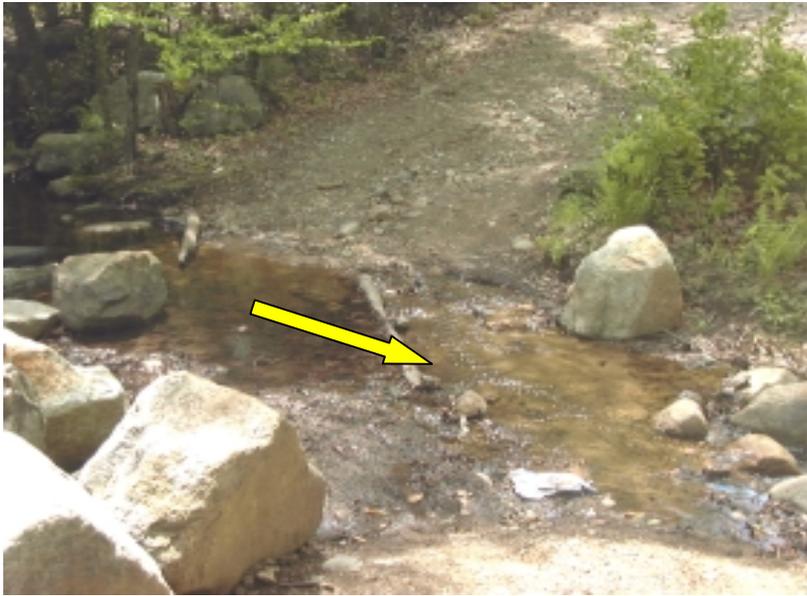
Quad	Site #	Watershed	Wetland Type	Restoration Code	Target Species	Access/Road	Ownership	Waypoint
Q-1	19	Walker Creek	Wooded Swamp Mixed Trees	BE, TR	Riverine	Forest Lane	Unknown	21
<b>Notes</b>				<b>Photo</b>				
Area used for recreational access to pipeline right-of-way				A.				
Bank degradation causes stream sedimentation								
Area prone to dumping due to proximity to road								
Culvert may not needed, need to limit area of denudation								
River becomes wider due to impact								
<b>Sketch</b>

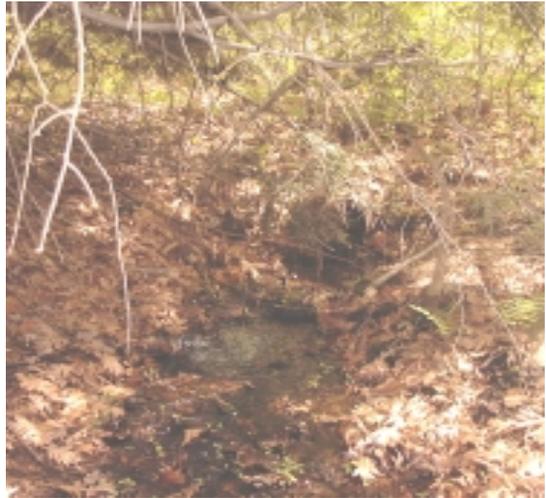
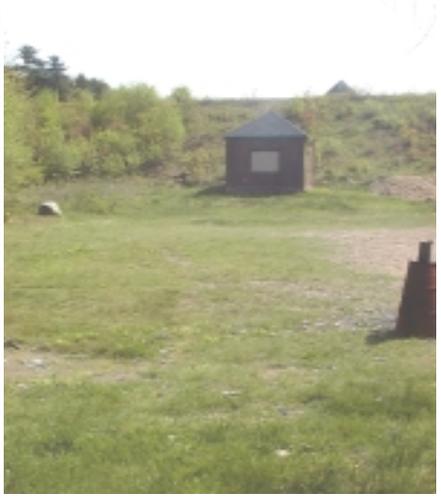
Quad	Site #	Watershed	Wetland Type	Restoration Code	Target Species	Access/Road	Ownership	Waypoint
Q-1	20	Walker Creek	Shallow Marsh Meadow	DL, BE	Riverine	Forest Lane	Municipal	22
<b>Notes</b>								
Stream runs under lawn				A.				
Outlet culvert approx. 1' in diameter				B.				
Approx. 100' of buried culvert

Source is small wetland that is probably feed by dam seep

Daylighting could be allowed with small bridge for access needs								
Walker Creek source (also spillway during high lake levels)								
Good potential to create resource area and replace upland								
Restoration could reduce stormwater build-up at dam base								
<b>Sketch</b>				C.

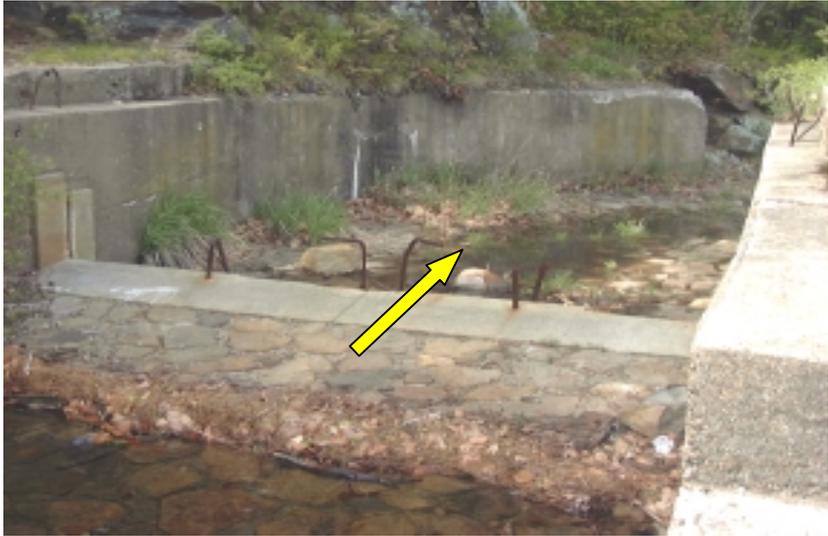
Quad	Site #	Watershed	Wetland Type	Restoration Code	Target Species	Access/Road	Ownership	Waypoint
Q-1	21	Walker Creek	Shrub Swamp	FL	Anadromous	Forest Lane	Municipal	23
<b>Notes</b>				A.				
Spillway for overflow

Not designed for anadromous fish								
Flashboards regulate flow								
Spillway drains to wetland - not main stream								
Steep run								
Could be retrofitted for alewife if good base flows are present and other improvements are made								
Intensive engineering requirements								
Approx. 30' elevation drop over a approx. 50' run								
<b>Sketch</b>				B.

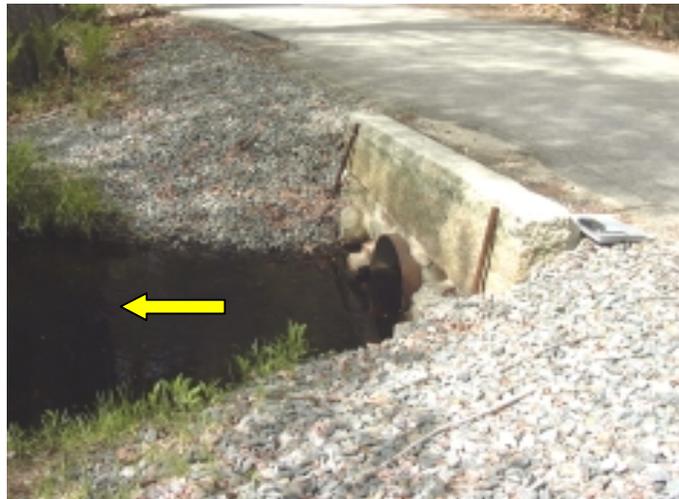
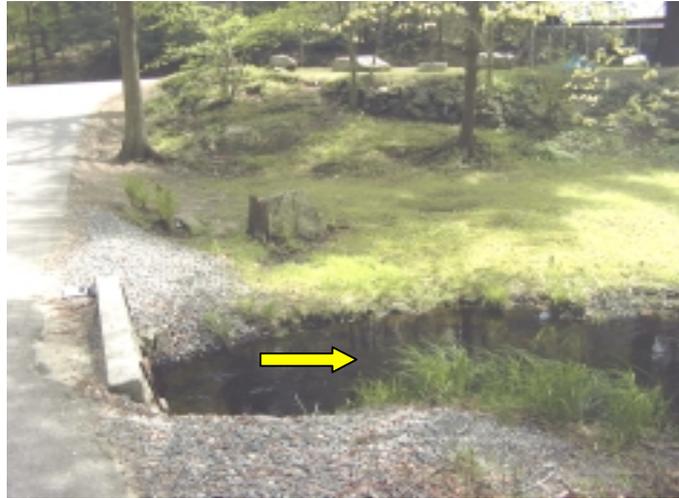
Quad	Site #	Watershed	Wetland Type	Restoration Code	Target Species	Access/Road	Ownership	Waypoint
Q-1	22	Walker Creek Trib.	Shrub Swamp/Wooded Swamp Deciduous	CU,BE	Riverine	Overlook Ave.	Public	24
<b>Notes</b>				<b>A.</b>				
Rip-rap bank stabilization effort reduces natural values								
Lawn comes to edge of stream								
Culvert is adequately sized								
Some ponding upstream								
Stream becomes more of a wetland stream upstream from culvert								
Natural buffer would enhance stream values and functions								
<b>Sketch</b>				<b>B.</b>				
<b>Restoration Priority</b>								
<i>General Classification:</i> minor								
<i>Restoration Potential Score:</i> NA

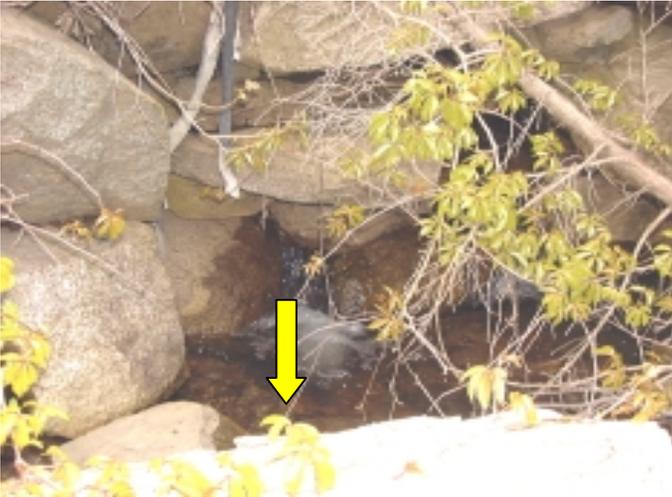
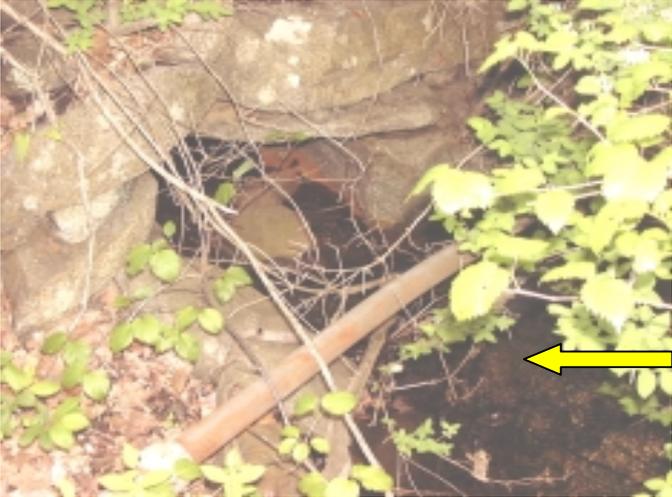
Granite box culvert in disrepair								
Potential smelt spawning area								
Heavy tide wrack build-up in area								
Just upstream of culvert stonewall runs across the stream								
Eel passage impeded								
Alewife potential - probably none - no headwater pond								
Water seeps through rocks								
<i>Phragmites australis</i> noted downstream								
<b>Sketch</b>

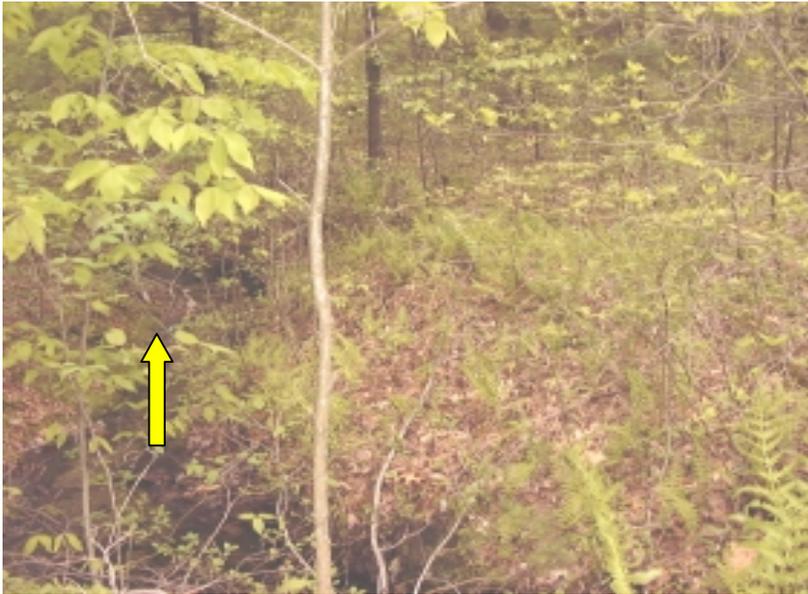
Quad	Site #	Watershed	Wetland Type	Restoration Code	Target Species	Access/Road	Ownership	Waypoint
Q-1	24	Unnamed	Wooded Swamp Deciduous	FR	Riverine	Concord St.	Unknown	26
<b>Notes</b>				<b>Photo</b>				
Bank looks like the excavation spoils from stream dredging or a drainage project				<p>A.</p>

Creates upland fill in area of natural stream bank								
Area has good canopy cover								
Two berms are 50' to 100' in length								
<b>Sketch</b>

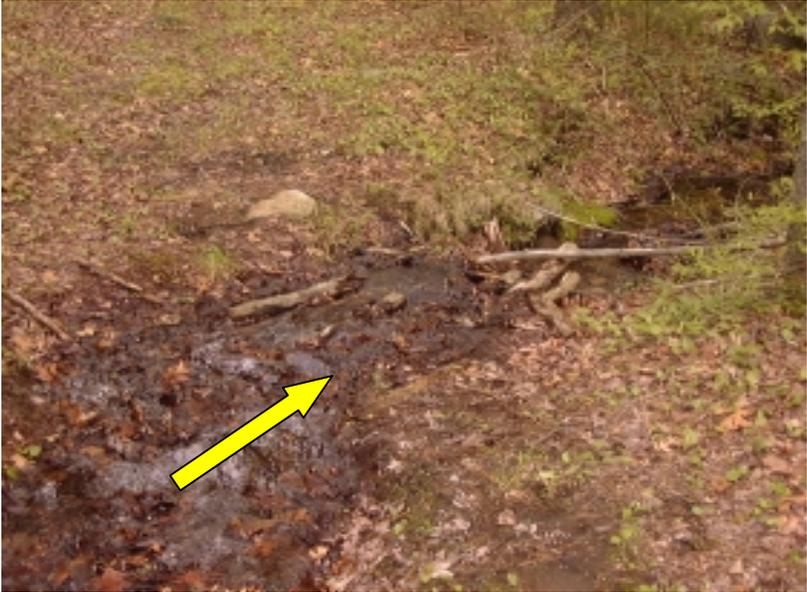
Quad	Site #	Watershed	Wetland Type	Restoration Code	Target Species	Access/Road	Ownership	Waypoint
Q-1	25	Unnamed	Wooded Swamp Deciduous	FR	Riverine	Concord St.	Unknown	27
<b>Notes</b>				<b>Photo</b>				
Minor stream disturbance				A.				
Leaf buildup upstream of bridge

Small corduroy bridge								
<b>Sketch</b>

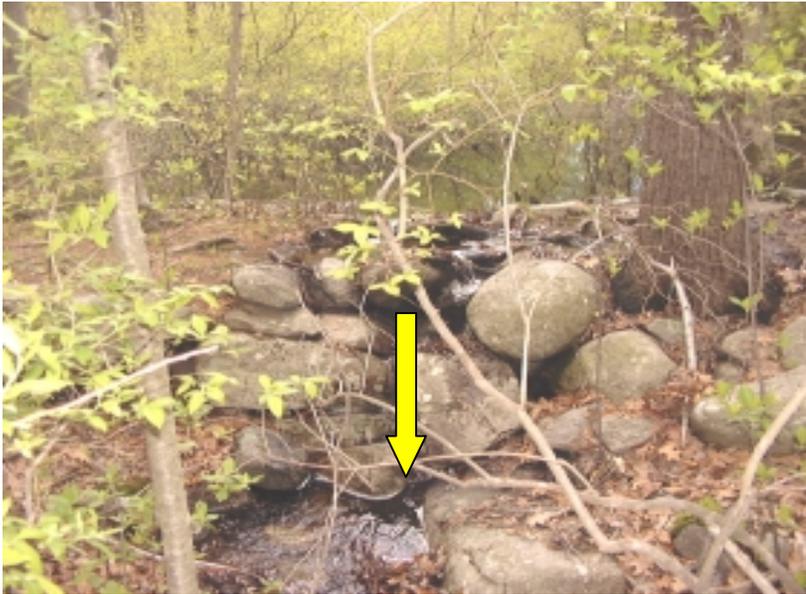
Quad	Site #	Watershed	Wetland Type	Restoration Code	Target Species	Access/Road	Ownership	Waypoint
Q-1	26	Unnamed	Wooded Swamp Deciduous	FR, FL	Riverine	Bray St.	Private	28
<b>Notes</b>				<b>Photo</b>				
Old earthen and stone dam creates impoundment for pond				<p>A.</p>

Berm is vegetated								
Impoundment creates healthy wetland system								
Limited need if no anadromous/catadromous fish passage								
Shrub swamp upstream								
<b>Sketch</b>

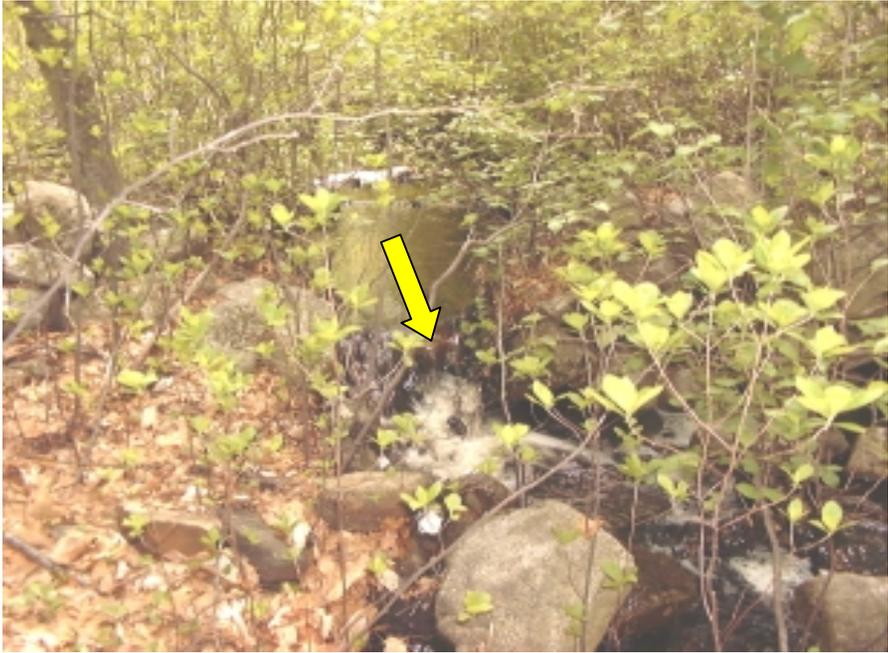
Quad	Site #	Watershed	Wetland Type	Restoration Code	Target Species	Access/Road	Ownership	Waypoint
Q-1	27	Unnamed	Wooded Swamp Deciduous	FR	Riverine	Thompson Cart Path	Municipal	29
<b>Notes</b>				<b>Photo</b>				
Stonewall across stream				<b>A.</b>

Passage obstruction								
Water is detained								
Stream has potential for native brook trout with proper base flows								
Slight disturbance								
Restoration needs to be looked at in context of entire watershed								
Plunge pool formed below								
<b>Sketch</b>

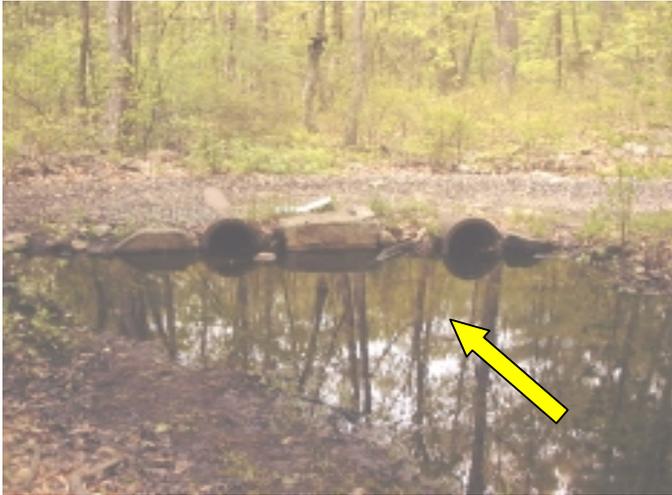
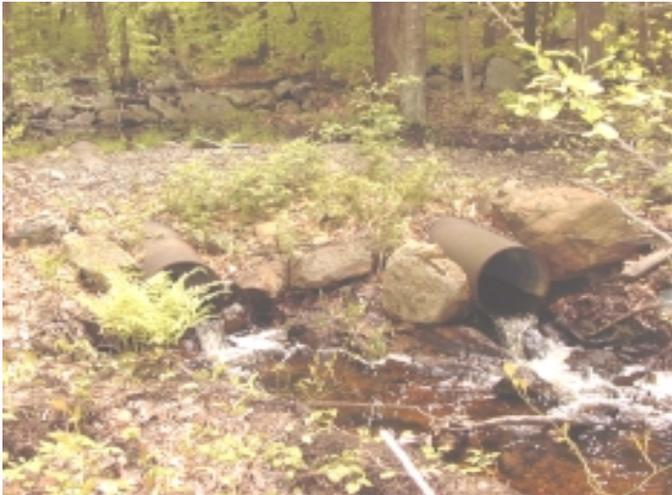
Two steel, 2' culverts								
Fish passage obstruction								
Water is detained								
Stream has potential for native brook trout if proper base flows								
Stonewall as well as culverts detain flow								
Repair needs to be looked at in context of entire watershed								
Gravel from trail slumping into stream								
Sedimentation from trail impacting stream								
Culverts elevated								
<b>Sketch</b>
