# City of Gloucester Comprehensive River and Stream Habitat Restoration Report

2003

Tim Purinton

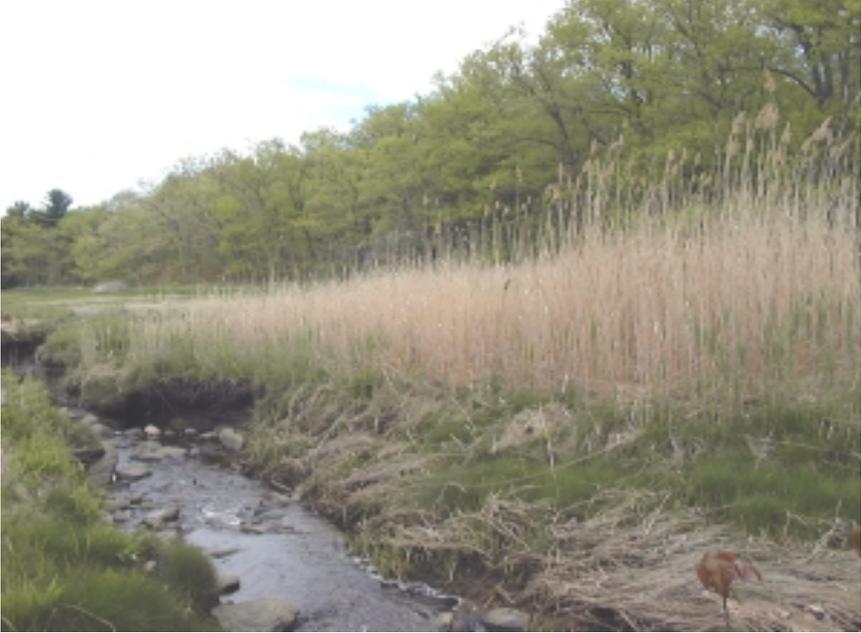
Quad	Site #	Watershed	Wetland Type	Restoration Code	Target Species	Access/Road	Ownership	Waypoint
Q-1	29	Unnamed	Salt Marsh	BMP, IM, TR	Anadromous/Estuarine	Concord St.	Unknown	31
<b>Notes</b>				<b>Photo</b>				
<i>Phragmites australis</i> growth area

Area of <i>Phragmites</i> limited - 50' x 50' (average of two areas)								
Wrack build-up along road and into salt marsh								
No stormdrains noted								
Area could be cleaned out periodically to keep elevations low to discourage <i>Phragmites</i> growth								
Area may be smelt spawning area								
Granite box culvert above (see site 30 and tidal restriction report)								
<b>Sketch</b>

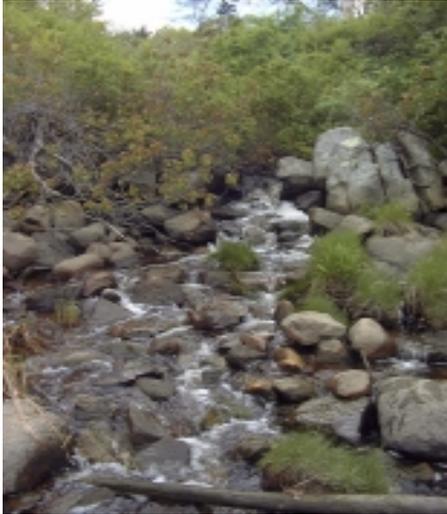
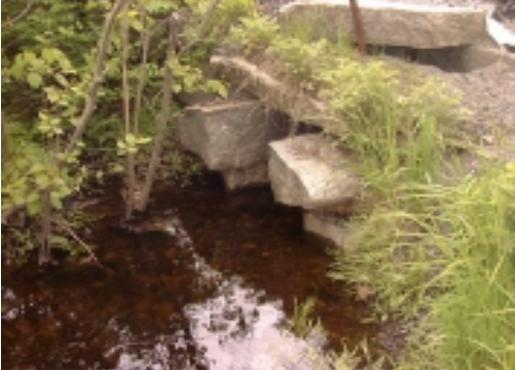
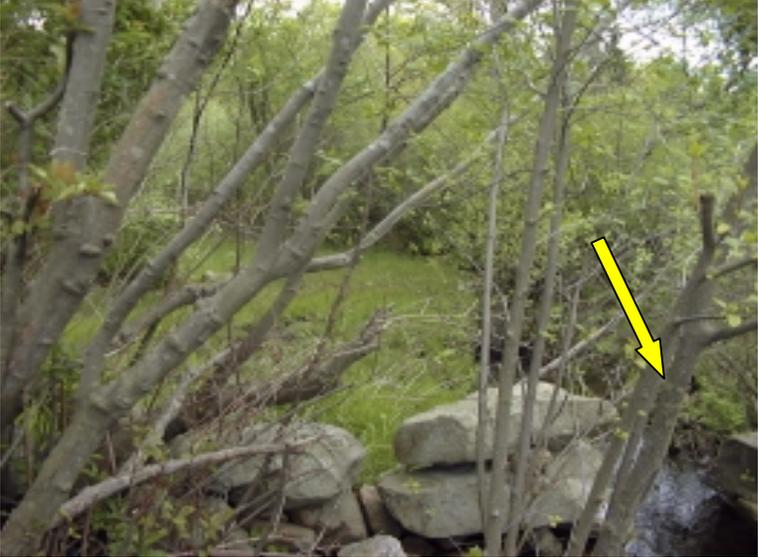
</p>				
Granite box culvert in disrepair (see tidal restriction study)								
Possible smelt spawning area								
Approx. 7' elevation drop from fresh to salt								
Heavy tide wrack build-up in area								
Just upstream of culvert stonewall runs across the stream								
Eel passage impeded								
Alewife potential - limited - no headwater pond								
Water seeps through rocks								
Phragmites noted downstream								
Upstream buffer enhancement lawn to stream edge								
<b>Sketch</b>

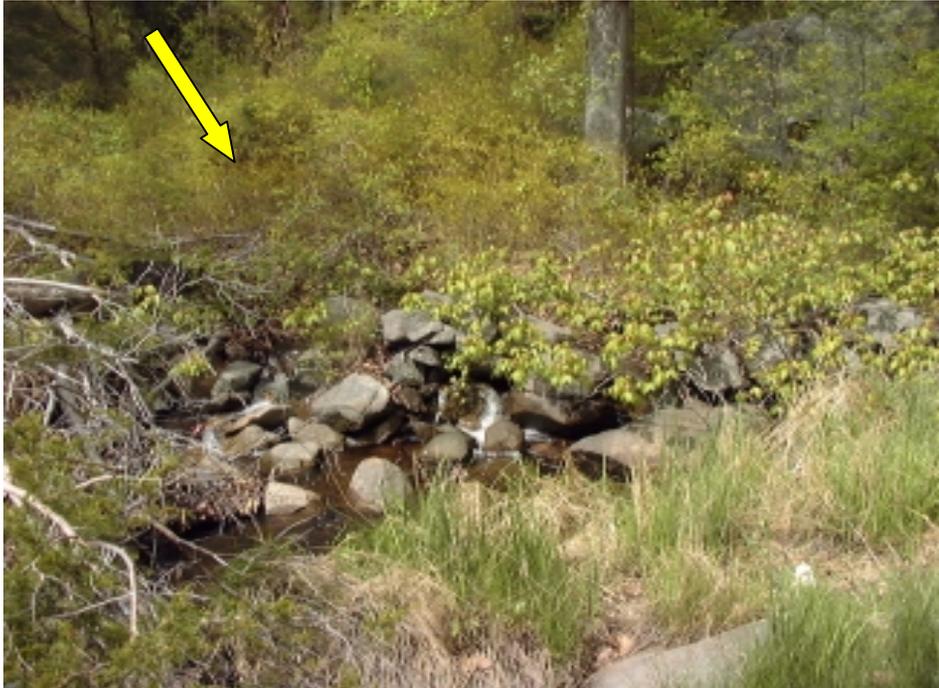
Quad	Site #	Watershed	Wetland Type	Restoration Code	Target Species	Access/Road	Ownership	Waypoint
Q-1	31	Unnamed	Shrub Swamp/Brackish Marsh	FR	Catadromous	Concord St.	Unknown	33
<b>Notes</b>				<b>Photo</b>				
Stonewall across stream				A.				
Stone fill in sensitive transition zone

Removal of stones would establish natural flow								
Easy restoration potential								
Minor disturbance								
Creek downstream is wide and deep, may be smelt spawning area								
Significant elevation change								
<b>Sketch</b>

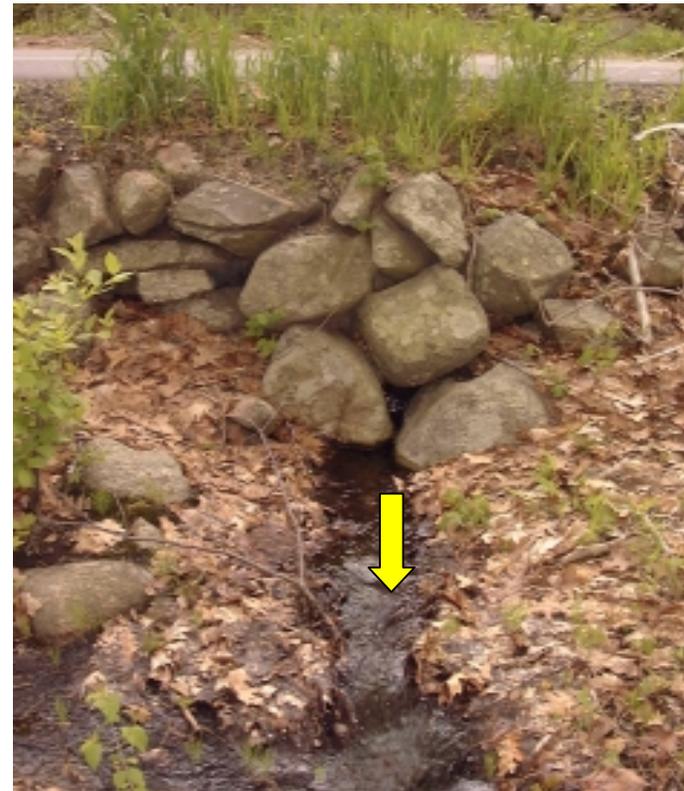
Quad	Site #	Watershed	Wetland Type	Restoration Code	Target Species	Access/Road	Ownership	Waypoint
Q-1	32	Unnamed	Shrub Swamp	CU, BE	Catadromous	Concord St.	Public/Private	34
<b>Notes</b>				<b>Photo</b>				
Inlet of culvert upstream is completely submerged				A.				
Small waterfall created downstream								
Upstream a wetland is formed								
Water seeps through the collapsed culvert								
Downstream lawn to stream edge, need for a greater buffer								
Culvert under private driveway downstream								
Due to restriction - wetland created upstream								
Need to consider improved drainage with wetland loss								
Salt marsh (Site 31) approx. 200 yards below site								
<b>Sketch</b>								
<b>Restoration Priority</b>								
<i>General Classification:</i> minor								
<i>Restoration Potential Score:</i> NA

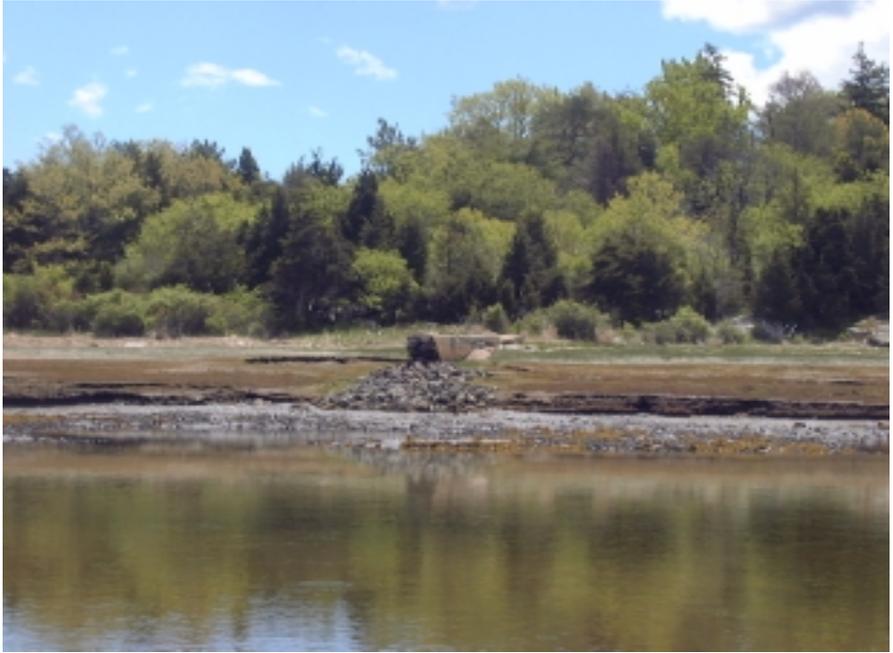
Quad	Site #	Watershed	Wetland Type	Restoration Code	Target Species	Access/Road	Ownership	Waypoint
Q-1	33	Farm Creek	Salt Marsh	FR	Estuarine	Unnamed	Unknown	35 (150' away)
<b>Notes</b>				<b>Photo</b>				
Old concrete pier, not used				<p>A.</p>

End extends to mudflat								
Extension of concrete slab across salt marsh								
Coastal access barrier								
Approx. 30-40 foot structure, 5' feet wide								
Waypoint taken across Farm Creek								
<b>Sketch</b>

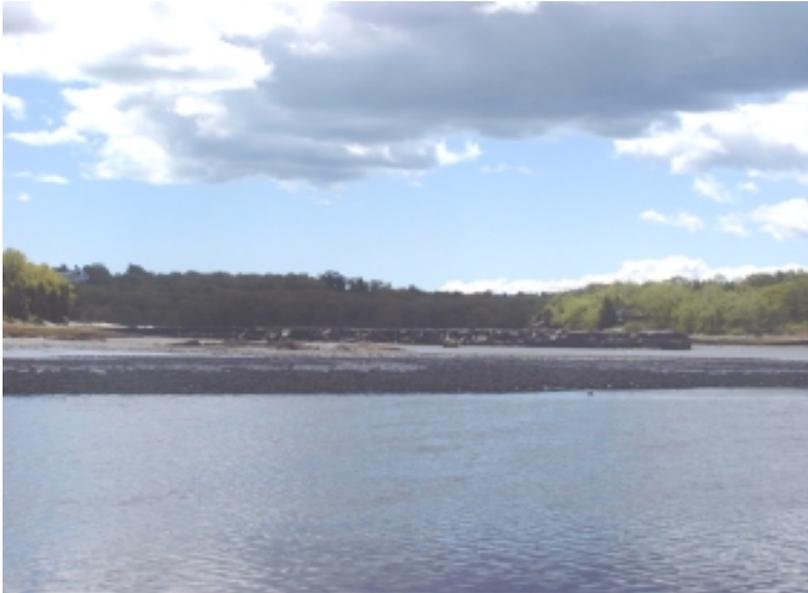
Quad	Site #	Watershed	Wetland Type	Restoration Code	Target Species	Access/Road	Ownership	Waypoint
Q-1	34	Farm Creek	Salt Marsh	FR	Estuarine	Cole Island	Unknown	NA
<b>Notes</b>				<b>Photo</b>				
Sizable pier shown on USGS				A.				
Historic structure composed of granite blocks

Length approximately 400-500 feet								
Pier not inspected close-up								
Pier may have influenced dispersal of sediment and mudflat locations								
<b>Sketch</b>

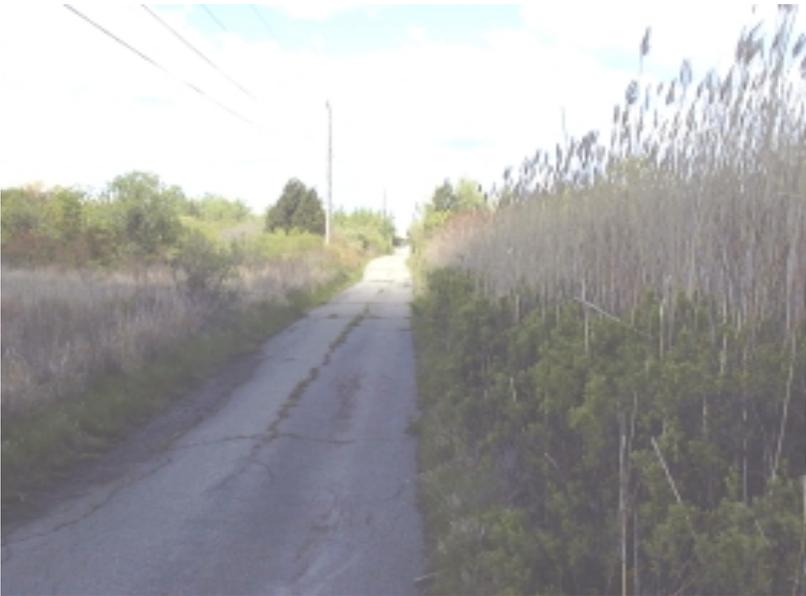
Quad	Site #	Watershed	Wetland Type	Restoration Code	Target Species	Access/Road	Ownership	Waypoint
Q-1	35	Farm Creek	Salt Marsh/Brackish Marsh	FR, CU, IM	Estuarine	Massachusetts Ave.	Unknown	36
<b>Notes</b>				<b>Photo</b>				
Road limits sheet flow across marsh to impacted area

A series of French drains may improve conditions, rather than a single culvert (or paved cross swales)								
Road elevation is low								
Road's utility not known seems low								
Area will probably always remain brackish even with tidal flow improvements								
Feeder creeks or ditches from salt marsh not apparent								
<b>Sketch</b>

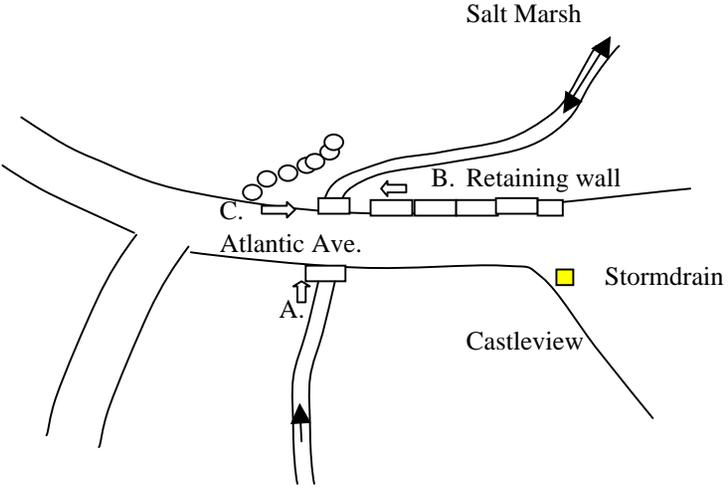
Low flow may reduce alewife passage								
Culvert improvements could be done in conjunction with stormwater improvements								
Erosion along roadway, sedimentation and siltation noted								
Approximately 2'x2' box culvert (upstream)								
Downstream side almost completely blocked								
Downstream stream channel may need to be improved for fish passage								
<b>Sketch</b>				<b>B.</b>

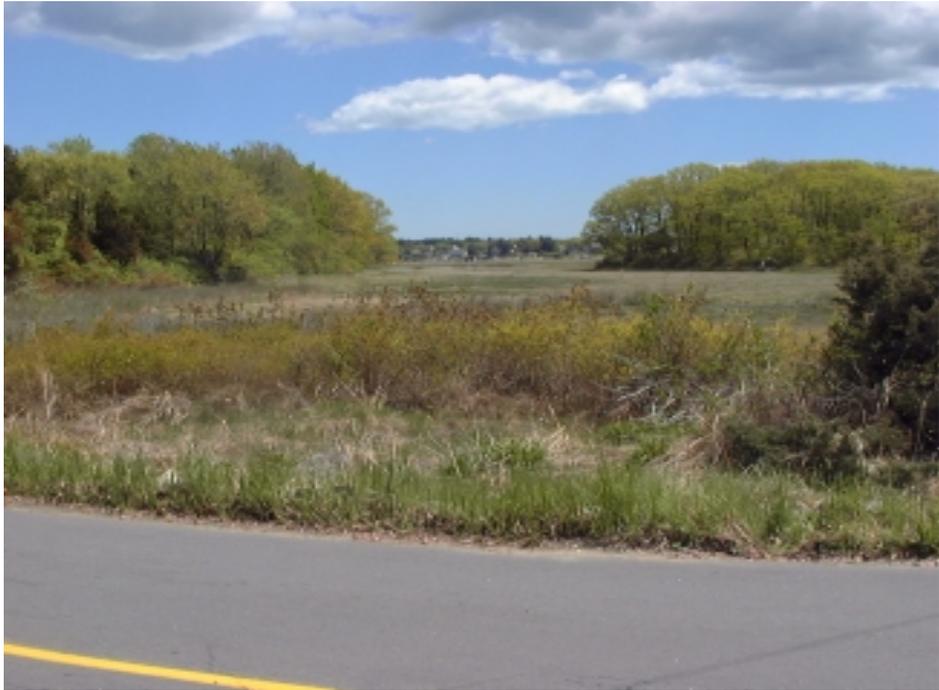
Quad	Site #	Watershed	Wetland Type	Restoration Code	Target Species	Access/Road	Ownership	Waypoint
Q-1	37	Sleepy Hollow Pond	Salt Marsh	FR	Estuarine	Atlantic St.	Public	38
<b>Notes</b>				<b>Photo</b>				
Area of historic fill				A.				
Upland plants dominate disturbed area

Approx. fill limits - 50' x 50'								
Site could be a good mitigation site or a BMP location								
<b>Sketch</b>

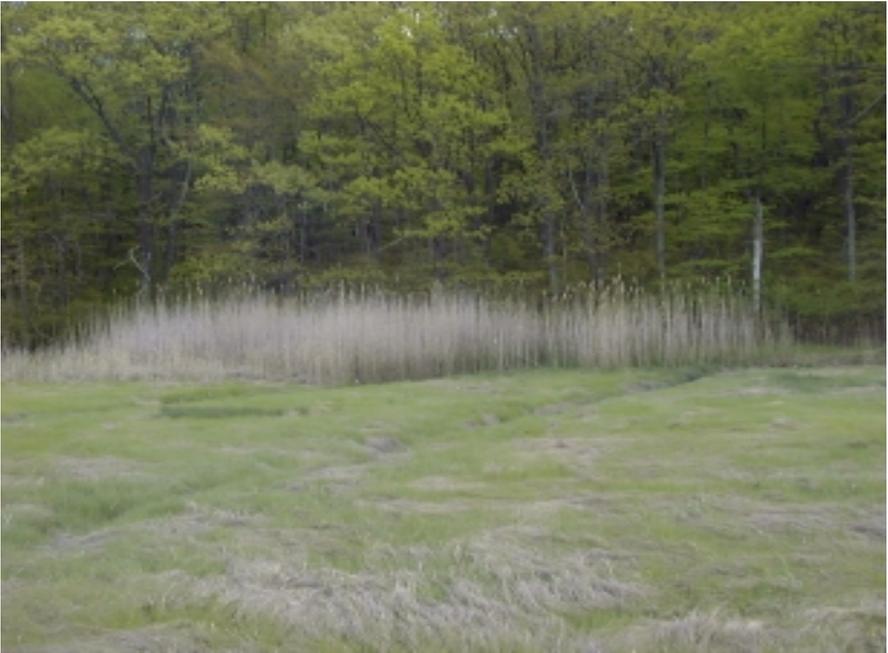
Quad	Site #	Watershed	Wetland Type	Restoration Code	Target Species	Access/Road	Ownership	Waypoint
Q-1	38	Farm Creek	Salt Marsh	IM, OMWM	Estuarine	Bray St.	Unknown	39
<b>Notes</b>				<b>Photo</b>				
Transition zone of <i>Phragmites australis</i> (upland vs. wetland)				A.				
Series of 4-5 small areas (approx. 40'x60') along transition zone

Well defined series of ditches in salt marsh area								
Litter ditches may reduce <i>Phragmites</i> expansion								
Restoration should include all <i>Phragmites</i> areas in marsh area								
Project could be done in conjunction with mosquito control								
<b>Sketch</b>

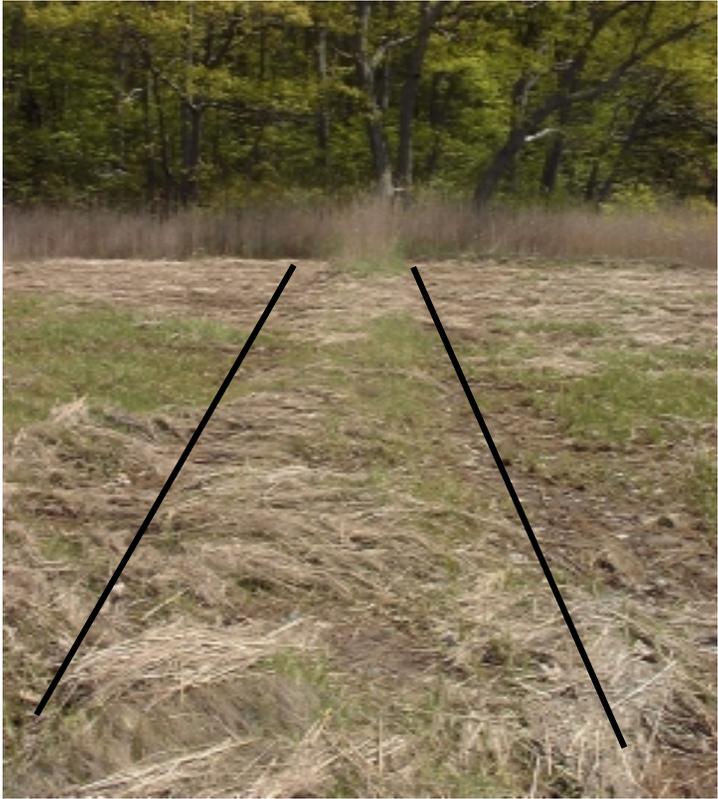
Quad	Site #	Watershed	Wetland Type	Restoration Code	Target Species	Access/Road	Ownership	Waypoint
Q-1	39	Farm Creek	Salt Marsh	FR	Estuarine	Bray St.	Unknown	40
<b>Notes</b>				<b>Photo</b>				
Old berm in salt marsh				A.				
Berm approx. 4' wide

At Bray St. edge Phragmites advancing along berm								
Approx. 6" elevation difference								
Berm collects wrack								
Berm supports high marsh plant species								
<b>Sketch</b>

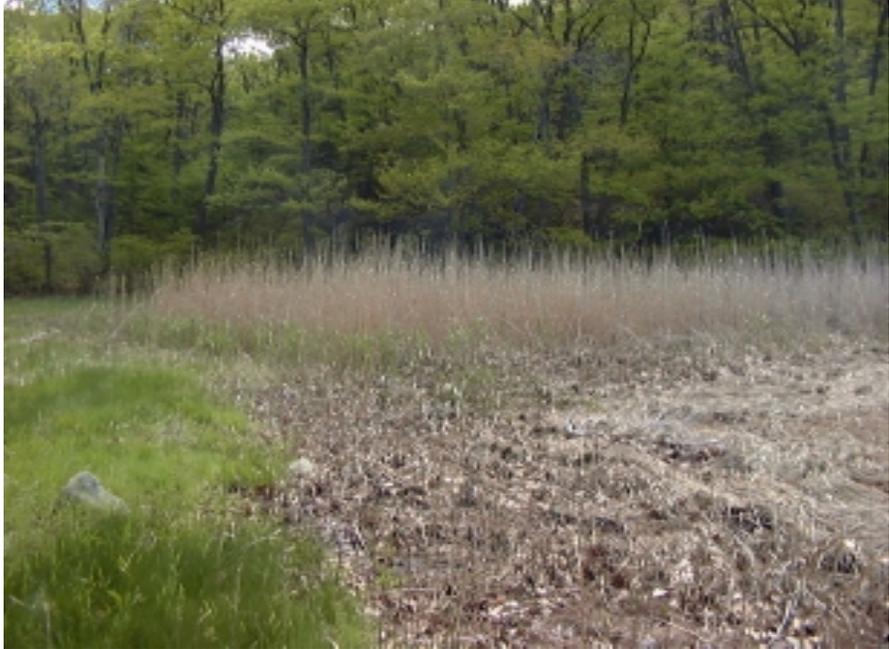
Quad	Site #	Watershed	Wetland Type	Restoration Code	Target Species	Access/Road	Ownership	Waypoint
Q-1	40	Farm Creek	Salt Marsh	IM	Estuarine	Bray St.	Unknown	41
<b>Notes</b>				<b>Photo</b>				
<i>Phragmites australis</i> patch measuring approx. 100' x 75'				A.				
In transition zone between upland (freshwater) and salt marsh

Limited restoration potential								
Isolated area								
<b>Sketch</b>

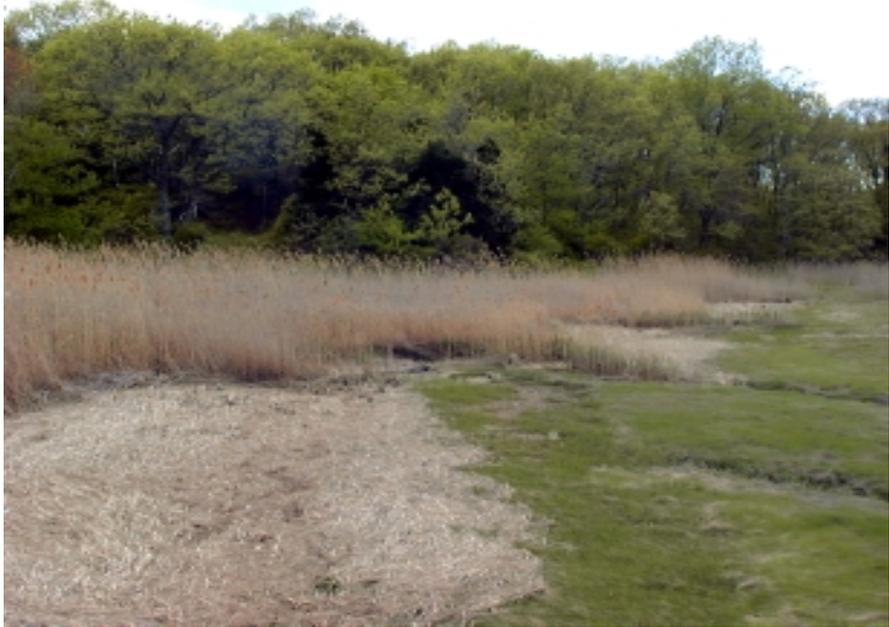
Quad	Site #	Watershed	Wetland Type	Restoration Code	Target Species	Access/Road	Ownership	Waypoint
Q-1	41	Farm Creek	Salt Marsh	IM	Estuarine	Coles Island	Unknown	42
<b>Notes</b>				<b>Photo</b>				
Sizable stand of <i>Phragmites australis</i>				A.				
Heavy tide wrack build-up along edge (see photo)

Transition zone (upland and wetland)								
<b>Sketch</b>

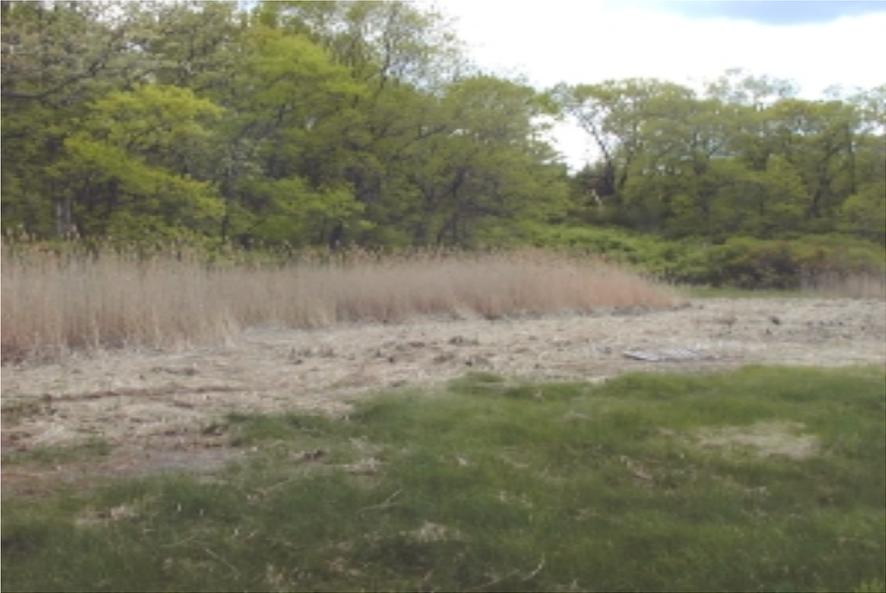
Quad	Site #	Watershed	Wetland Type	Restoration Code	Target Species	Access/Road	Ownership	Waypoint
Q-1	42	Farm Creek	Salt Marsh	IM, FR	Estuarine	Coles Island	Unknown	43
<b>Notes</b>				<b>Photo</b>				
Sizable stand of <i>Phragmites australis</i> on either side of road				A.				
Heavy tide wrack build-up along edge

Transition zone variable thickness of Phragmites area								
(varies 10-50 feet)								
<b>Sketch</b>

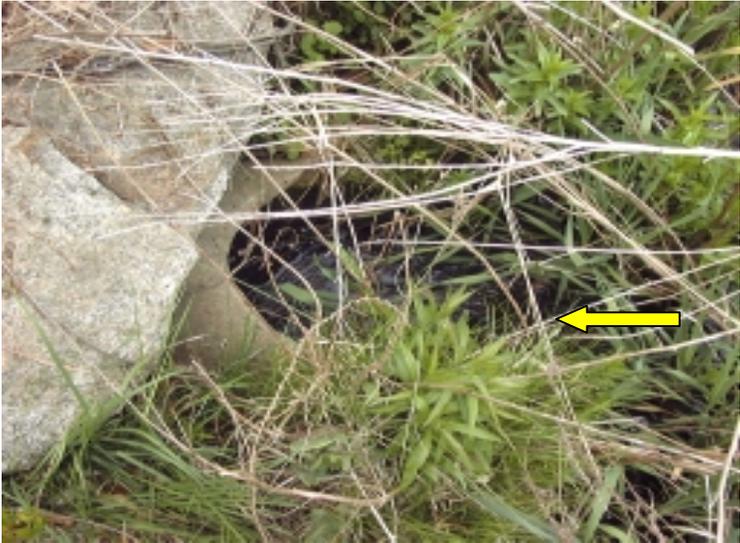
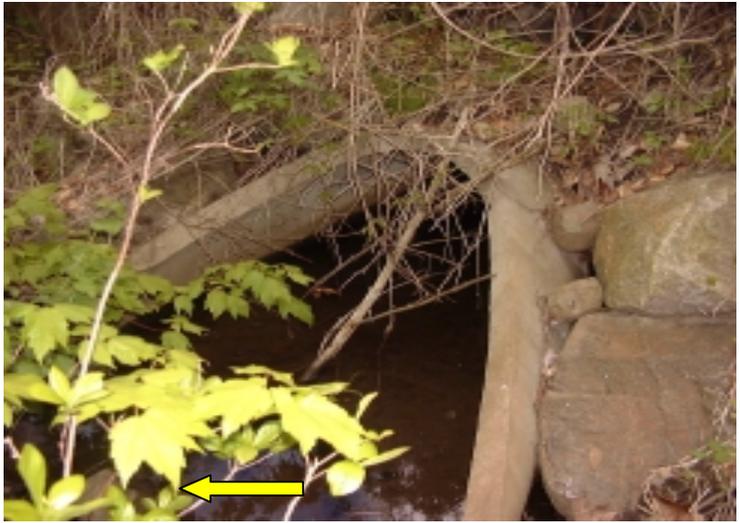
Culvert part of constructed stormwater basin								
Stream culverted for 40', 2' concrete culvert								
Berm part of detention system								
Upstream marsh contains invasive								
Direct stormwater discharge contributes to wetland area								
Low priority due to stormwater detention need								
Natural drainage area converted for stormwater management								
Berm constructed of large stone								
<b>Sketch</b>

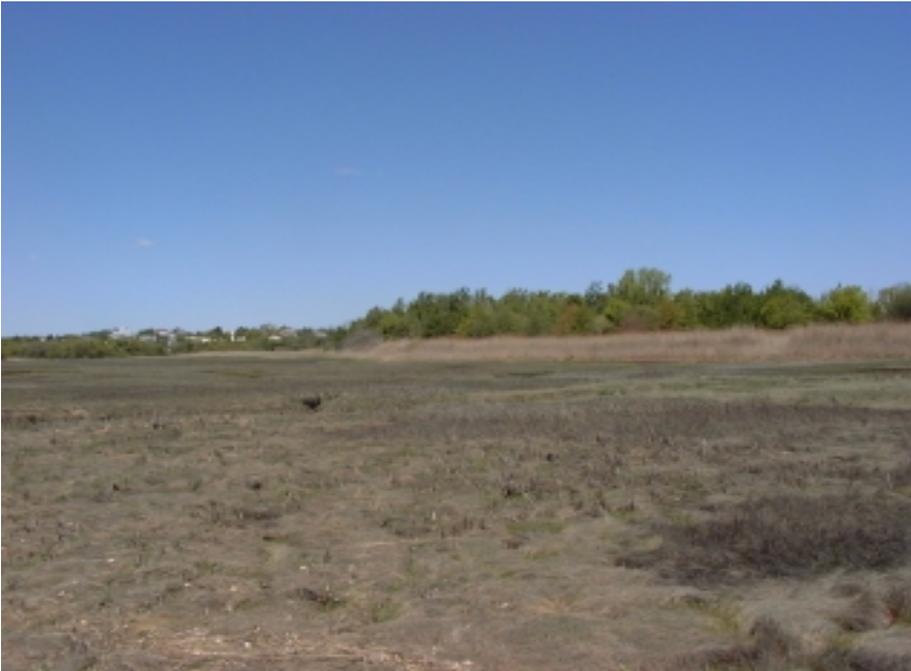
Quad	Site #	Watershed	Wetland Type	Restoration Code	Target Species	Access/Road	Ownership	Waypoint
Q-1	44	Jones/Annisquam Riv.	Salt Marsh	IM, OMWM	Estuarine	Atlantic St.	Unknown	48
<b>Notes</b>				<b>Photo</b>				
Four major areas of <i>Phragmites australis</i> growth				A.				
Thin transition zone patches

Some ditches extend to Phragmites								
Potential for combined restoration and mosquito control								
Site should be combined with restoration at site 45								
Perimeter or litter ditches possible								
Salt marsh provides excellent shorebird habitat due to extensive ditches that expose mudflats								
<b>Sketch</b>

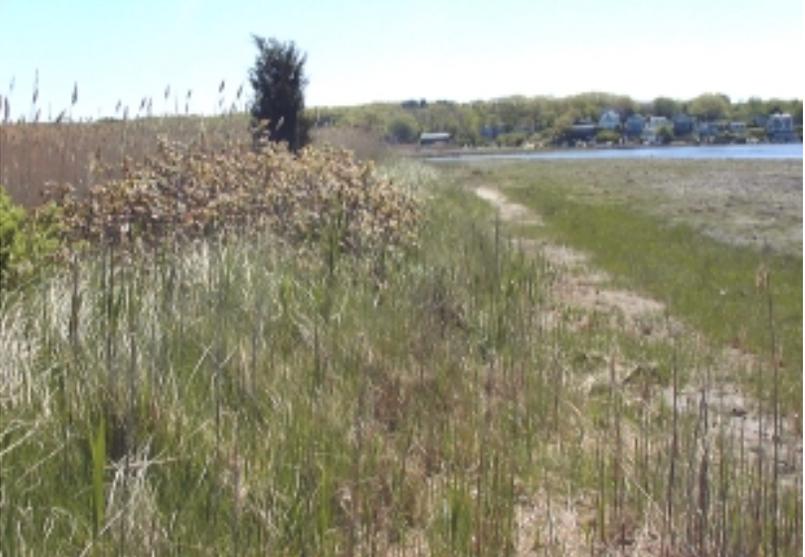
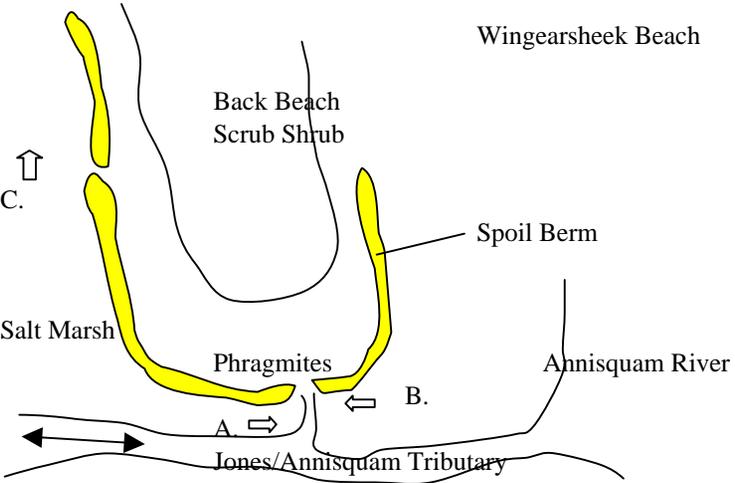
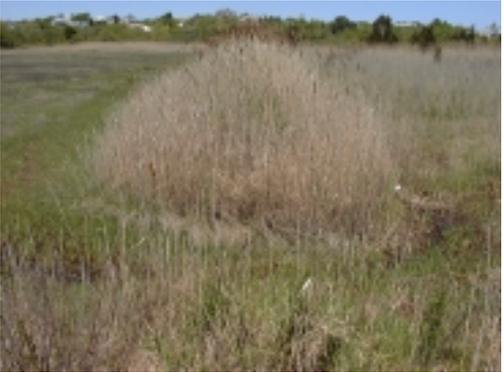
Long spoil berm limits tidal flow								
Berm is vegetated, supports beach grass, woody species								
Pockets of salt marsh grass present inside of berm								
Proximity of main creek enhances restoration potential								
Spoils could be used to create back dune system								
Breaks in berm allow some tidal flooding								
Multiple acres of <i>Phragmites</i>								
Site has high potential for restoration								
<b>Sketch</b>				<p>B.</p>

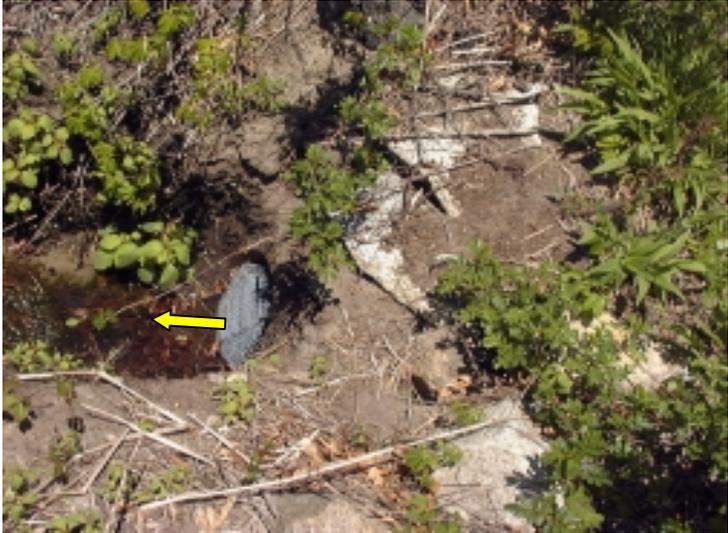
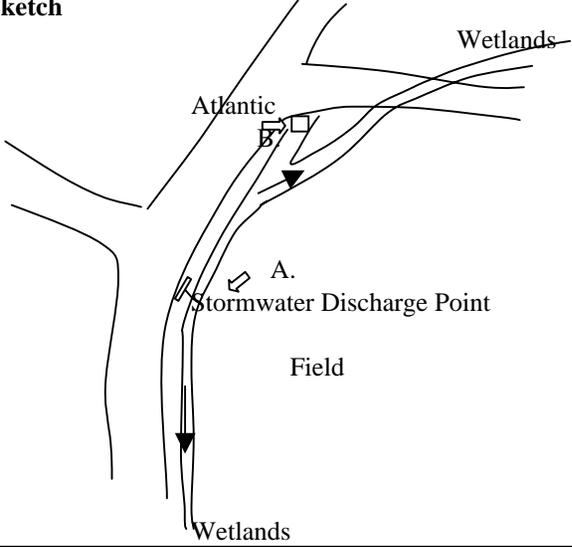
Ditch may have replaced natural stream									
Ditch may have been excavated to allow for better drainage									
Stream runs across paved area into wetlands									
Stormwater input noted from adjacent roadway									
<b>Sketch</b>				B.

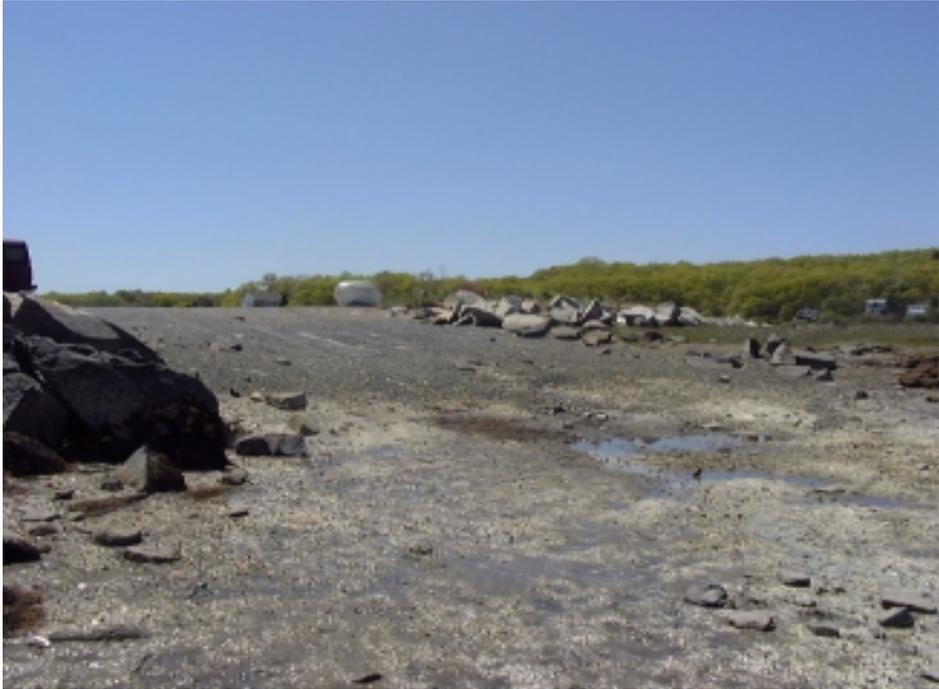
Quad	Site #	Watershed	Wetland Type	Restoration Code	Target Species	Access/Road	Ownership	Waypoint
Q-1	48	Jones River	Salt Marsh/Tidal Flat	BMP, FR	Estuarine	Long Wharf	Municipal	51
<b>Notes</b>				<b>Photo</b>				
Disposal point for clam shells				A.				
Access for clamming and recreational boating

Limited restoration potential								
Some sedimentation from loose gravel ramp to wetlands								
Ramp could be paved to limit fill								
<b>Sketch</b>

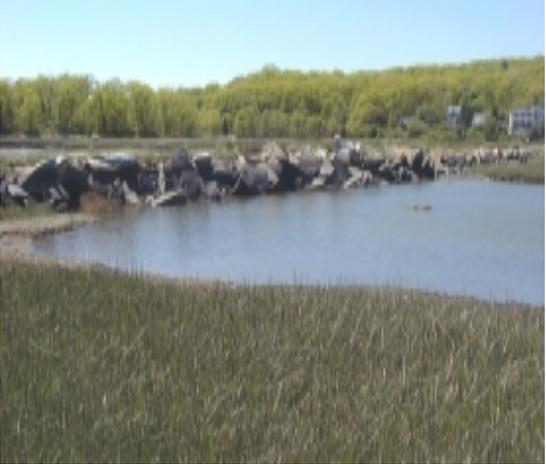
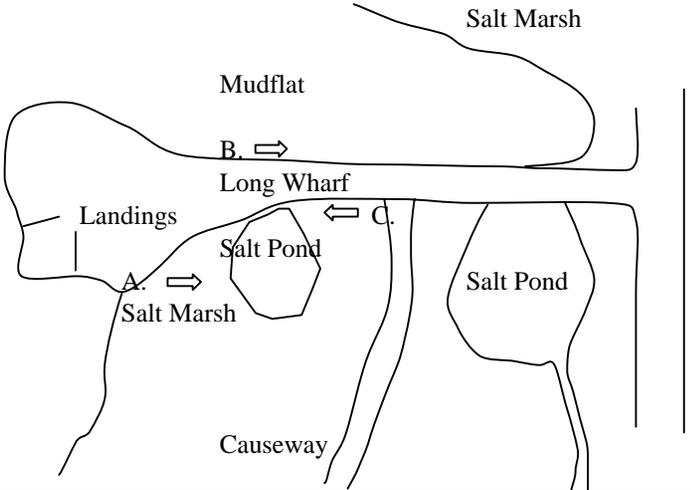
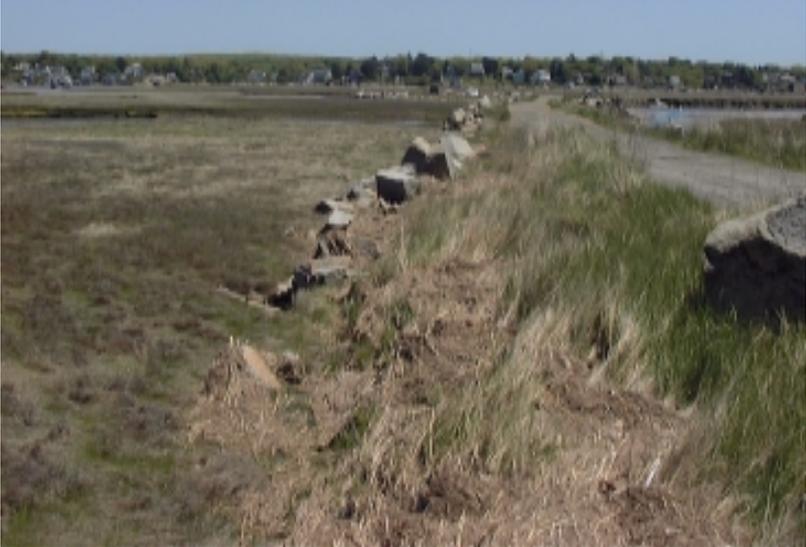
Quad	Site #	Watershed	Wetland Type	Restoration Code	Target Species	Access/Road	Ownership	Waypoint
Q-1	49	Jones River	Salt Marsh/Tidal Flat	FR, CU	Estuarine	Long Wharf	Municipal	52
<b>Notes</b>				<b>A.</b>				
Opportunities along wharf to limit stone fill and improve hydrologic conditions

A series of culvert could be installed along wharf								
Need to balance draining of salt pond and maintaining existing high habitat values								
Many stones have spilled out onto marsh, destroying vegetation								
Site should be considered in reference to anadromous fish restoration (Sleepy Hollow Pond)								
Wharf should be analyzed for larger fill removal opportunities								
<b>Sketch</b>				<b>B.</b>

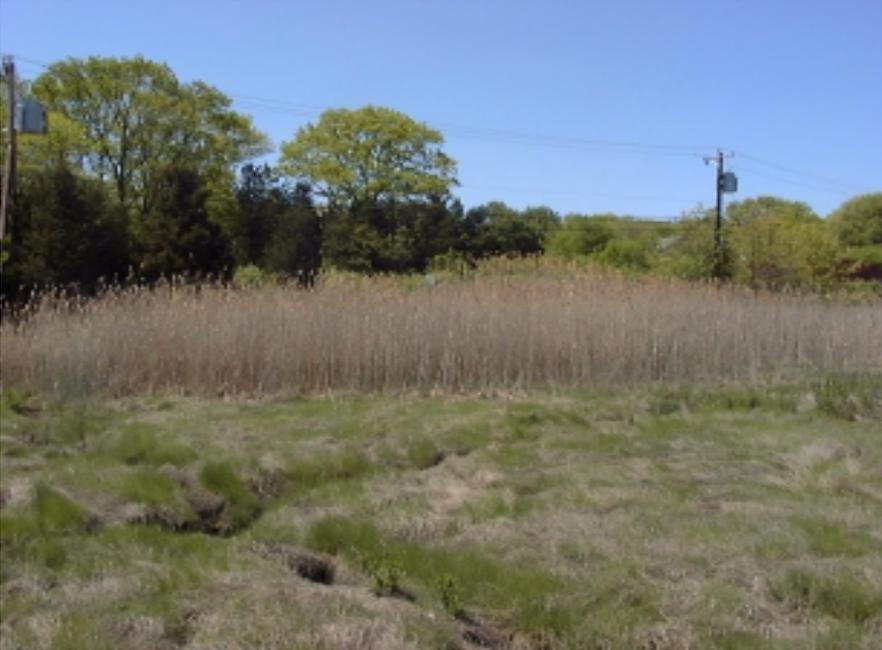
Quad	Site #	Watershed	Wetland Type	Restoration Code	Target Species	Access/Road	Ownership	Waypoint
Q-1	51	Jones River/Sleepy Ho	Salt Marsh	IM	Estuarine	Atlantic St.	Unknown	54
<b>Notes</b>				<b>Photo</b>				
<p><i>Phragmites australis</i> area, approximately 75' x 150'</p> <p>Typical transition zone <i>Phragmites</i> growth pattern</p> <p><i>Phragmites</i> growth encouraged by road runoff and tidal restriction from Jones Wharf</p> <p>Area might have slight elevation difference favoring the growth of <i>Phragmites</i></p> <p>Site could be addressed in conjunction with a mosquito control project</p>				A.				
<b>Sketch</b>

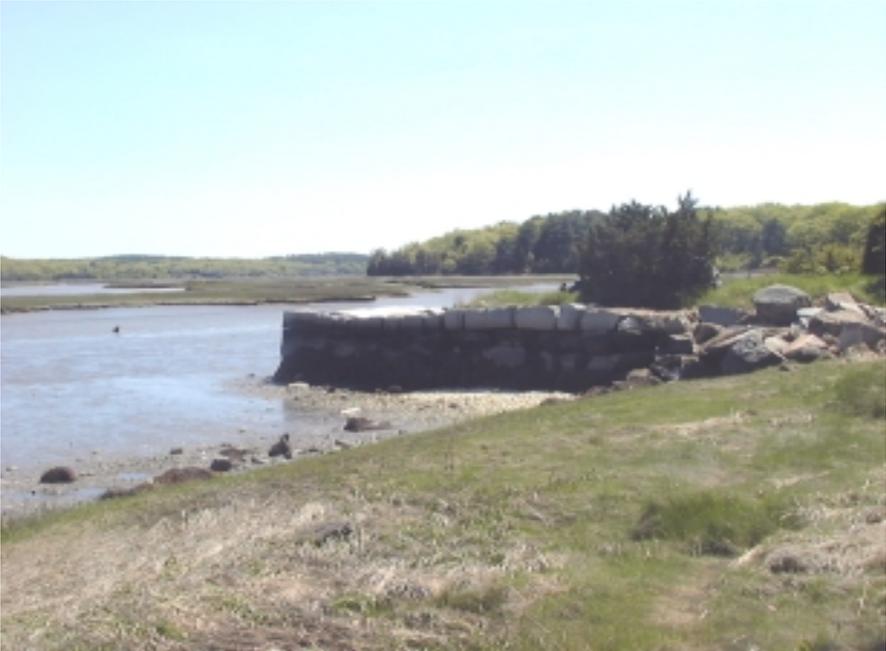
Quad	Site #	Watershed	Wetland Type	Restoration Code	Target Species	Access/Road	Ownership	Waypoint
Q-1	53	Jones River	Salt Marsh/Tidal Flat	FR	Estuarine	Atlantic St.	Unknown	56
<b>Notes</b>				<b>Photo</b>				
Potential to restore coastal bank, tidal flat and salt marsh				A.				
Approximately 50' x 75' of fill area

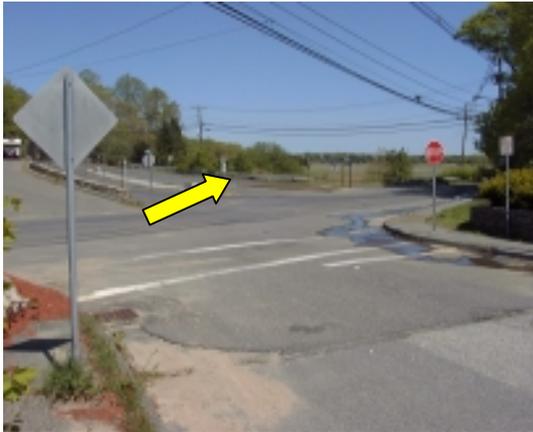
Quad	Site #	Watershed	Wetland Type	Restoration Code	Target Species	Access/Road	Ownership	Waypoint					
Q-1	54	Unnamed	Brackish Marsh	DL, BE, IM	Anadromous/Riverine	Concord St./Cedarwood Rd.	Public/Private	57, 58					
<b>Notes</b>				<b>A.</b>									
Stream diverted under intersection and behind houses

Approximately 500' of stream bed is culverted													
18" culvert, too small for storm flows													
Culvert continuously clogged													
Wetland has formed over culvert													
Thick bed of <i>Phragmites australis</i> at outlet													
Outlet culverts set too high													
Stormwater from intersection mixed with streamwater													
Contributing watershed relatively pristine													
Houses and lawn area right to edge of old stream													
<b>Sketch</b>				<b>B.</b>

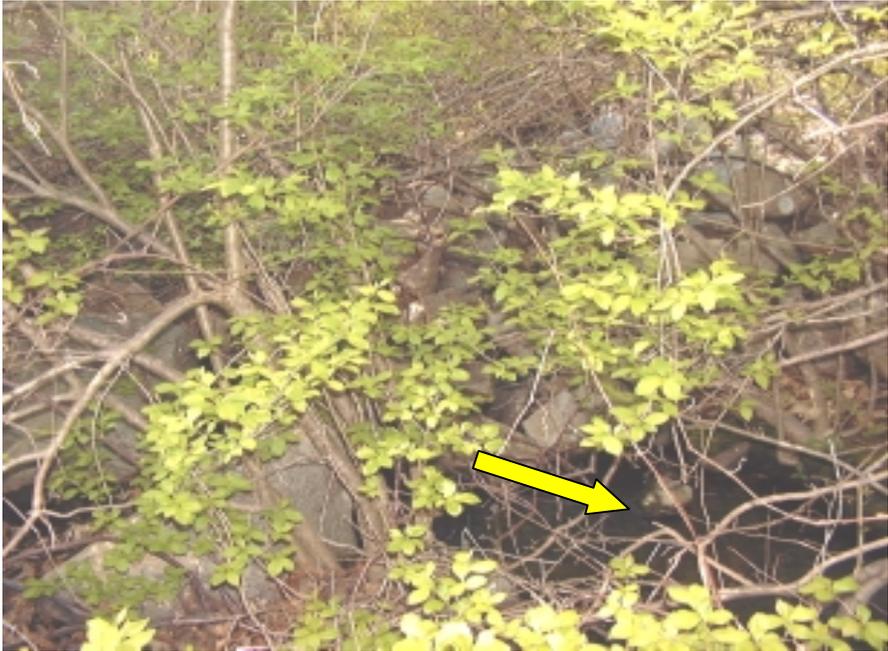
Quad	Site #	Watershed	Wetland Type	Restoration Code	Target Species	Access/Road	Ownership	Waypoint
Q-1	55	Unnamed	Wooded Swamp Deciduous	FR	Riverine	Concord St.	Unknown	59
<b>Notes</b>				<b>Photo</b>				
Stone dam in stream				A.				
Originally created to hold back ice pond

Maintains wetland area above								
Dam area vegetated								
<b>Sketch</b>

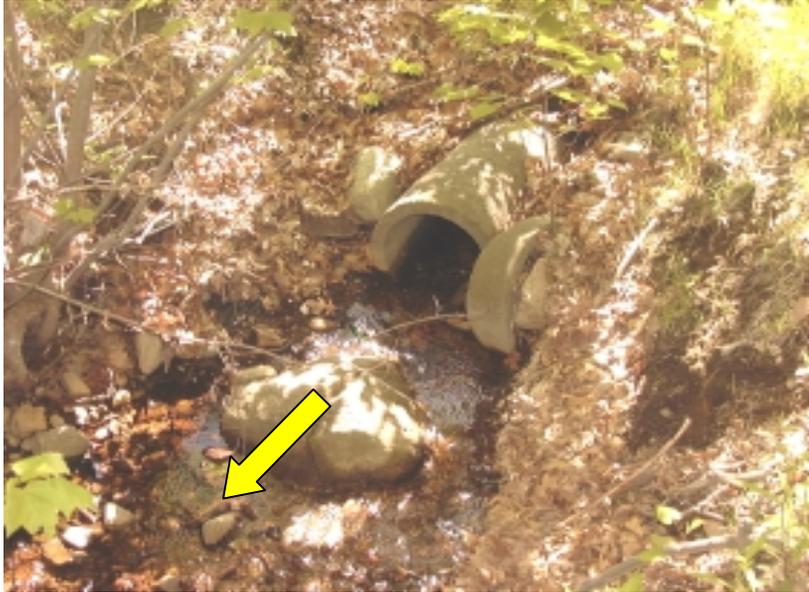
Quad	Site #	Watershed	Wetland Type	Restoration Code	Target Species	Access/Road	Ownership	Waypoint
Q-1	56	Unnamed	Wooded Swamp Deciduous	DL	Riverine	Cedarwood Rd.	Unknown	60
<b>Notes</b>				<b>Photo</b>				
Upstream end of culvert not found, on private property				A.				
Slash and debris piled on top of culvert inlet

Approx. 8" concrete culvert								
Stream is tributary of the main stream below								
<b>Sketch</b>

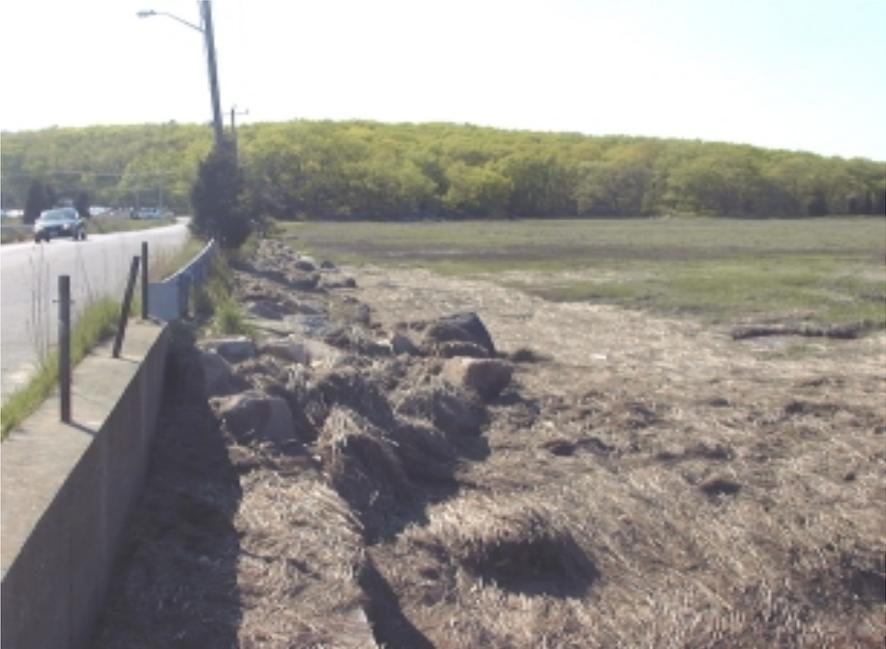
Quad	Site #	Watershed	Wetland Type	Restoration Code	Target Species	Access/Road	Ownership	Waypoint
Q-1	57	Jones/Annisquam Riv	Salt Marsh	FR, CU	Estuarine	Causeway St.	Municipal	61
<b>Notes</b>				<b>Photo</b>				
Granite blocks along causeway spilling onto salt marsh				<p>A.</p>

Causeway blocks tidal flow, small culverts placed along causeway may help tidal flushing								
No stormwater infrastructure noted								
Heavy tidal wrack build-up along causeway								
Upstream marsh small, isolated and impounded by Rte. 128								
Culvert causes tidal restriction								
<b>Sketch</b>

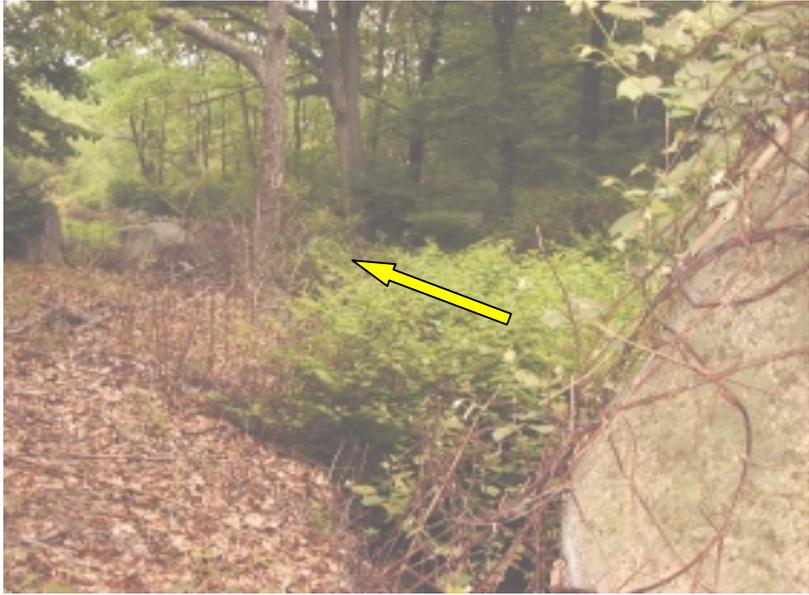
Quad	Site #	Watershed	Wetland Type	Restoration Code	Target Species	Access/Road	Ownership	Waypoint
Q-1	58	Unnamed	Wooded Swamp Deciduous	BE, IM, TR	Riverine	Concord St.	Unknown	62
<b>Notes</b>				<b>Photo</b>				
Robust growth of Japanese knotweed along bank				A.				
Large elevation drop above

Trash in stream (tires)								
Dumping site along south bank								
Upstream relatively pristine								
Apparent clearing along bank								
<b>Sketch</b>

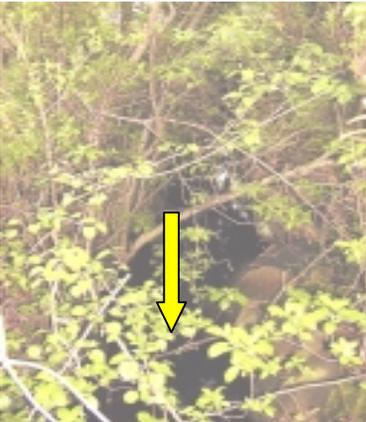
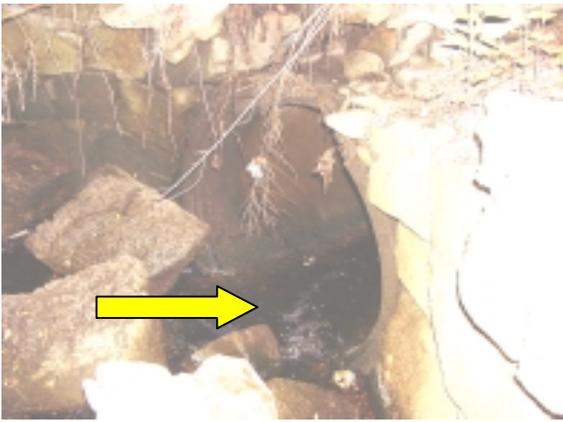
Quad	Site #	Watershed	Wetland Type	Restoration Code	Target Species	Access/Road	Ownership	Waypoint
Q-1	59	Unnamed	Brackish Marsh	DL, CR, CU, BMP	Riverine	Concord St.	State	63
<b>Notes</b>				<b>A.</b>		<b>B.</b>		
Part of 128 off-ramp infrastructure

Stream culverted for approx. 75-100 yards								
Stream channelized above with 2-3' granite rocks								
Stream bottom is gravelly								
Culvert size is approx. 3.5'								
Downstream the stream channel is wider to possibly account for stormwater input								
Downstream odd stream bed configuration (see sketch)								
Stream configuration complicated and further study needed								
<b>Sketch</b>				<b>C.</b>		<b>D.</b>

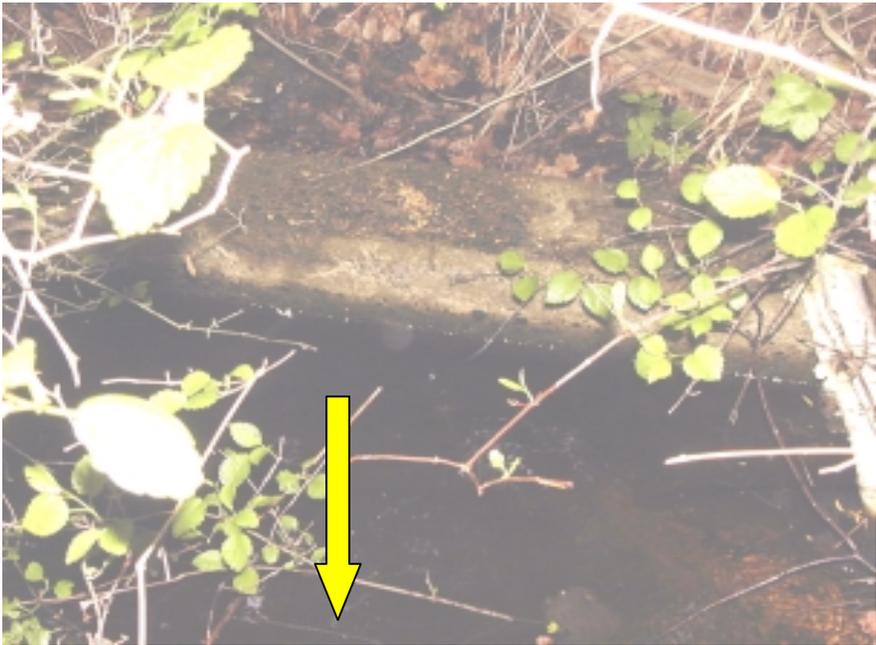
Quad	Site #	Watershed	Wetland Type	Restoration Code	Target Species	Access/Road	Ownership	Waypoint
Q-1	60	Unnamed	Brackish Marsh	BMP	Riverine	Rte. 128	State	64
<b>Notes</b>				<b>Photo</b>				
Slumped concrete headwall				A.				
Stormwater discharge, sediment plume from culvert

At point where ditch and stream converge								
Densely vegetated wetland stream								
Thick invasive along bank								
Steep bank (highway)								
<b>Sketch</b>

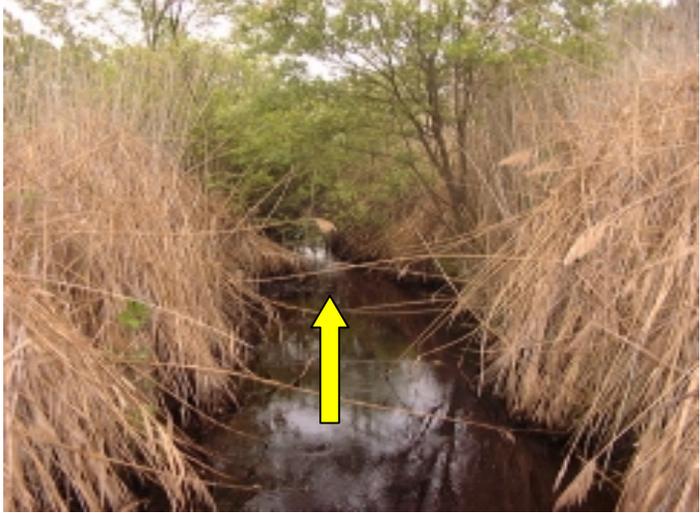
Quad	Site #	Watershed	Wetland Type	Restoration Code	Target Species	Access/Road	Ownership	Waypoint
Q-1	61	Unnamed	Brackish Marsh	BE, CR	Anadromous	Rte. 128	State	65
<b>Notes</b>				A.				
Dense <i>Phragmites australis</i> along both banks

Stretch may be productive smelt spawning area								
Stream bottom variable cobble and stone								
Stream should be monitored and obstructions removed to increase spawning area/potential								
Long/small culvert under Rte. 128 may limit fish passage								
Stream seems ditched - banks are linear								
<b>Sketch</b>				B.

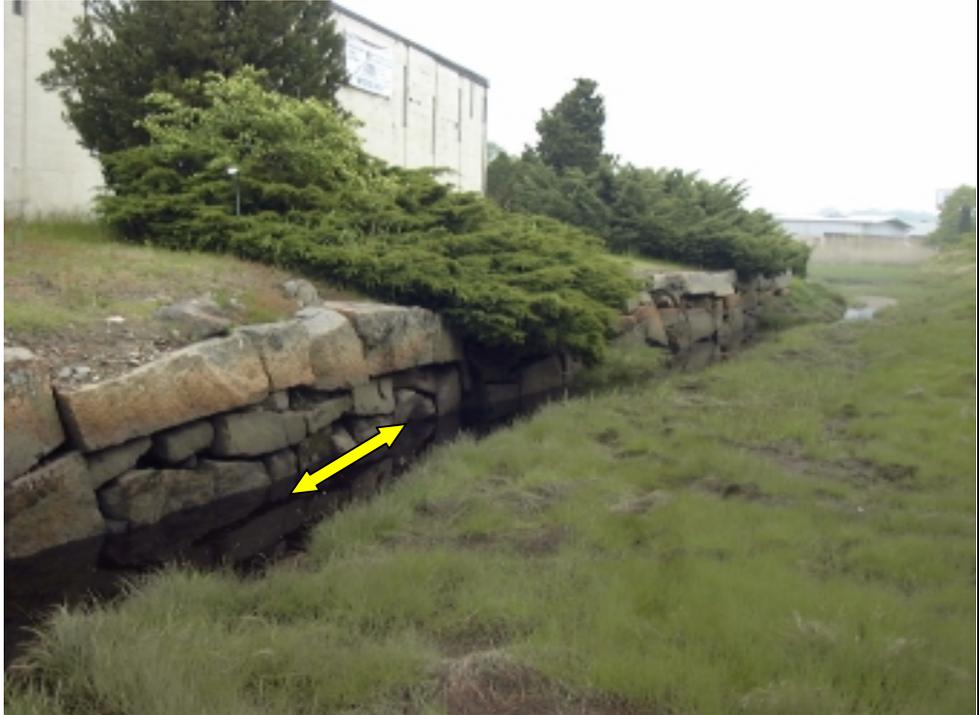
Quad	Site #	Watershed	Wetland Type	Restoration Code	Target Species	Access/Road	Ownership	Waypoint
Q-1	62	Unnamed	Salt Marsh	BE, BI	Anadromous	Rte. 128	Private	66
<b>Notes</b>				<b>Photo</b>				
Fill critical to structural integrity of warehouses				A.				
If redone, toe of slope could be pulled back to form a natural stream bank

Retaining wall acts as stream bank								
<b>Sketch</b>
