# City of Gloucester Comprehensive River and Stream Habitat Restoration Report

2003

Tim Purinton

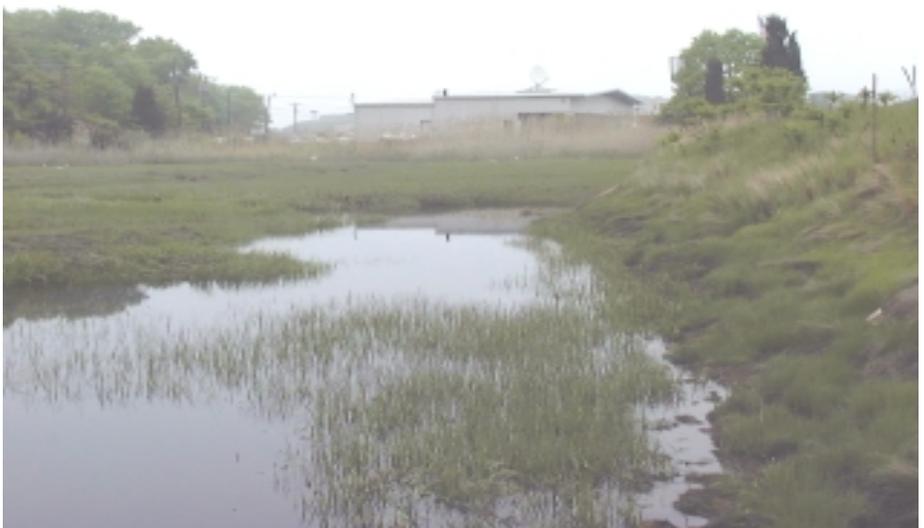
Quad	Site #	Watershed	Wetland Type	Restoration Code	Target Species	Access/Road	Ownership	Waypoint
Q-1	63	Unnamed	Salt Marsh	IM, CU	Anadromous	Rte. 128	Private/State	67
<b>Notes</b>				<b>Photo</b>				
Culvert may need to be improved to promote smelt spawning

<i>Phragmites australis</i> present at salt marsh transition zone								
may be due to tidal restriction								
Fringe almost completely ringed with Phragmites								
<b>Sketch</b>

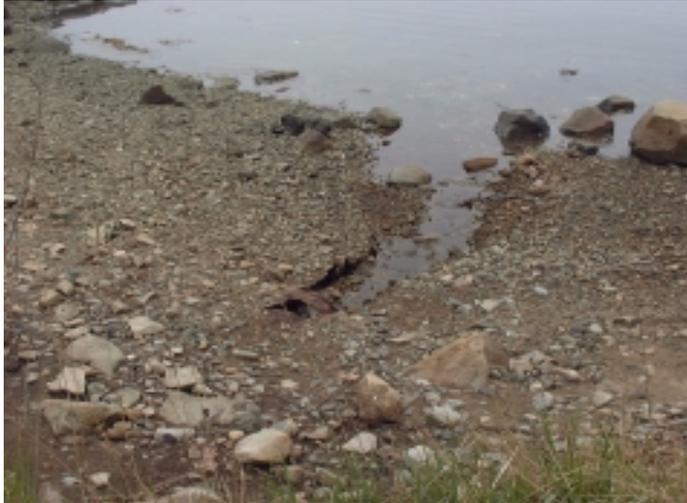
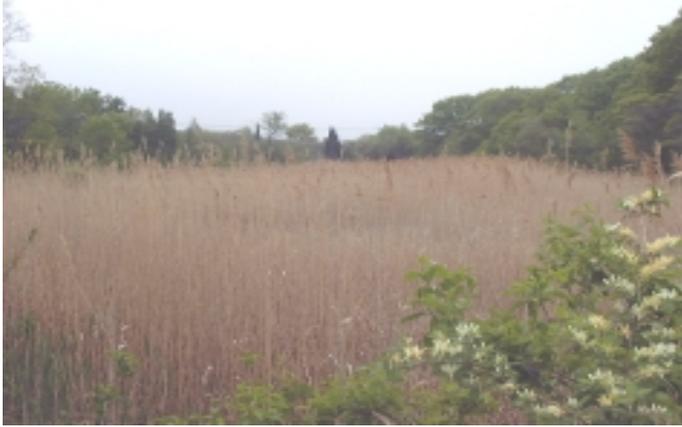
Small degraded culvert could be easily upgraded								
Evidence of salt marsh plants in impounded area								
Increased tidal flow would reduce <i>Phragmites australis</i>								
Native salt marsh grasses present upstream								
Series of small filled in ditches in upstream wetland								
<b>Sketch</b>

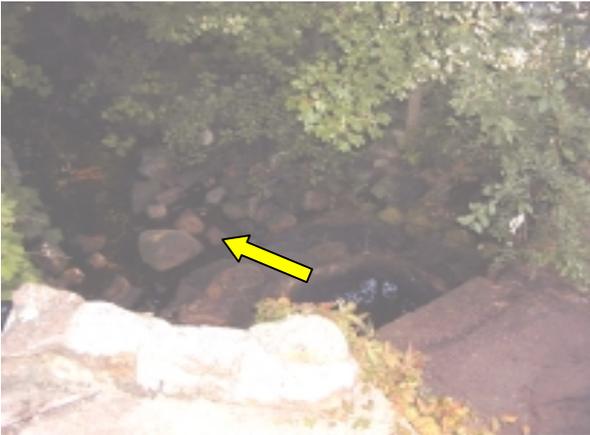
Quad	Site #	Watershed	Wetland Type	Restoration Code	Target Species	Access/Road	Ownership	Waypoint
Q-1	65	Walker Creek	Open Water	FL, RR	Anadromous/Catadromous	Essex Ave.	Municipal	223
<b>Notes</b>				<b>Photo</b>				
Ownership of dam in question between adjacent landowner and city				<b>A.</b>				
Dam is not that tall (6-8') and could take a steep pass fish ladder

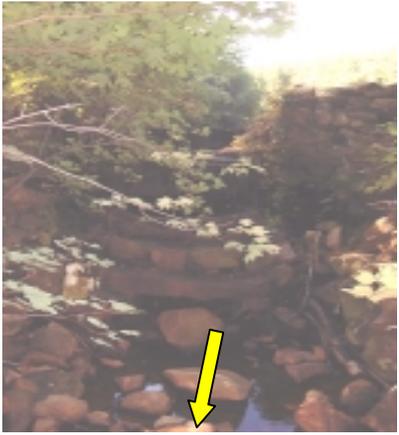
Pond may be too small to support alewife				<b>B.</b>				
More information about pond size and depth is needed to determine usefulness of enhanced fish passage

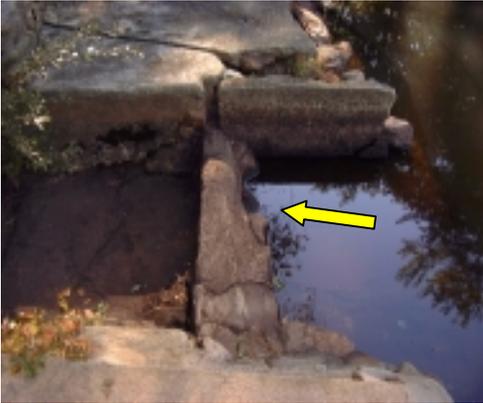
A roughed ramp could be installed to enhance eel passage				<b>D.</b>

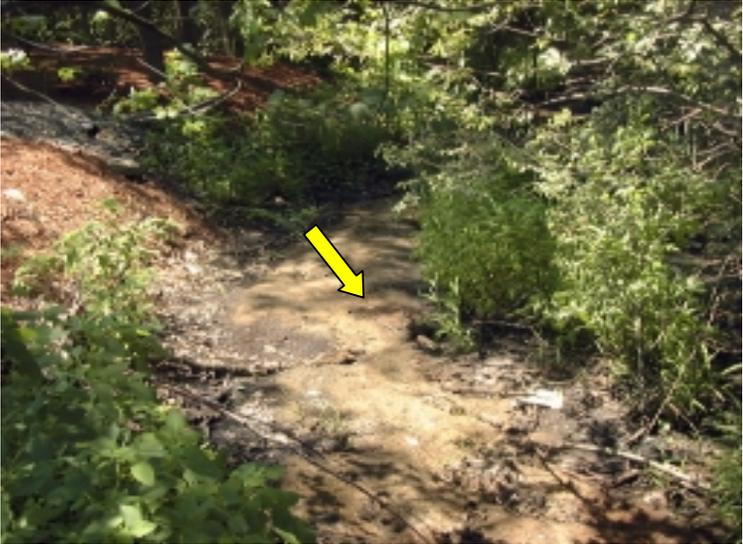
Quad	Site #	Watershed	Wetland Type	Restoration Code	Target Species	Access/Road	Ownership	Waypoint
Q-1	66	Unnamed	Wooded Swamp Deciduous	BMP	Riverine	Essex Ave.	Unknown	203
<b>Notes</b>				<b>Photo</b>				
Site impacted by stormwater and sediment from stormwater discharge				A.				
Downstream culvert plugged up so only 1" of opening remains

Culvert size: 1-1.5'								
<b>Sketch</b>				B.

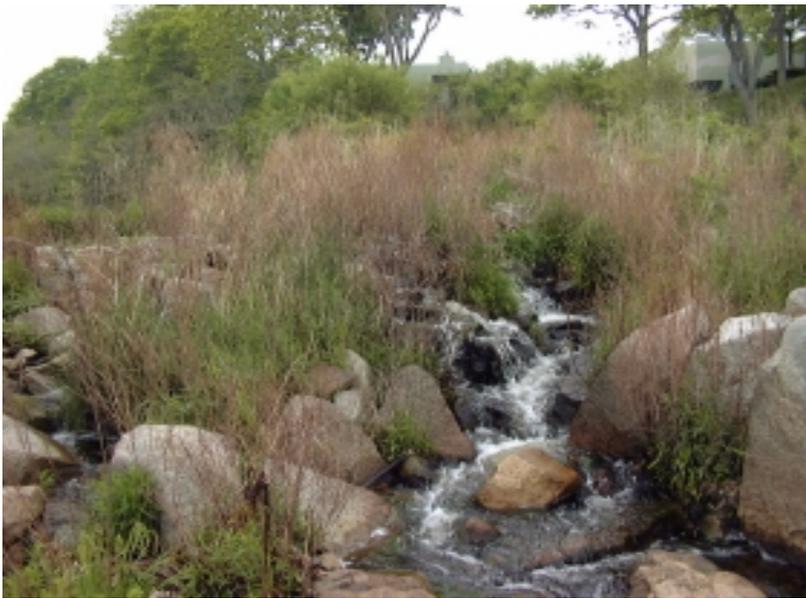
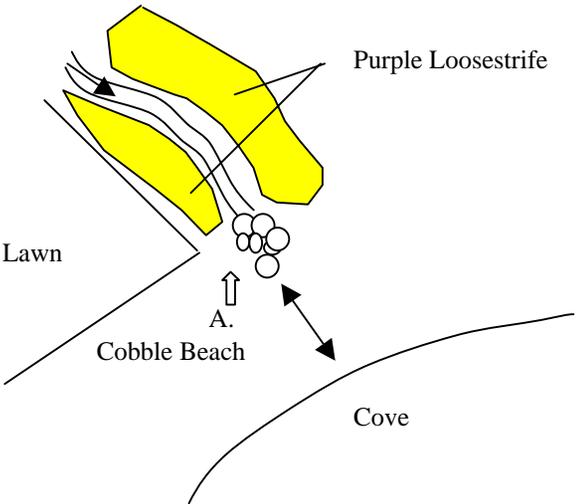
Quad	Site #	Watershed	Wetland Type	Restoration Code	Target Species	Access/Road	Ownership	Waypoint
Q-2	1	Folly Cove/Stony Brook	Brackish Marsh/Coastal Beach	FR, RR, BE, IM	Anadromous/Catadromous	Folly Cove Beach	Private	69
<b>Notes</b>				<b>Photo</b>				
Area above seems to be potential smelt spawning habitat

A roughed ramp would assist eel passage								
Stream may be accessible to fish at high tides								
Stream above has a dense shrub canopy which keeps temps. low								
Some lawn to stream edge above restriction								
Purple loosestrife present								
<b>Sketch</b>

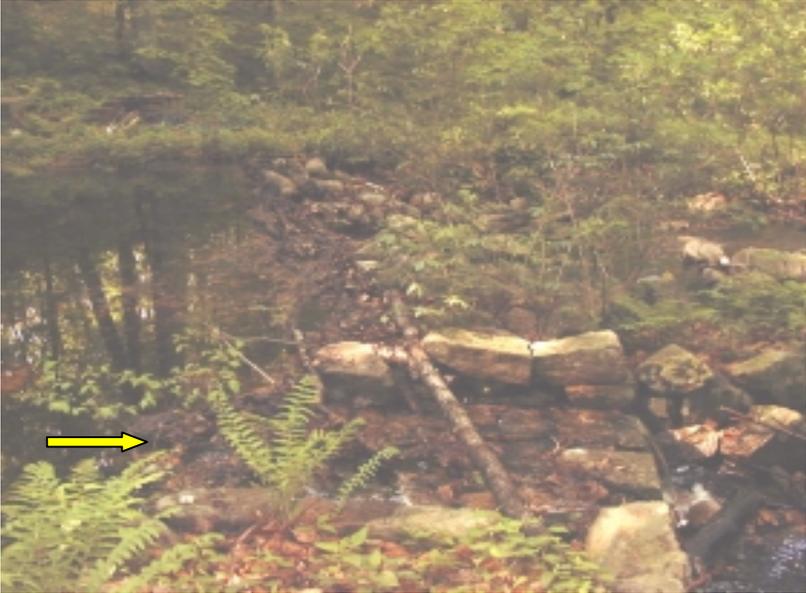
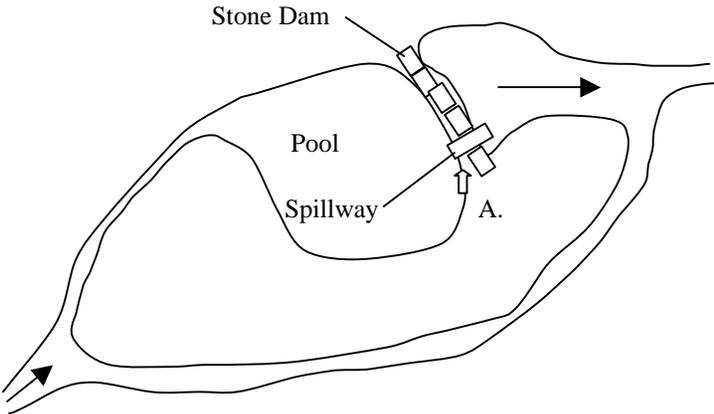
Quad	Site #	Watershed	Wetland Type	Restoration Code	Target Species	Access/Road	Ownership	Waypoint
Q-2	2	Stony Brook	Wooded Swamp Deciduous	DR	Riverine	Woodward Ave.	Private	71
<b>Notes</b>				<b>Photo</b>				
Stone dam probably built for aesthetic reasons				A.				
Shallow small pond (50'x50')

Minor disturbance if no fish passage								
Small raceway/spillway built on one edge of dam								
<b>Sketch</b>

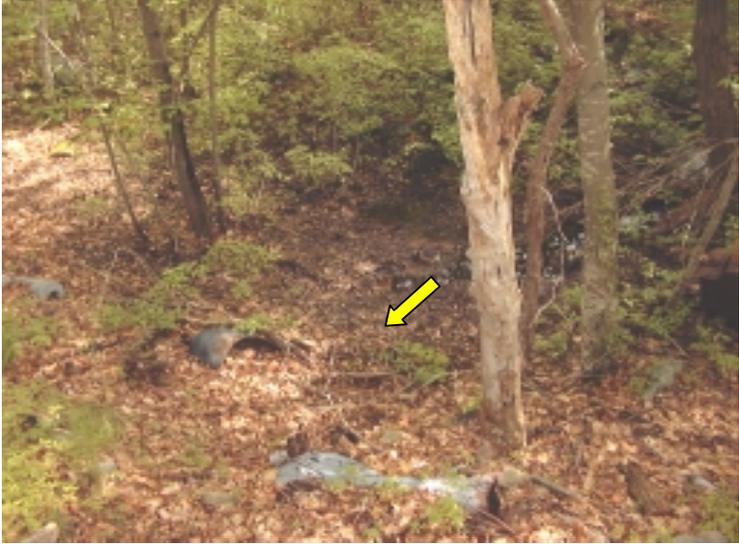
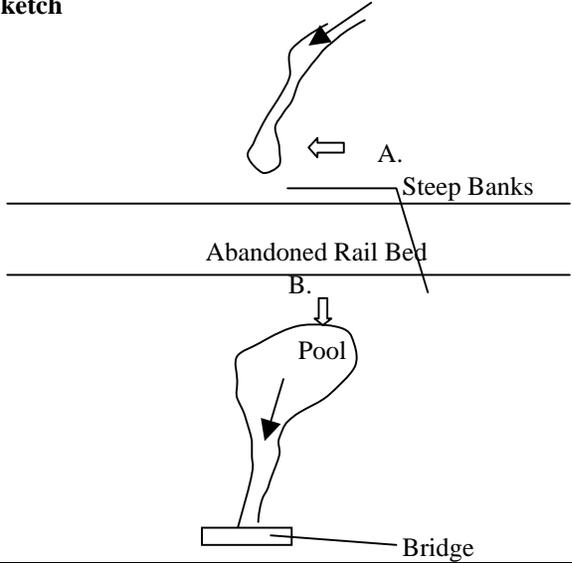
Quad	Site #	Watershed	Wetland Type	Restoration Code	Target Species	Access/Road	Ownership	Waypoint
Q-2	3	Stony Brook	Wooded Swamp Deciduous/Shrub Swamp	CU, BE	Riverine	Railbed	Private	72
<b>Notes</b>				<b>Photo</b>				
Debris in upstream wetlands, dumping area due to slope and access				<p>A.</p>

Upstream culvert not found, completely collapsed								
Downstream landowners have mowed to stream edge and channelized the stream								
Larger buffer recommended downstream								
<b>Sketch</b>

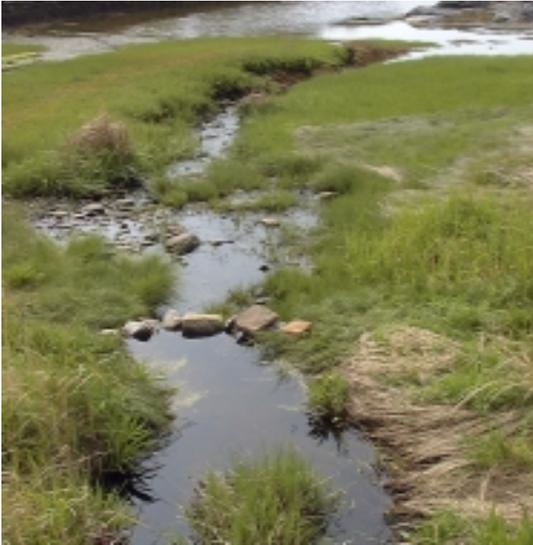
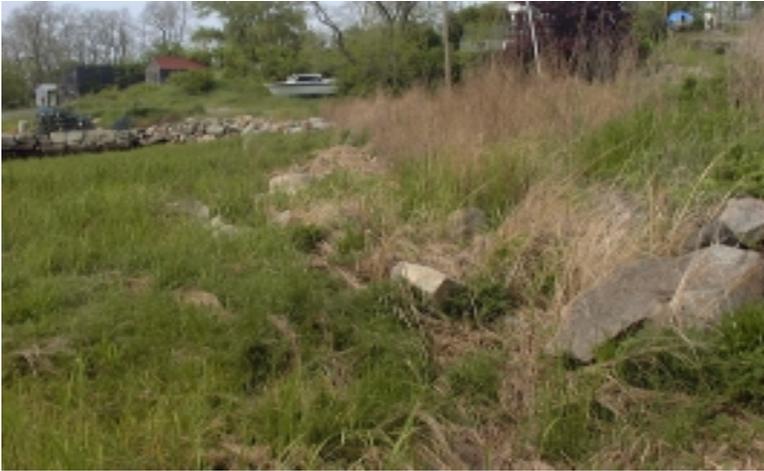
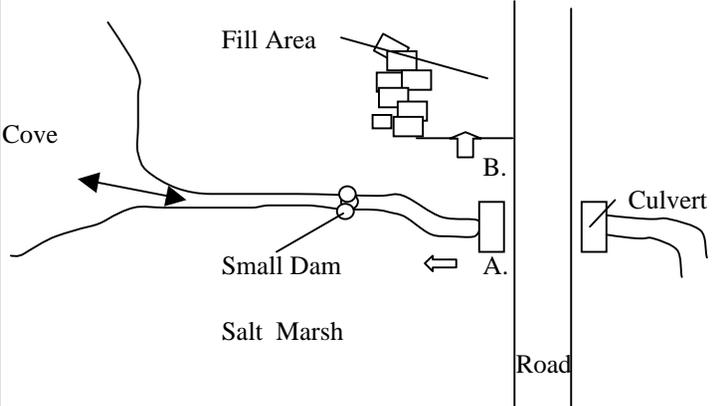
Quad	Site #	Watershed	Wetland Type	Restoration Code	Target Species	Access/Road	Ownership	Waypoint
Q-2	4	Lanes Cove	Salt Marsh	FR	Anadromous/Catadromous	Lanes Cove	Municipal	73
<b>Notes</b>				<b>Photo</b> A.

Small dam in waterway								
Fill area in marsh 25'x50' (old town landing)								
Minor habitat disturbances								
On site granite culvert is sized correctly								
<b>Sketch</b>				<b>B.</b>

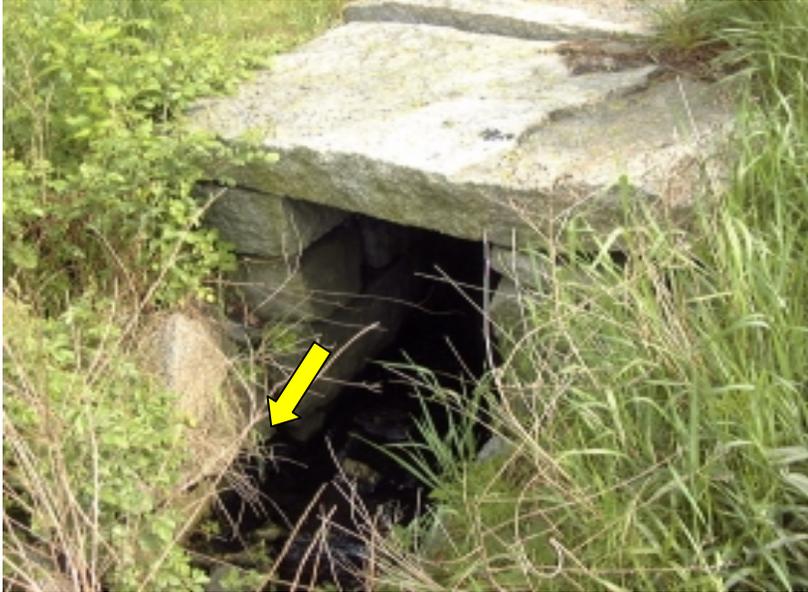
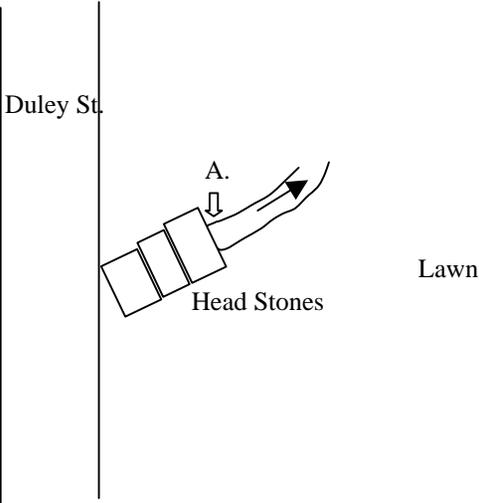
Quad	Site #	Watershed	Wetland Type	Restoration Code	Target Species	Access/Road	Ownership	Waypoint
Q-2	5	Lanes Cove	Brackish Marsh	DL	Estuarine	Duley St.	Private	74
<b>Notes</b>				<b>Photo</b>				
Steam runs through residential property				<b>A.</b>

Source not found (above Rte. 127 per local information)								
Stream mixes with stormwater								
Potentially large scale daylighting project								
Water flowing indicates potentially perennial stream								
<b>Sketch</b>

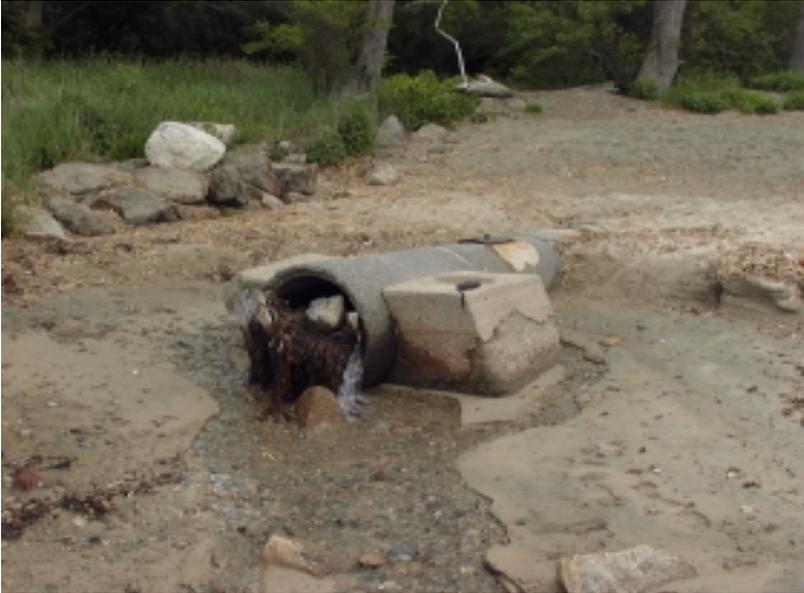
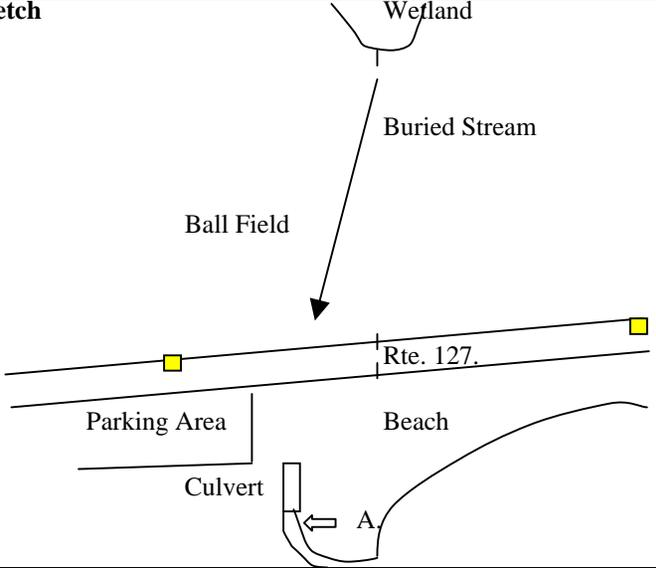
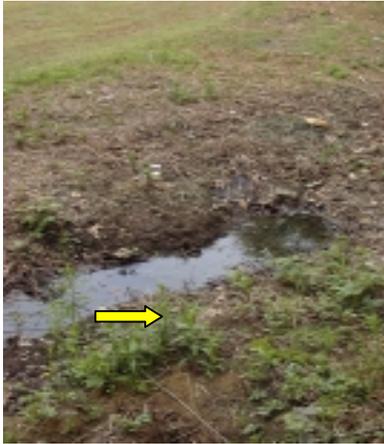
Quad	Site #	Watershed	Wetland Type	Restoration Code	Target Species	Access/Road	Ownership	Waypoint
Q-2	6	Plum Cove	Coastal Beach/Shallow Marsh Meadow	DL, BMP	Anadromous/Catadromous	Plum Cove Beach	Municipal	75
<b>Notes</b>				<b>Photo</b>				
Fresh water stream drains to Plum Cove				<b>A.</b>

Buried stream for over 100 yards								
Critical habitat area for smelt spawning								
Culvert blocked								
Partial daylighting project								
Stormwater should be treated if stream is daylighted								
16-18" concrete culvert								
Inlet is a stormdrain, draining wetland, not stream								
<b>Sketch</b>				<b>B.</b>

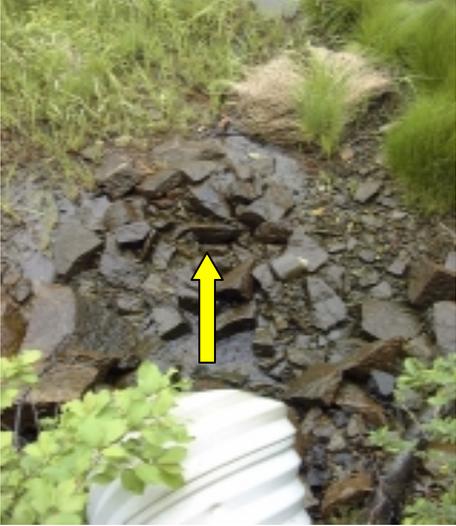
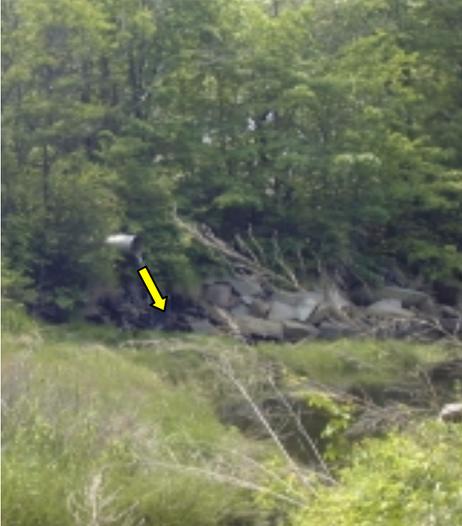
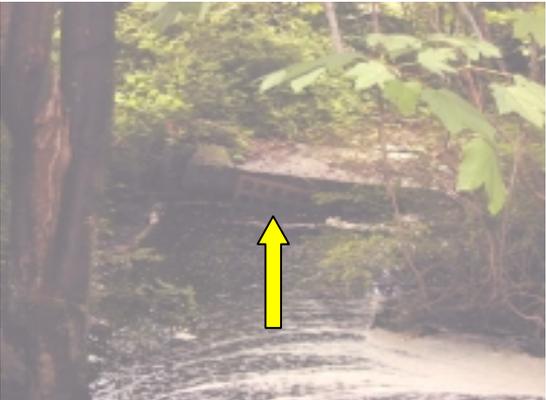
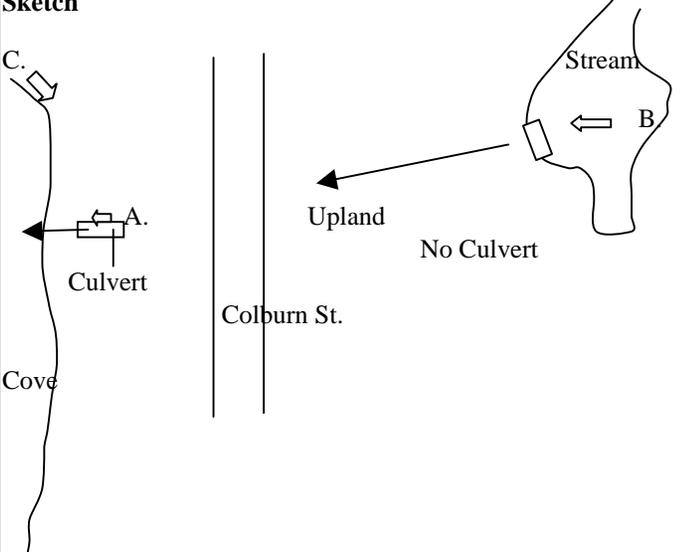
Quad	Site #	Watershed	Wetland Type	Restoration Code	Target Species	Access/Road	Ownership	Waypoint
Q-2	7	Hodgkins Cove	Wooded Swamp Deciduous/Brackish Marsh	CU, DL	Catadromous	Colburn St.	Unknown	76
<b>Notes</b>				<b>Photo</b>				
2' corrugated aluminium pipe discharges to cove				A.				
Steep drop from culvert to cove				C.				
Flow in dry weather indicats culvert serves natural stream flow

Watershed source is Klondike Reservoir

Site connects with site 8				B.				
Discharge to salt marsh

Culvert too high for tidal influence								
<b>Sketch</b>

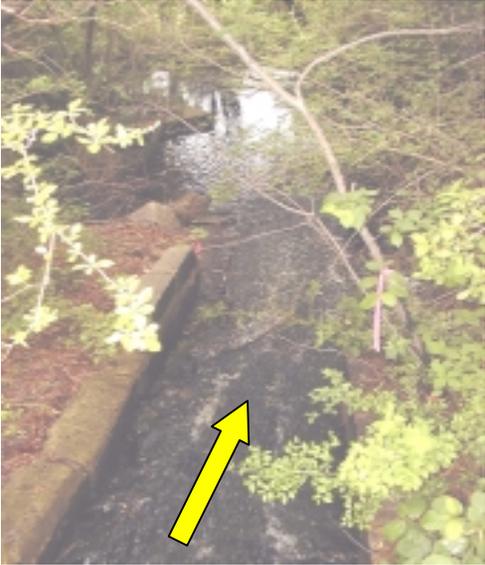
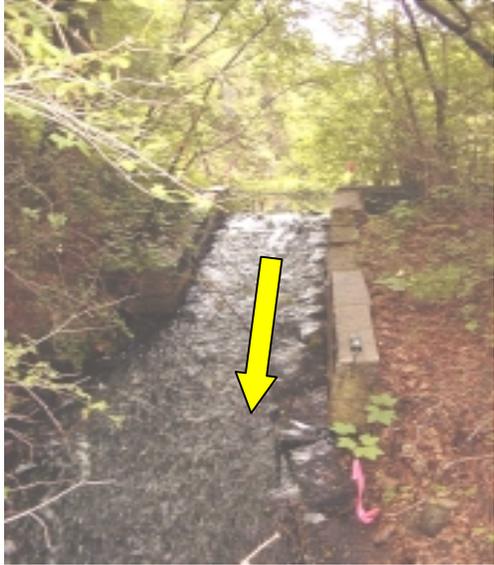
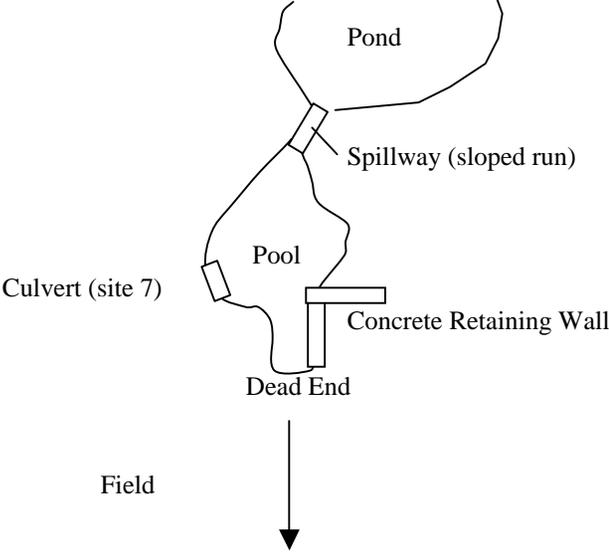
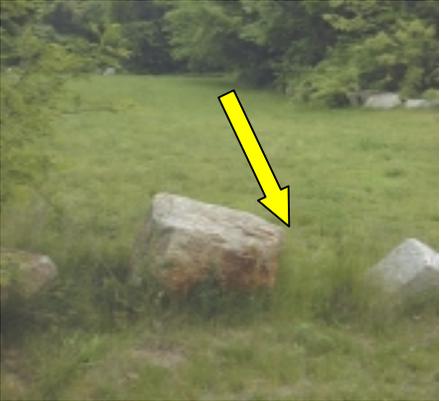
Quad	Site #	Watershed	Wetland Type	Restoration Code	Target Species	Access/Road	Ownership	Waypoint
Q-2	8	Klondike Reservoir	Wooded Swamp Deciduous	FL, DL, CR	Catadromous	Colburn St.	Unknown	77
<b>Notes</b>				<b>Photo</b>				
Major stream bed alteration				<b>A.</b>				
Natural stream appears to have flowed across the field to the coast				<b>B.</b>				
Daylight section may provide habitat for smelt

Strong flows from pond								
Natural outlet near Umass Station (field area/private beach)								
<b>Sketch</b>				<b>C.</b>

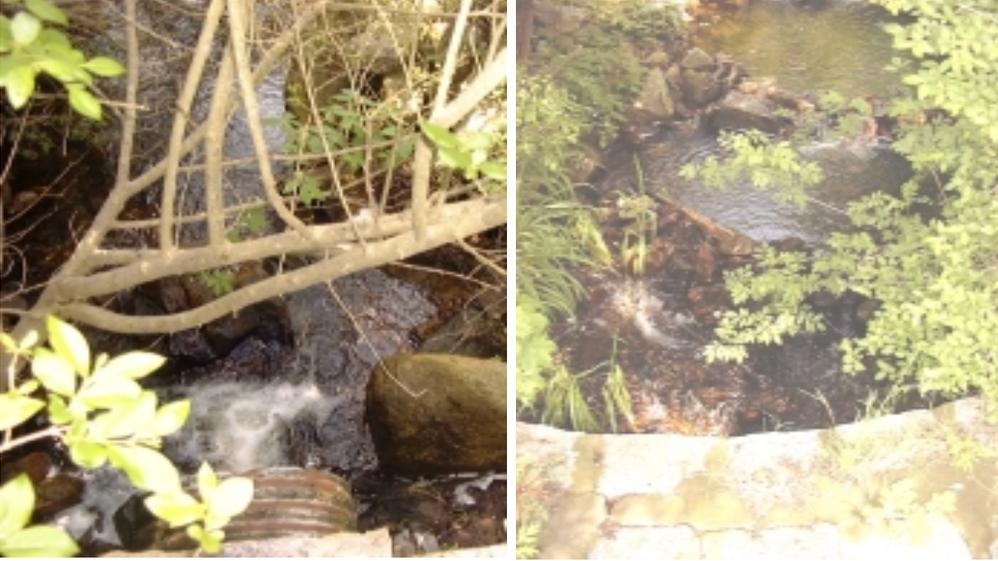
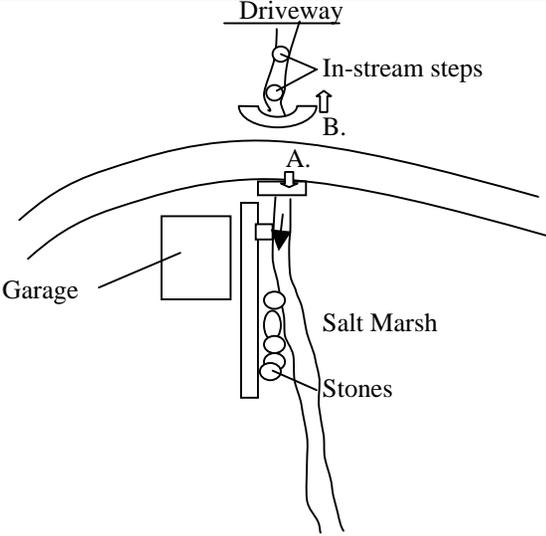
Quad	Site #	Watershed	Wetland Type	Restoration Code	Target Species	Access/Road	Ownership	Waypoint
Q-2	9	Hodgkins Cove	Brackish Marsh/Shrub Swamp	CU, BMP, BE, DL	Catadromous	N. Kilby St.	Private/Public	78
<b>Notes</b>				<b>Photo</b>				
Channel has been reconfigured for apparently aesthetic reasons				A.				
Downstream retaining wall has been rebuilt, old stones left on marsh				B.				
Area of concern for smelt habitat

Culvert under driveway, inlet not seen, amount of daylight potential not known								
Culvert set too high								
2-2.5' culvert								
<b>Sketch</b>

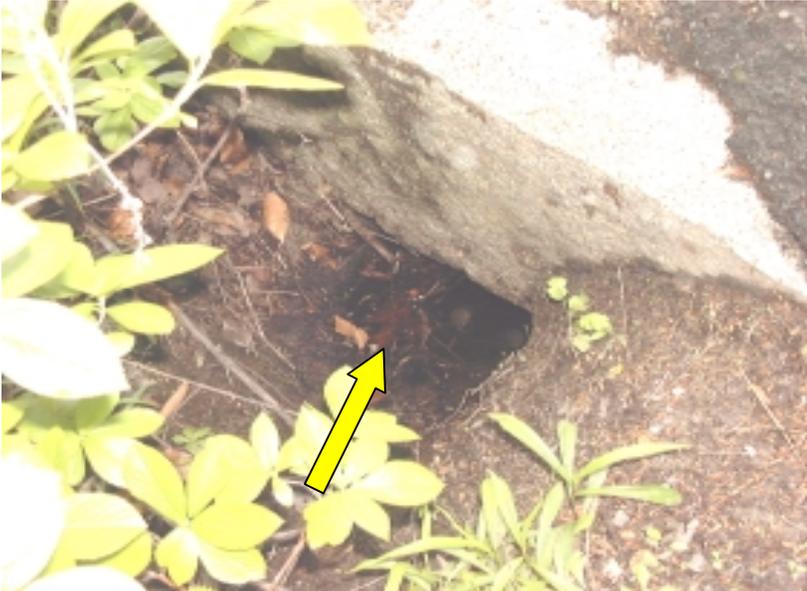
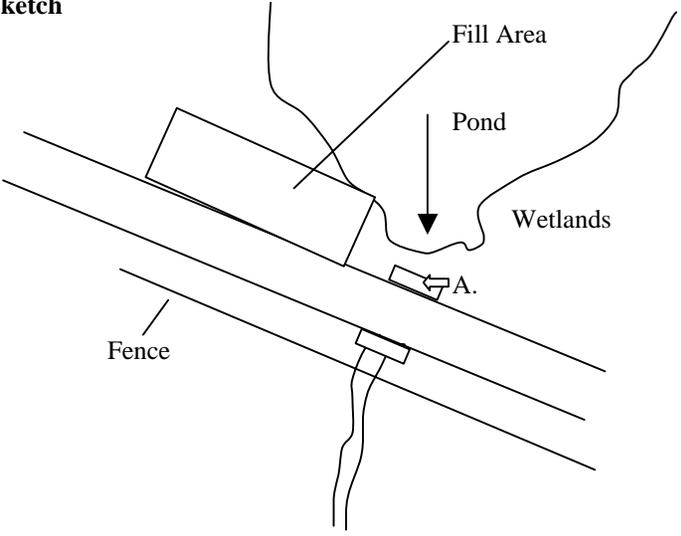
Quad	Site #	Watershed	Wetland Type	Restoration Code	Target Species	Access/Road	Ownership	Waypoint
Q-2	10	Unnamed	Shrub Swamp	CU, FR	Catadromous	Quarry St.	Municipal	79
<b>Notes</b>				<b>Photo</b>				
Stream not flowing from pond				A.				
Pond infilling with emergent vegetation, seems shallow

No flow conditions suggest not a good anadromous fish run site								
Klondike Reservoir not examined in relationship with this site								
<b>Sketch</b>

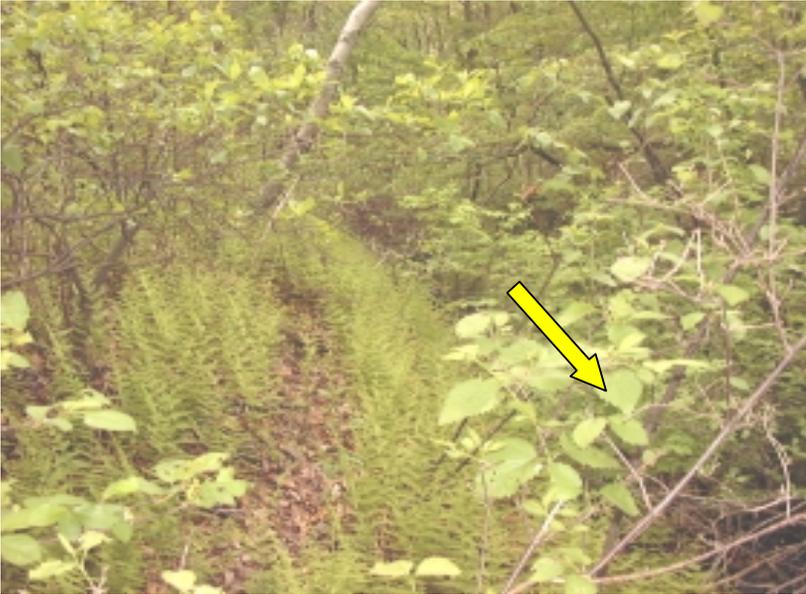
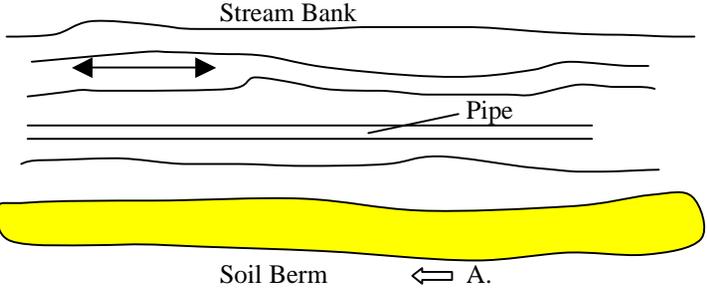
Quad	Site #	Watershed	Wetland Type	Restoration Code	Target Species	Access/Road	Ownership	Waypoint
Q-2	11	Unnamed	Wooded Swamp Deciduous	FR	Riverine	Quarry St.	Municipal	80
<b>Notes</b>				<b>Photo</b>				
Trench dug for water supply purposes				A.				
Supply pipe in stream

Stream not flowing								
Long linear berm along stream bed presumably dredge material								
<b>Sketch</b>

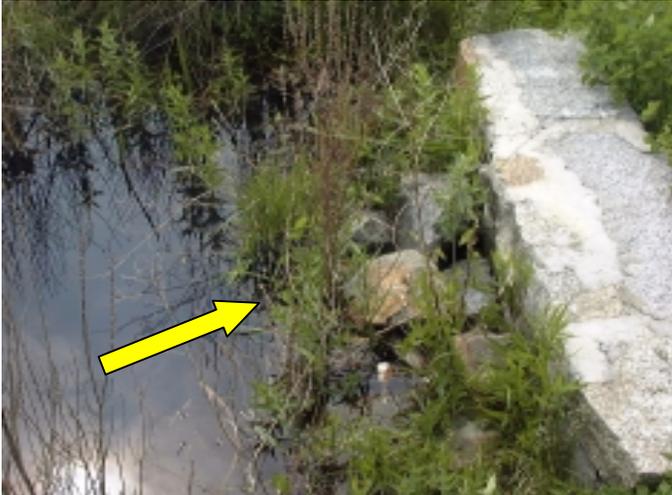
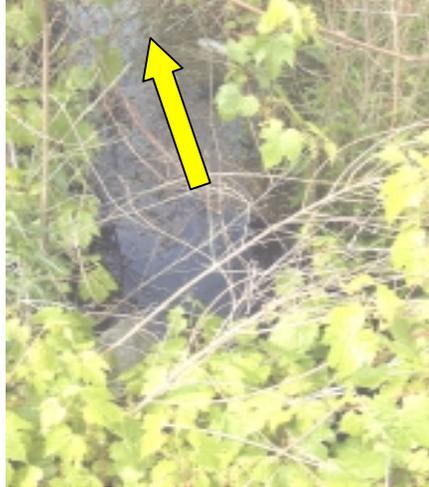
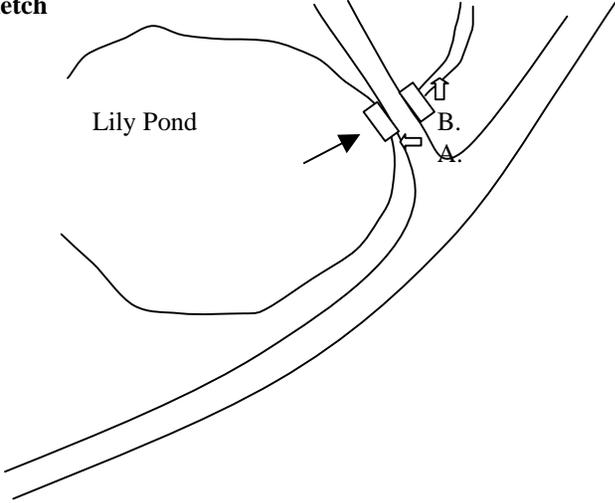
Quad	Site #	Watershed	Wetland Type	Restoration Code	Target Species	Access/Road	Ownership	Waypoint
Q-2	12	Lily Pond	Open Water	CR, IM, CU	Anadromous/Catadromous	Stonehouse Lane	Private	81
<b>Notes</b>				<b>Photo</b>				
Pond may have limited potential for alewife due to size				<p><b>A.</b></p>

Eel potential high if not already present								
Unique brackish pond habitat								
Improvement in tidal flow may reduce invasive								
Pond ringed with purple loosestrife								
Culvert allows limited flow (clogged)								
<b>Sketch</b>

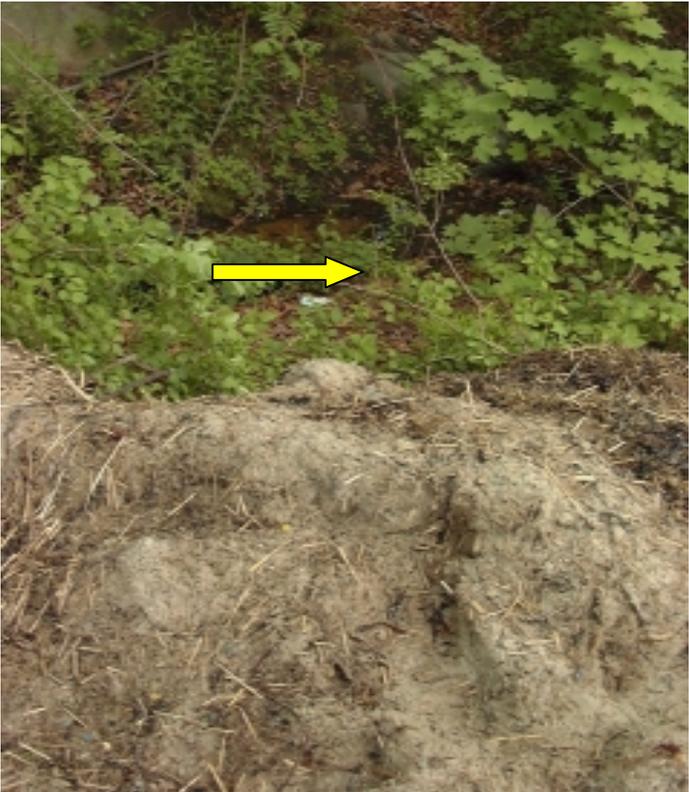
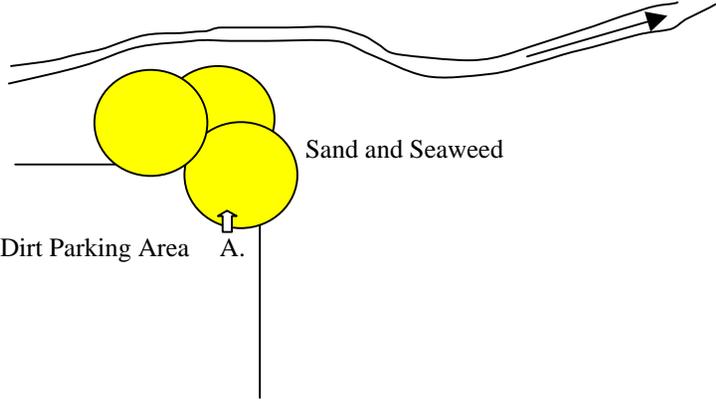
Quad	Site #	Watershed	Wetland Type	Restoration Code	Target Species	Access/Road	Ownership	Waypoint
Q-2	13	Plum Cove	Shrub Swamp	FR, BE	Riverine	Western Ave.	Municipal	82
<b>Notes</b>				<b>Photo</b>				
Beach debris dumped along stream (15'), upslope				A.				
Primarily management issue

Area drains to ball field stormdrains								
<b>Sketch</b>

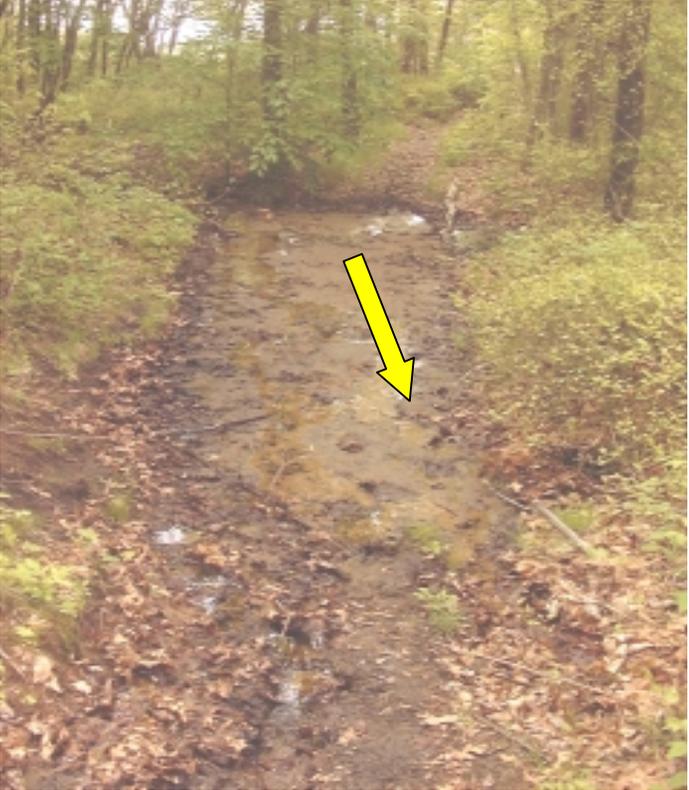
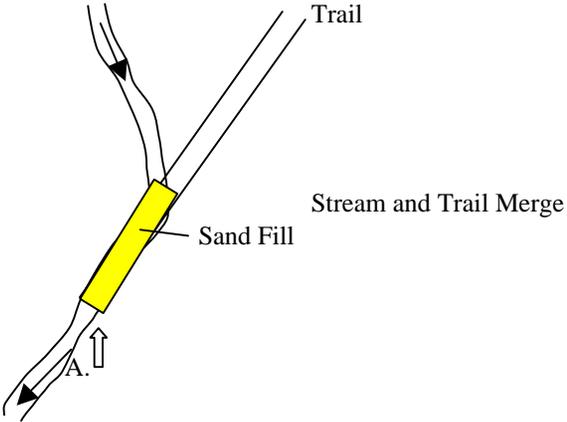
Quad	Site #	Watershed	Wetland Type	Restoration Code	Target Species	Access/Road	Ownership	Waypoint
Q-2	14	Unnamed	Wooded Swamp Deciduous	FR	Riverine	Western Ave.	Municipal	83
<b>Notes</b>				<b>Photo</b>				
Trail cuts through stream				A.				
Stream filled with beach sand to allow/improve access

Sedimentation problem transferred downstream								
Remove sand and place a boardwalk to eliminate/reduce impact								
<b>Sketch</b>

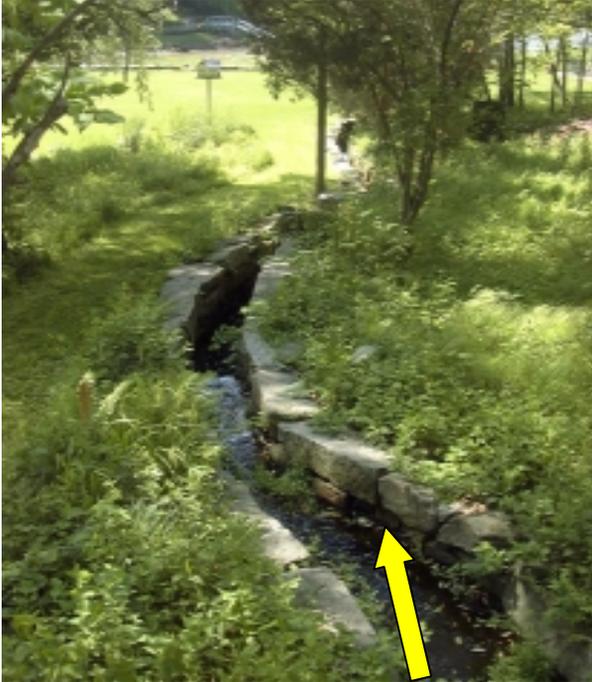
Quad	Site #	Watershed	Wetland Type	Restoration Code	Target Species	Access/Road	Ownership	Waypoint
Q-2	15	Lobster Cove	Brackish Marsh	BI, BE, BMP, DL	Anadromous/Catadromous	Annisquam Road	Private/Public	84
<b>Notes</b>				<b>Photo</b>				
Creek channelized, natural buffer destroyed				<b>A.</b>

Creek could be altered to form a smelt run if one does not exist								
Upstream driveway abuts creek								
Stream is buried for 50' to make way for lawn								
Small pond upstream could be eel habitat								
Outlet to marsh not seen								
<b>Sketch</b>

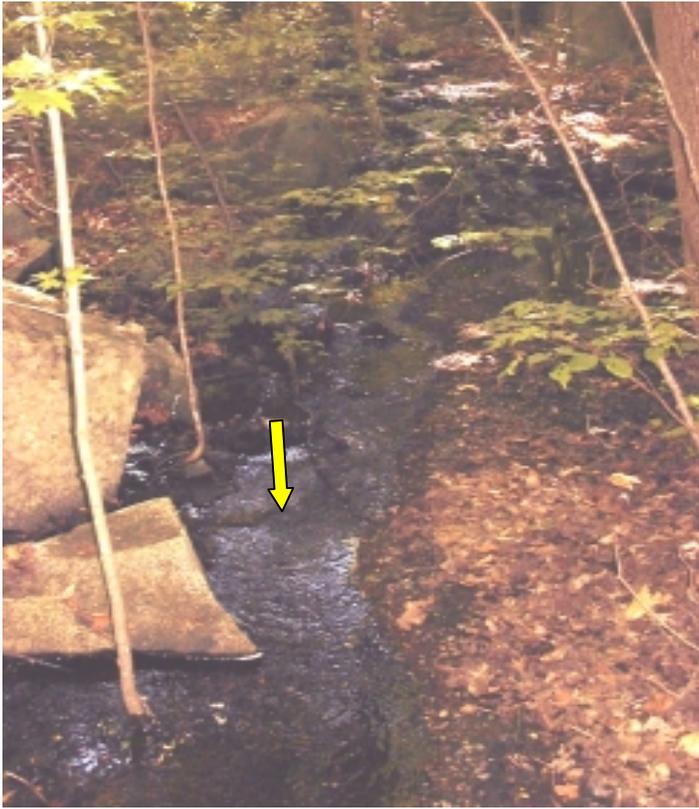
Quad	Site #	Watershed	Wetland Type	Restoration Code	Target Species	Access/Road	Ownership	Waypoint
Q-2	17	Langsford Pond	Wooded Swamp Deciduous	FR, DL	Anadromous/Catadromous	Dorset St.	Unknown	86
<b>Notes</b>				<b>Photo</b>				
Stream disappears under a pile of stones				A.				
Low flow due to dispersal of stream

Stream emerges, forms small pools								
Field of stone fill								
Upstream there is good flow from pond								
Field of stones approx. 100 yards long								
<b>Sketch</b>

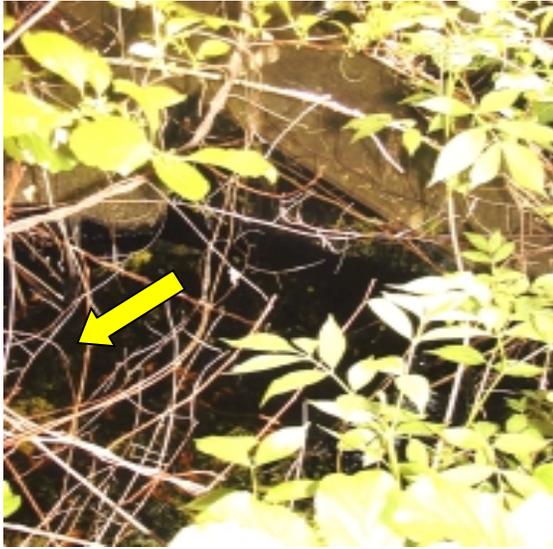
Quad	Site #	Watershed	Wetland Type	Restoration Code	Target Species	Access/Road	Ownership	Waypoint
Q-2	18	Langsford Pond	Wooded Swamp Deciduous	CU	Anadromous/Catadromous	Dorset St.	Unknown	87
<b>Notes</b>				<b>Photo</b>				
Culvert under driveway is collapsed and needs to be improved if there is potential for fish passage to pond				<b>A.</b>

Size of opening not measured								
<b>Sketch</b>				<b>B.</b>

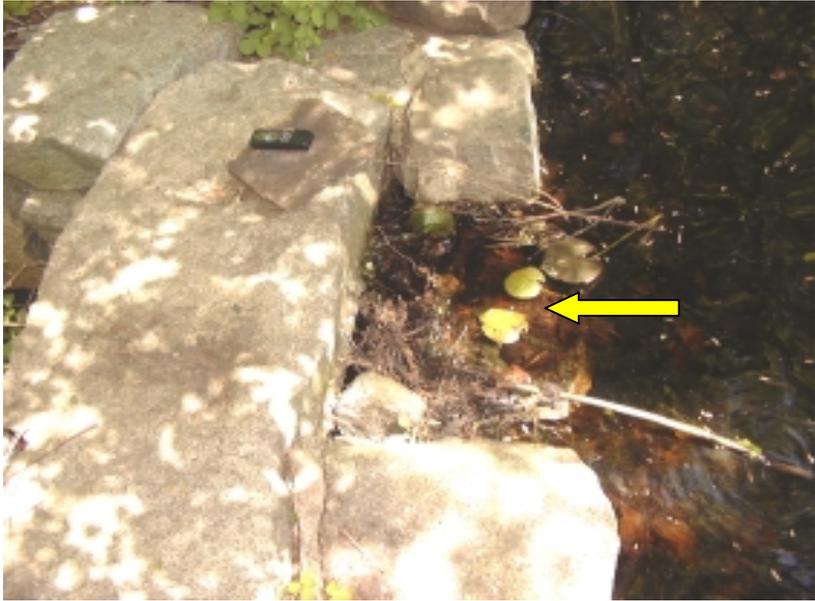
Quad	Site #	Watershed	Wetland Type	Restoration Code	Target Species	Access/Road	Ownership	Waypoint
Q-2	19	Langsford Pond	Wooded Swamp Deciduous/Open Water	FL	Anadromous/Catadromous	Dorset St.	Private	88
<b>Notes</b>				<b>Photo</b>				
Pond levels could be managed for alewife passage				A.				
Pond may be too small to support alewife

Slight elevation drop from pond outlet								
Project should only be done in conjunction with downstream improvements								
Pond appears to be owned by Essex County Greenbelt Assoc.								
<b>Sketch</b>

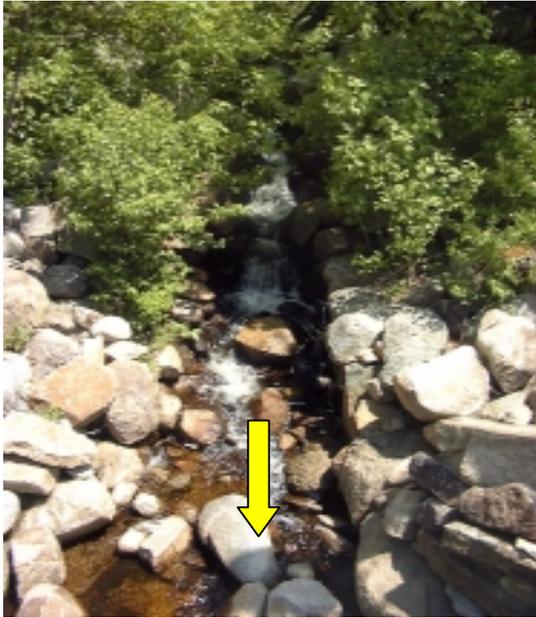
Quad	Site #	Watershed	Wetland Type	Restoration Code	Target Species	Access/Road	Ownership	Waypoint
Q-2	20	Duck Pond	Brackish Marsh	RR, FL	Anadromous/Catadromous	Dennison St.	Unknown	89
<b>Notes</b>				<b>Photo</b>				
Possible smelt spawning habitat below culvert				<p>A.</p>

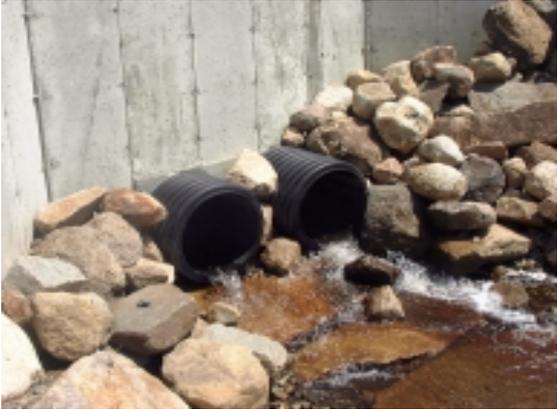
<p>B.</p>

Two new corrugated plastic 3' culverts								
Significant elevation change from fresh water to salt water								
Site is problematic due to steep drop and configuration of stream								
Culverts set too high								
<b>Sketch</b>

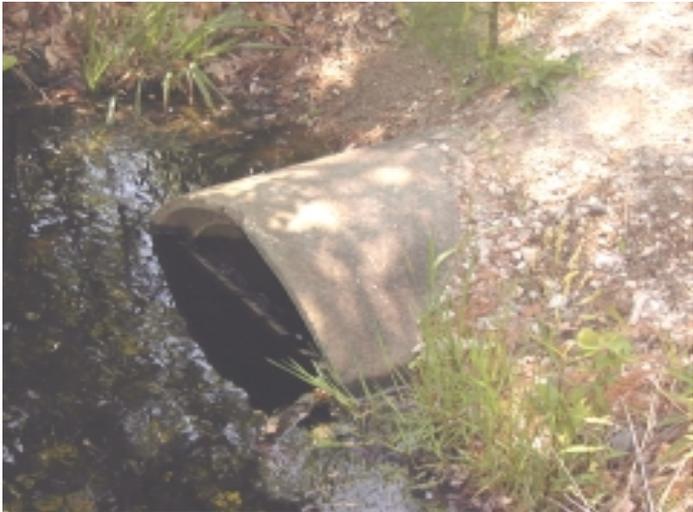
Quad	Site #	Watershed	Wetland Type	Restoration Code	Target Species	Access/Road	Ownership	Waypoint
Q-2	21	Duck Pond	Open Water	DL	Anadromous/Catadromous	Dennison St.	Unknown	91
<b>Notes</b>				<b>Photo</b>				
Outlet for Duck Pond				<p><b>A.</b></p>

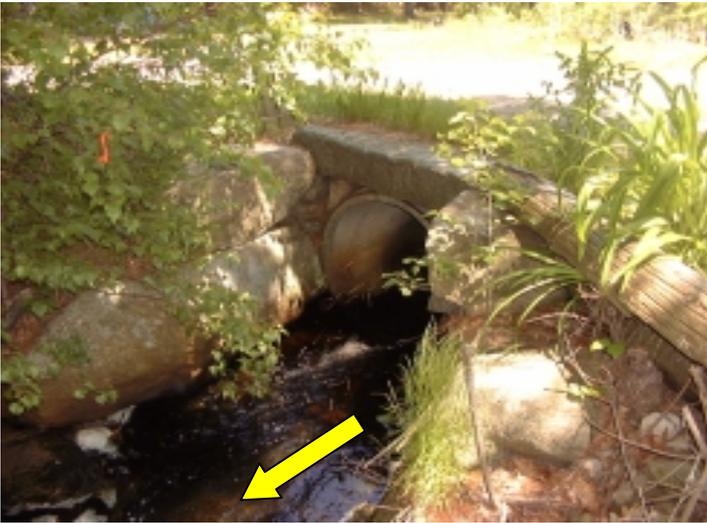
<p><b>B.</b></p>

30-40' potential daylight opportunity								
Culvert may be undersized								
Weir board in place - limits pond level								
Approx. 2.5' concrete culvert								
Pond should be studied to determine alewife potential								
<b>Sketch</b>

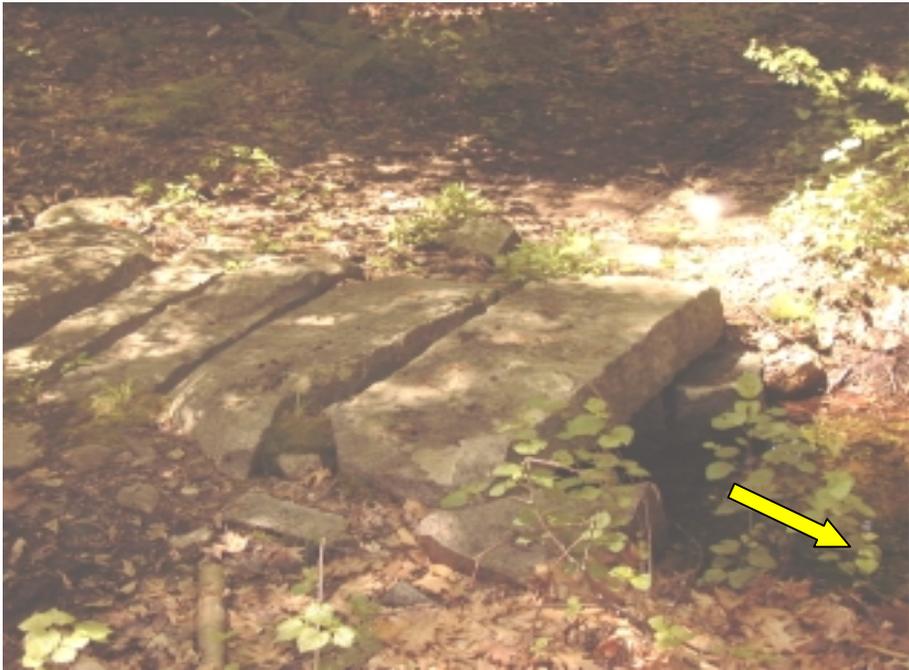
Quad	Site #	Watershed	Wetland Type	Restoration Code	Target Species	Access/Road	Ownership	Waypoint
Q-2	22	Unnamed	Wooded Swamp Deciduous	FR	Riverine	Dennison St.	Unknown	92
<b>Notes</b>				<b>Photo</b>				
Minor disturbance				<b>A.</b>

Old bridge slumped into stream								
Creates more wetlands upstream								
Restricts natural flow								
10-15' in length								
<b>Sketch</b>

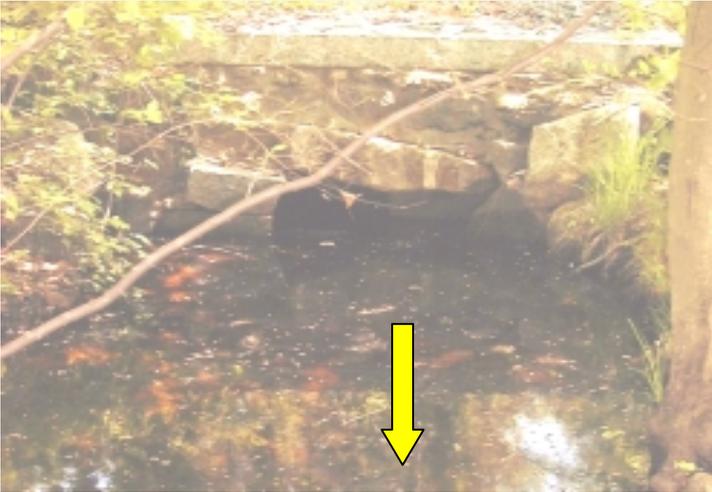
Quad	Site #	Watershed	Wetland Type	Restoration Code	Target Species	Access/Road	Ownership	Waypoint
Q-2	23	Goose Cove	Shrub Swamp	CU, FR	Riverine	Dennison St.	Public/Private	93
<b>Notes</b>				<b>Photo</b>				
Culvert slightly undersized and in poor shape				<p>A.</p>

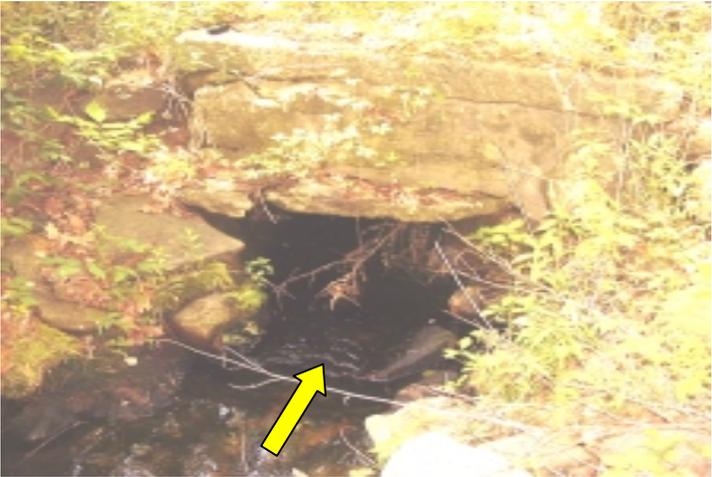
<p>B.</p>

Granite box culvert roughly 2' x 2'								
Rocks in stream below culvert retard natural flow								
Low impact, minor disturbance								
<b>Sketch</b>

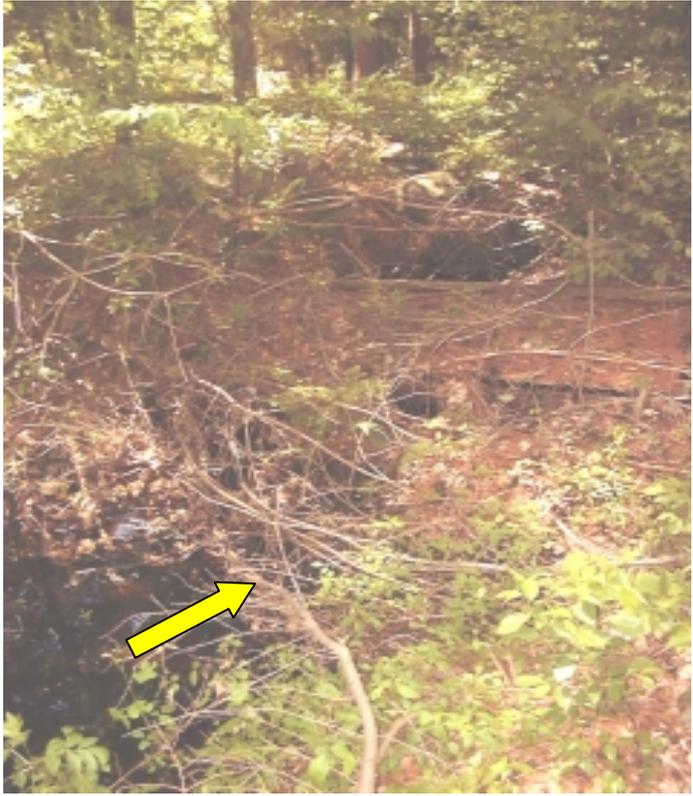
Quad	Site #	Watershed	Wetland Type	Restoration Code	Target Species	Access/Road	Ownership	Waypoint
Q-2	25	Unnamed	Wooded Swamp Deciduous	FR	Riverine	Dennison St.	Private	95
<b>Notes</b>				<b>Photo</b>				
Old bridge across stream has slumped				A.				
Bridge could be removed to restore natural flow patterns								
Formally a trail bridge								
Minimal disturbance								
Stream is loosely channelized below the bridge								
Approx. 5-6' wide and long								
Site might be owned by Essex County Greenbelt Assoc.								
<b>Sketch</b>								
<b>Restoration Priority</b>								
<i>General Classification:</i> minor								
<i>Restoration Potential Score:</i> NA
