# City of Gloucester Comprehensive River and Stream Habitat Restoration Report

2003

Tim Purinton

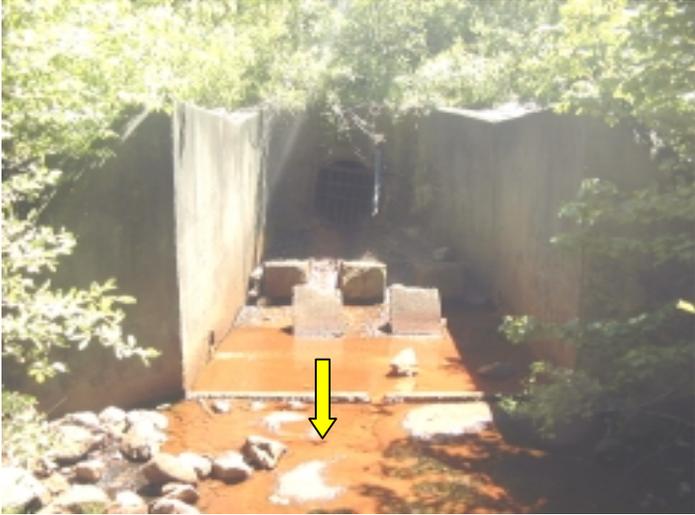
Quad	Site #	Watershed	Wetland Type	Restoration Code	Target Species	Access/Road	Ownership	Waypoint	
Q-2	26	Goose Cove Reservoir	Wooded Swamp Deciduous	CU, FL	Riverine	Reservoir Road	Municipal	96	
<b>Notes</b>				<b>Photo</b>					
Control structure for reservoir				<b>A.</b>

Main 3' culvert in center of concrete retaining wall									
Only flowing culverts are side smaller culverts									
Vital structure to dam and water supply									
Stream may not be large enough to support alewives									
Stream channelized below dam									
<b>Sketch</b>				<b>B.</b>

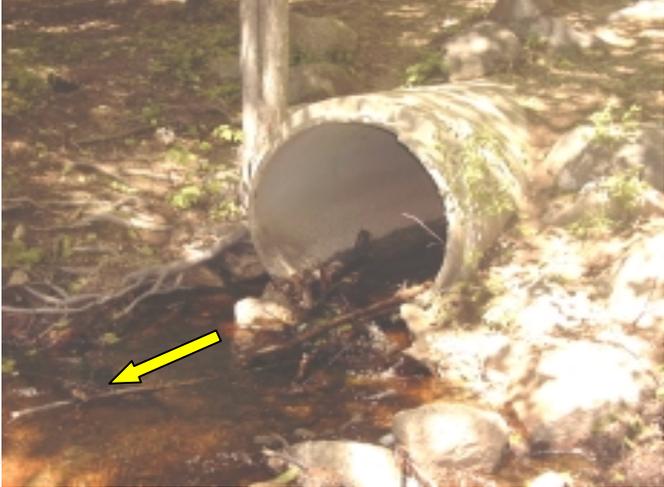
3.5' concrete culvert								
Culvert set too high								
Culvert too long, 45' to 50' total length, road approx. 20' wide								
Culvert could be shortened to daylight more stream								
<b>Sketch</b>				B.

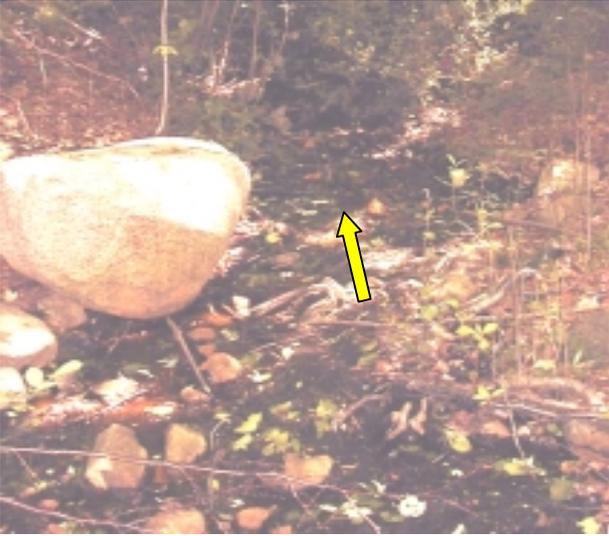
Quad	Site #	Watershed	Wetland Type	Restoration Code	Target Species	Access/Road	Ownership	Waypoint
Q-2	28	Unnamed	Wooded Swamp Deciduous/Open Water	FL	Riverine	Reservoir Road	Unknown	99
<b>Notes</b>				<b>Photo</b>				
Almost dry stream bed due to lack of flow from dam				<p>A.</p>

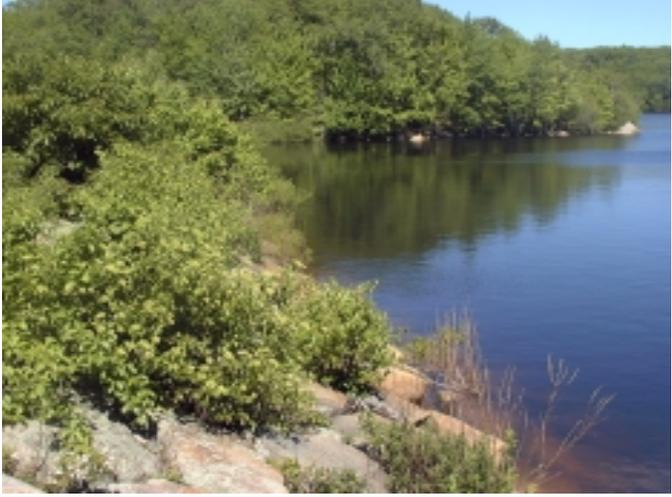
<p>B.</p>

Slight runoff from reservoir would return some stream functions								
Difficult to engineer site, need to assess flooding potential								
Check historic maps								
No culvert seen emanating from bank								
<b>Sketch</b>

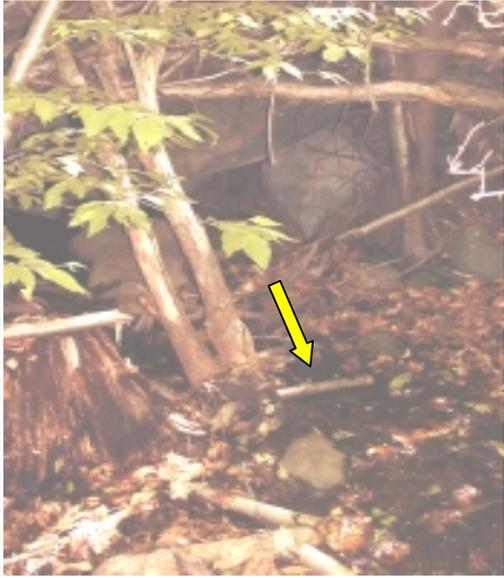
Quad	Site #	Watershed	Wetland Type	Restoration Code	Target Species	Access/Road	Ownership	Waypoint
Q-2	29	Unnamed	Wooded Swamp Deciduous/Shrub Swamp	DL	Riverine	Reservoir Road	Unknown	98
<b>Notes</b>				<b>Photo</b>				
Stream disappears under area of old fill				<b>A.</b>				
Stream culverted for about 125-150'				<b>B.</b>				
Low flow stream

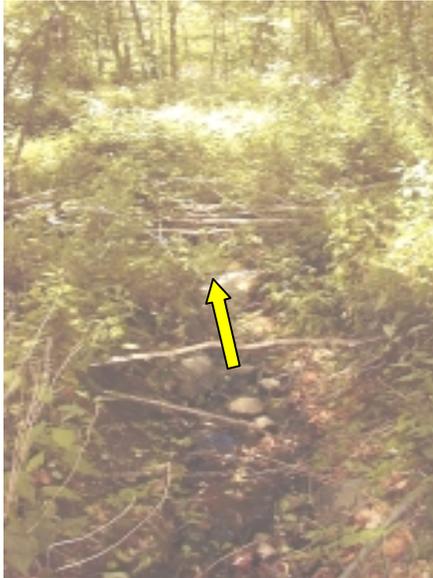
Stream emerges into wetland

Slash deposited in wetlands								
<b>Sketch</b>

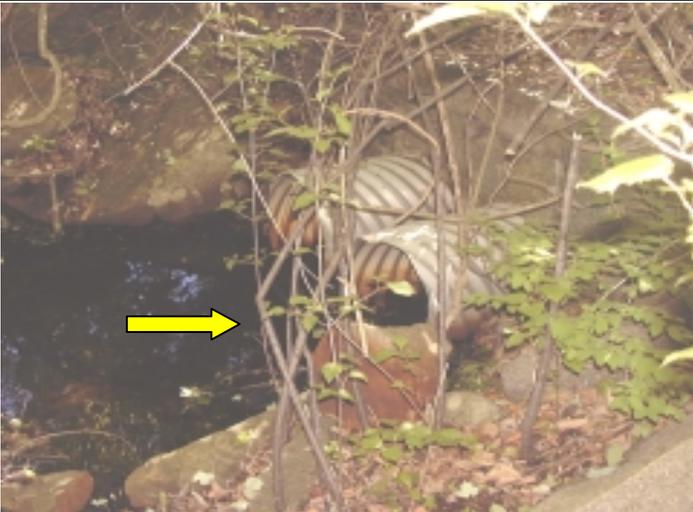
Quad	Site #	Watershed	Wetland Type	Restoration Code	Target Species	Access/Road	Ownership	Waypoint
Q-2	30	Unnamed	Brackish Marsh	CU, FL, BMP, BI	Estuarine/Riverine	Holly St.	Unknown	100
<b>Notes</b>				<b>Photo</b>				
Double corrugated metal culverts (~14")				<p><b>A.</b></p>

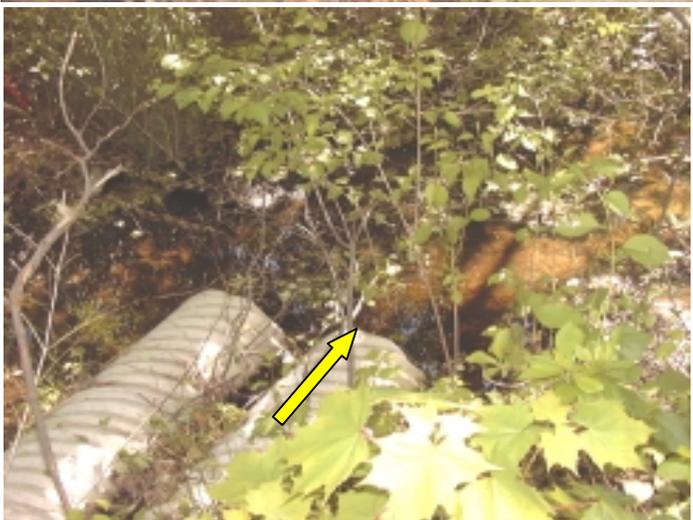
<p><b>B.</b></p>

Culverts may be too small								
Debris in stream below culverts								
Sensitive area, potential for smelt spawning (if it does not exist)								
Culvert outlet extended too far								
<b>Sketch</b>

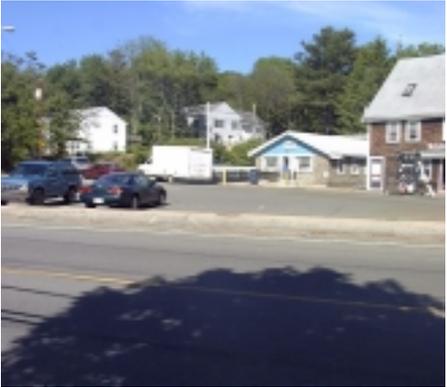
Quad	Site #	Watershed	Wetland Type	Restoration Code	Target Species	Access/Road	Ownership	Waypoint
Q-2	31	Unnamed	Brackish Marsh	DL, BMP	Riverine	Washington St.	Municipal	101
<b>Notes</b>				<b>Photo</b>				
Large disturbance area				A.				
Stormwater part of natural stream				B.				
Source of discharge - Goose Gove Reservoir

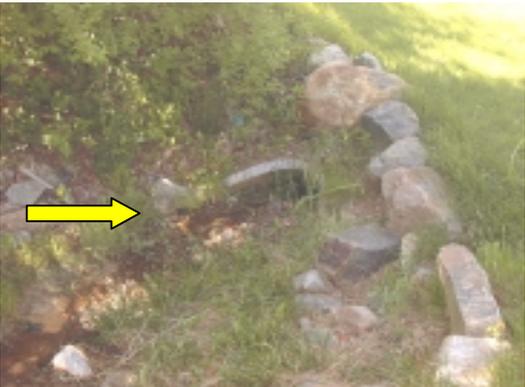
Low flow stream

Final discharge - 2' culvert								
Retaining wall contains 4 discharge culverts of various sizes								
Main stream runs along garden (B) and is channelized (stone)								
<b>Sketch</b>				C.

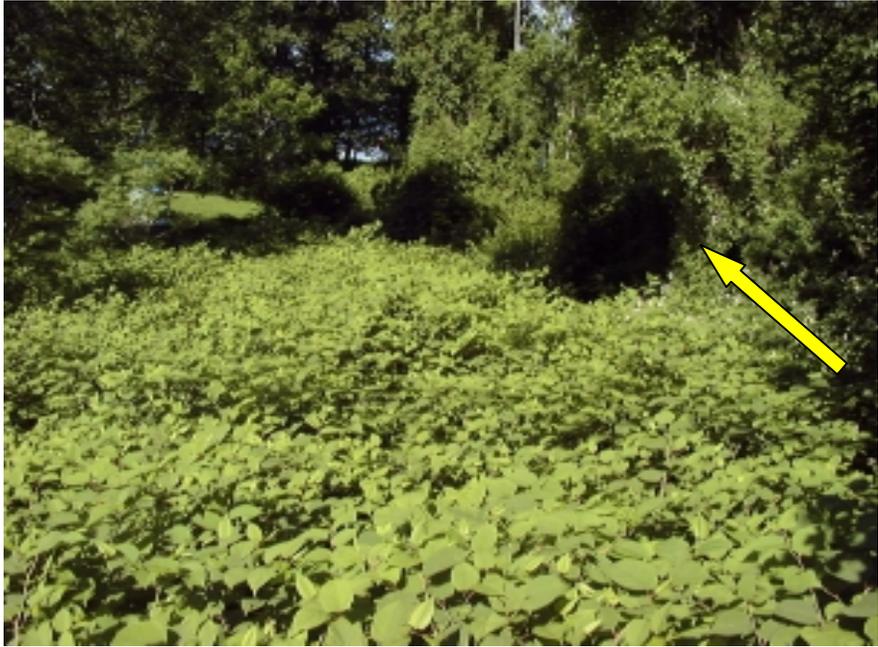
Quad	Site #	Watershed	Wetland Type	Restoration Code	Target Species	Access/Road	Ownership	Waypoint
Q-2	32	Mill River Trib.	Shrub Swamp	IM	Riverine	Washington St.	Unknown	102
<b>Notes</b>				<b>Photo</b>				
Large area of Japanese knotweed				A.				
Area approx. 100' x 100'

Immediately adjacent to stream bank								
Area may be potential smelt spawning habitat								
Private ownership								
Area adjacent to site 31								
<b>Sketch</b>

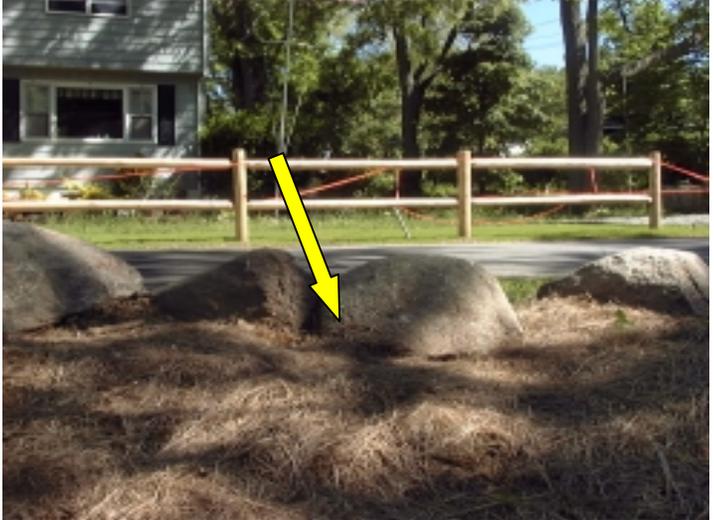
Quad	Site #	Watershed	Wetland Type	Restoration Code	Target Species	Access/Road	Ownership	Waypoint	
Q-2	33	Mill River Trib.	Shrub Swamp	DL	Riverine	Vine St.	Public/Private	103	
<b>Notes</b>				<b>Photo</b>					
2' black corrugated culvert recently installed				A.

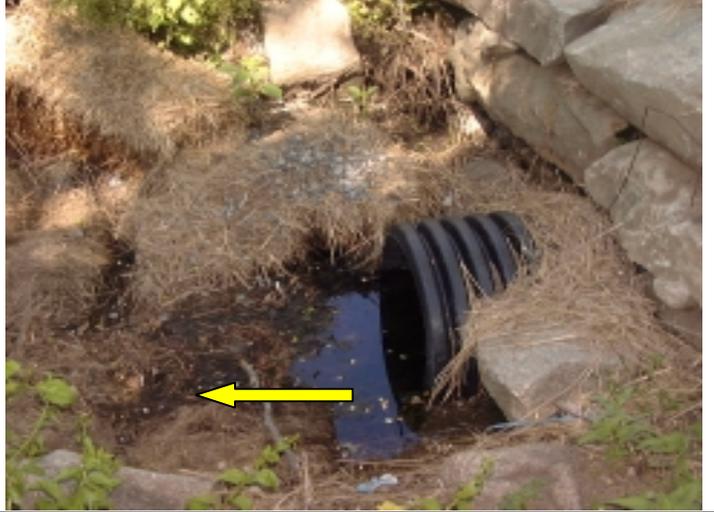
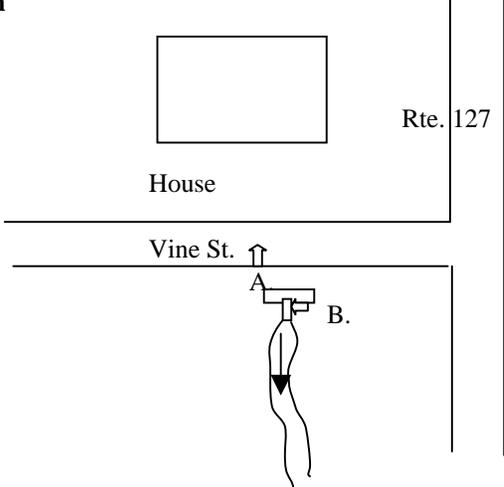
Presumably part of stormwater infrastructure									
Upstream - stream not found									
Stream appears to go under residential area									
Potential for daylighting not known									
<b>Sketch</b>				B.

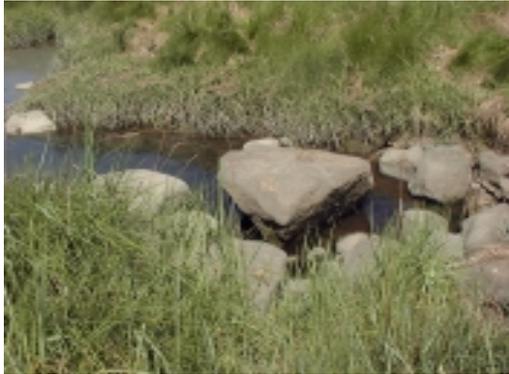
Quad	Site #	Watershed	Wetland Type	Restoration Code	Target Species	Access/Road	Ownership	Waypoint
Q-2	34	Mill River Trib.	Brackish Marsh	RR, IM, CR	Andromous/Estuarine	Washington St.	Unknown	104
<b>Notes</b>				<b>Photo</b>				
Approx. 4' drop - fresh to salt water				<b>A.</b>				
Fresh water channel is braided and poorly formed

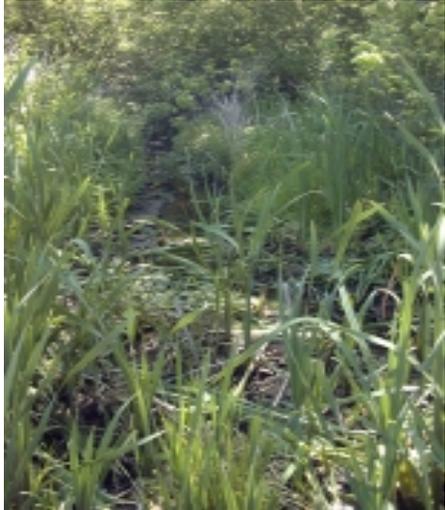
A ramp for eels or channel alteration for smelt may be possible				<b>B.</b>				
Approx. 200 yards of restoration area for smelt (to Rte. 127)

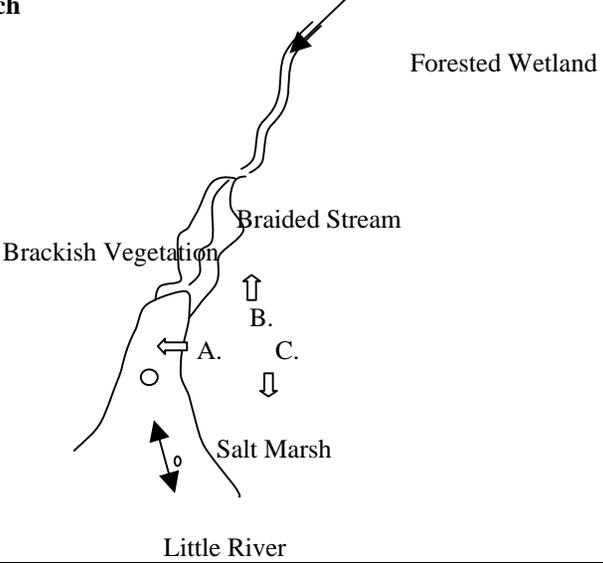
Excellent canopy upstream								
Base flows may be too low for smelt								
Base flows may be enhanced with stormwater redirection and more salt water influence								
<b>Sketch</b>				<b>C.</b>

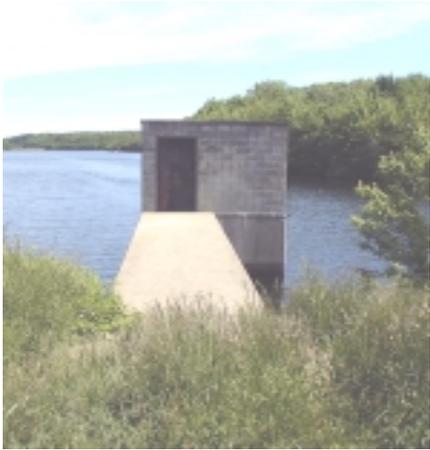
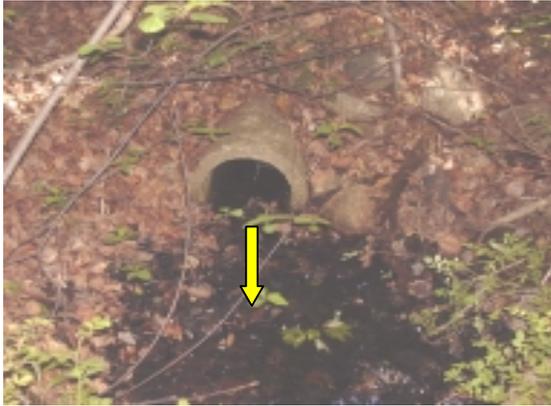
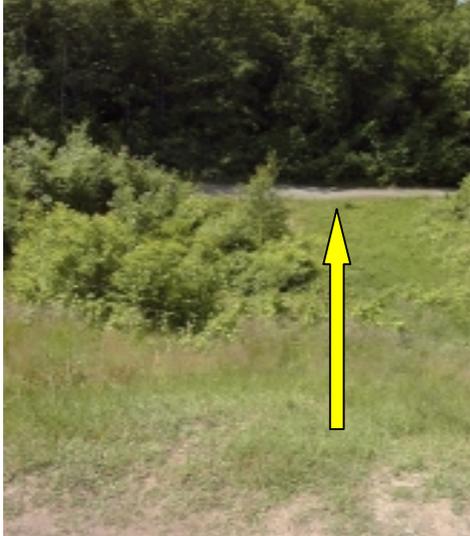
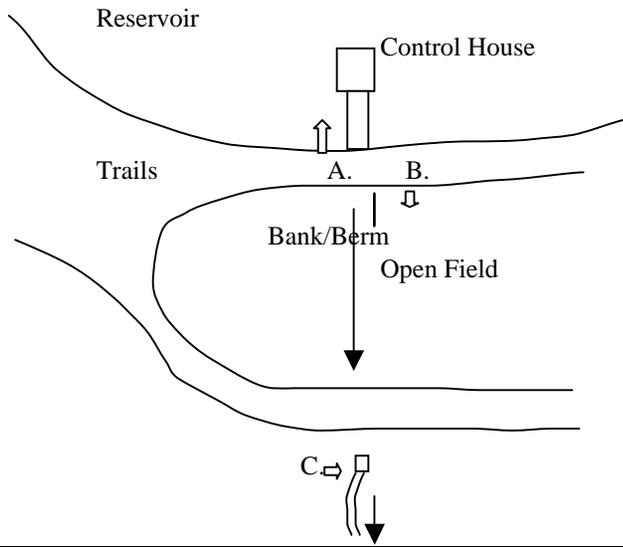
Quad	Site #	Watershed	Wetland Type	Restoration Code	Target Species	Access/Road	Ownership	Waypoint
Q-2	35	Goose Cove Res.	Wooded Swamp Deciduous/Open Water	DL	Riverine	Reservoir Road	Municipal	105
<b>Notes</b>				<b>Photo</b>				
Controlled outlet from reservoir				A.				
1' culvert, low flow				C.				
Flow is probably seep rather than any controlled escape

Approx. 200' of culverted stream								
<b>Sketch</b>				B.

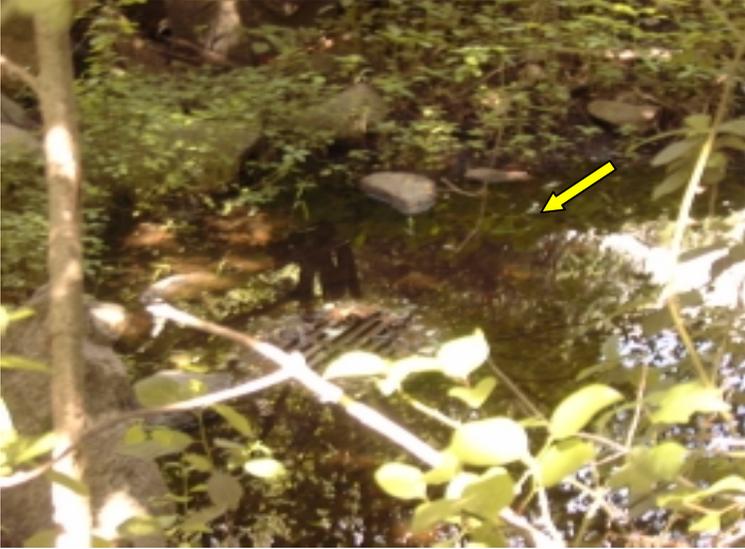
Quad	Site #	Watershed	Wetland Type	Restoration Code	Target Species	Access/Road	Ownership	Waypoint
Q-2	36	Goose Cove Res.	Wooded Swamp Deciduo	BE, DL	Riverine	Reservoir Road	Unknown	106-107
<b>Notes</b>				<b>Photo</b>				
Stream runs along backyards, lawns to stream drain				<b>A.</b>

Stream dead-ends into a stormdrain that goes under a cul-de-sac								
Site connects to site 37								
Stream has been piped under residential subdivision								
Stream side buffer should be expanded (20' minimum)								
<b>Sketch</b>

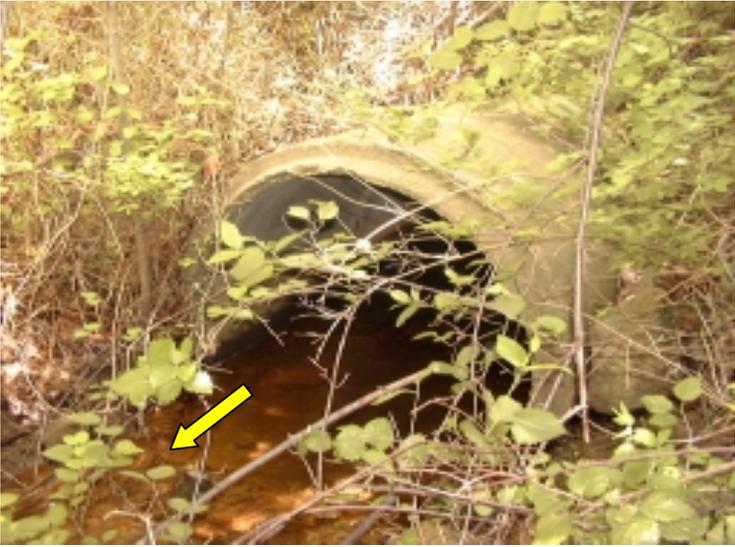
Quad	Site #	Watershed	Wetland Type	Restoration Code	Target Species	Access/Road	Ownership	Waypoint
Q-2	37	Unnamed	Shrub Swamp	DL	Riverine	Cherry St.	Public/Private	108
<b>Notes</b>				<b>Photo</b>				
Stream buried under residential neighborhood				<b>A.</b>

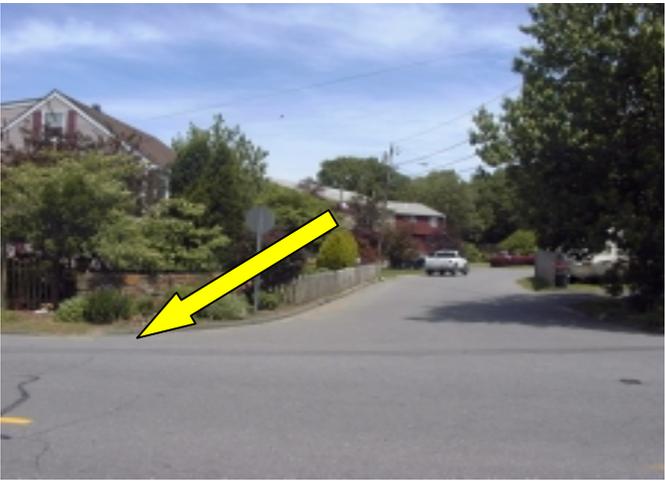
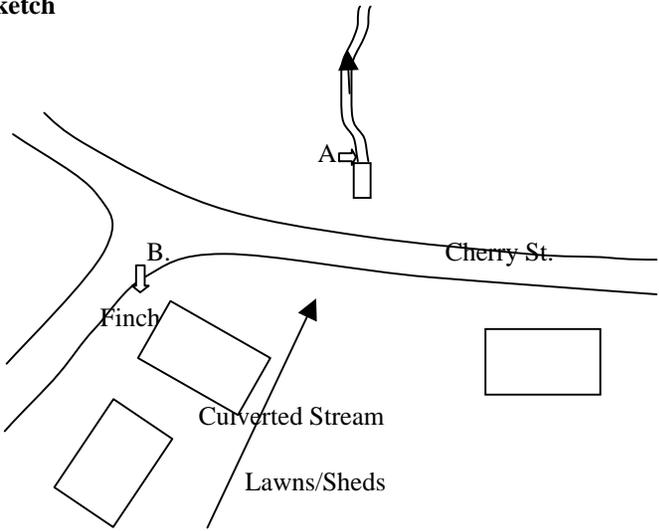
Stream shown on 1982 USGS								
Stream discharges to 3.5' concrete culvert								
Land ownership needs to be studied to determine how to daylight (partially or full) stream, if possible								
Major impact area, total resource loss								
Stream may be culverted up to a couple hundred yards or more								
<b>Sketch</b>				<b>B.</b>

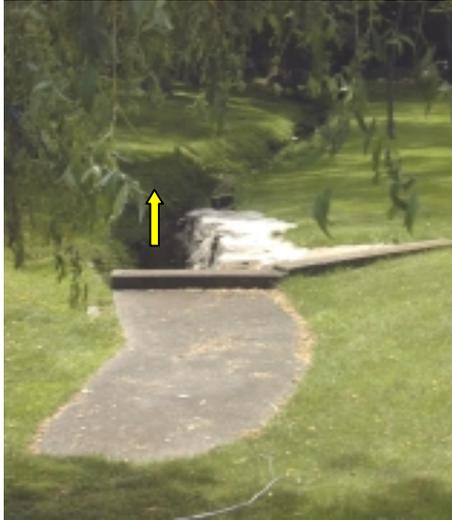
Quad	Site #	Watershed	Wetland Type	Restoration Code	Target Species	Access/Road	Ownership	Waypoint
Q-2	38	Mill River Trib.	Shallow Marsh Meadow	DL, BE, BMP	Anadromous/Riverine	Reynard St.	Public/Private	109
<b>Notes</b>				<b>Photo</b>				
Stream has been converted to lawn and other developed uses				A.

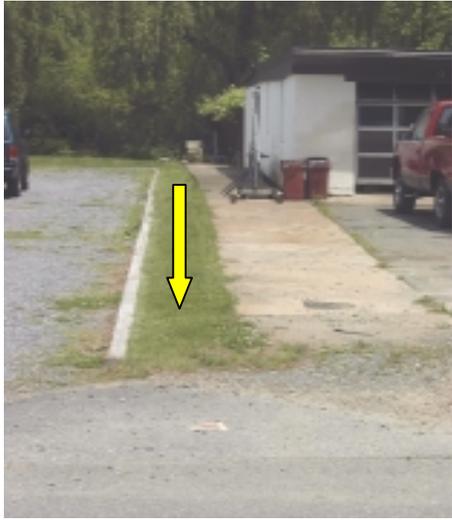
Stream culverted for ~100'				B.

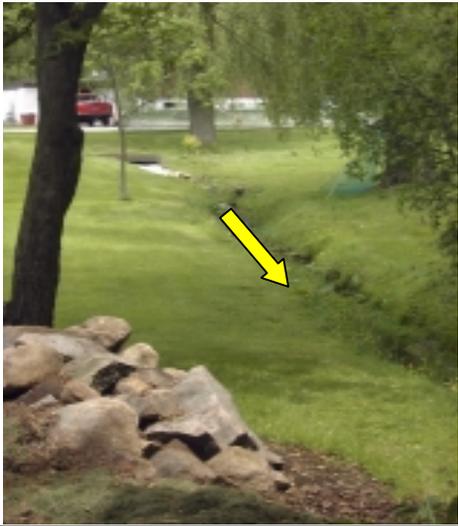
Stream appears ditched downstream (too linier)				C.

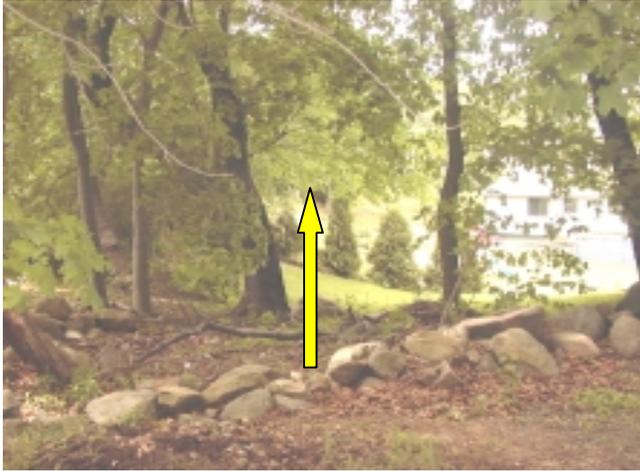
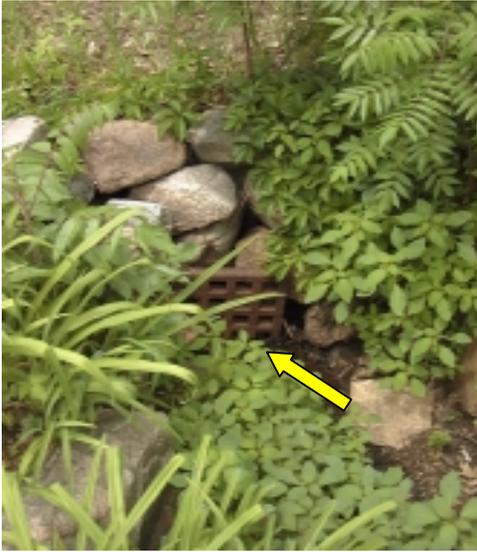
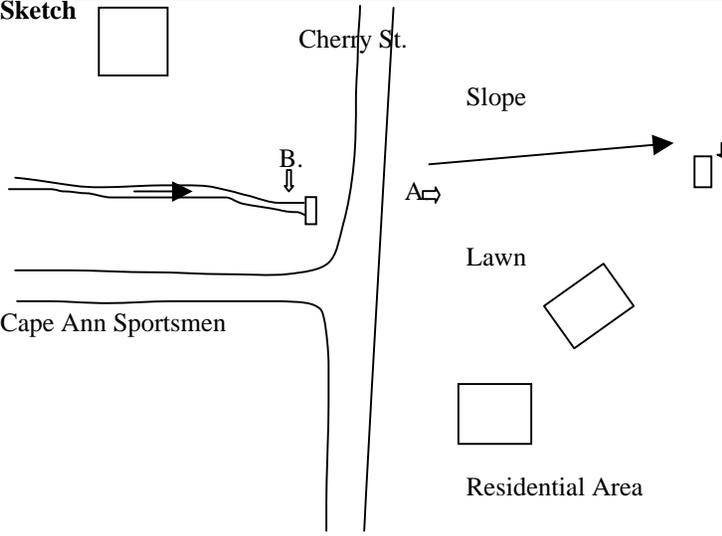
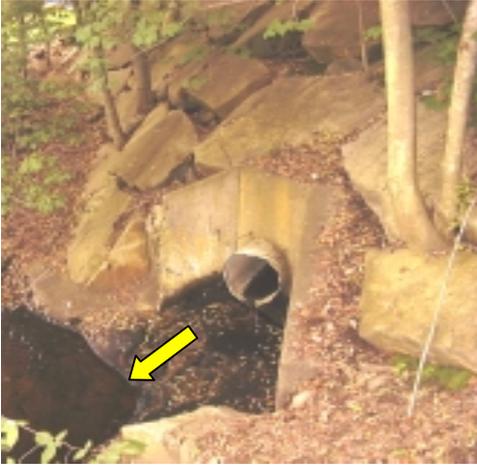
Quad	Site #	Watershed	Wetland Type	Restoration Code	Target Species	Access/Road	Ownership	Waypoint
Q-2	39	Mill River Trib.	Brackish Marsh	FL, DL, BE, CU	Catadromous/Riverine	Cherry St.	Private/Public	110
<b>Notes</b>				<b>Photo</b>				
Site drains to site 38 via 1.5' corrugated culvert

Low flow conditions								
Strangman pond is source water								
Former stream channel filled, steep slope								
Alewife passage probably not possible under flow conditions and given extent of culverted stream								
Downstream - potential smelt spawning area								
Stream enters slumped granite culvert								
<b>Sketch</b>

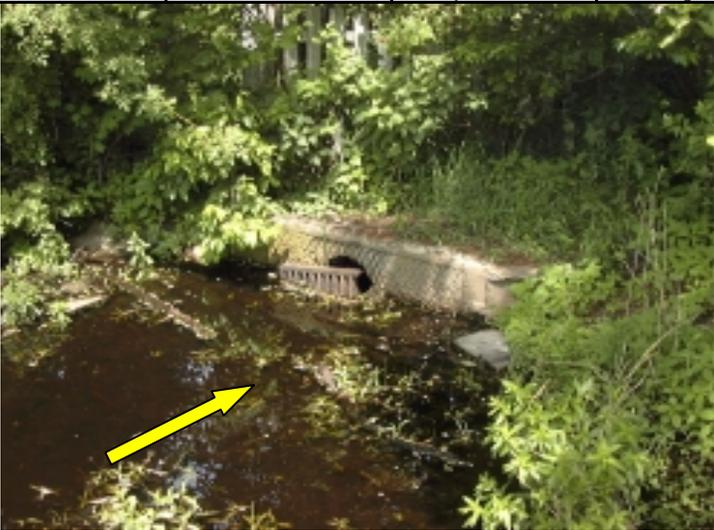
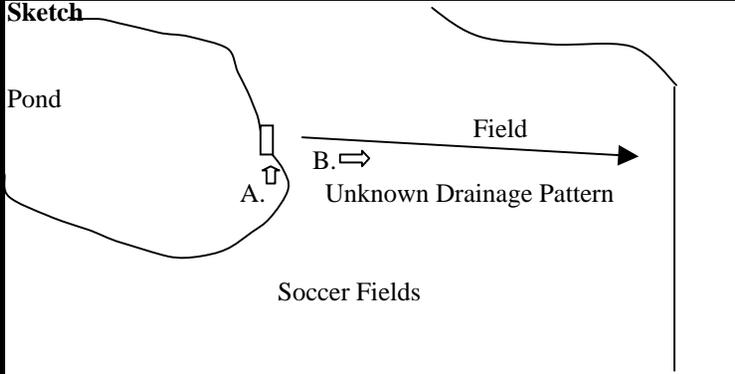
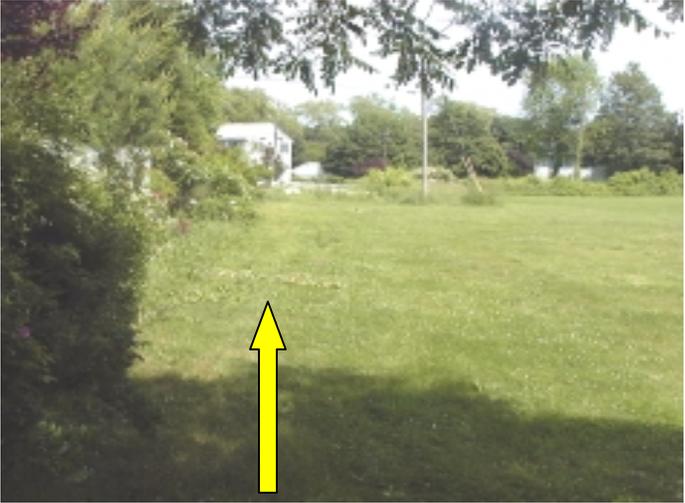
Quad	Site #	Watershed	Wetland Type	Restoration Code	Target Species	Access/Road	Ownership	Waypoint					
Q-2	40	Mill River Trib.	Shallow Marsh Meadow/	DL	Riverine	Honeysuckle Rd.	Municipal	111					
<b>Notes</b>				<b>Photo</b>									
200' of daylight potential													
Pond outlet/stream is culverted													
Outlet not found may be along Mill River Causeway													
Opportunity to daylight along field edge													
<b>Sketch</b>				<b>A.</b>

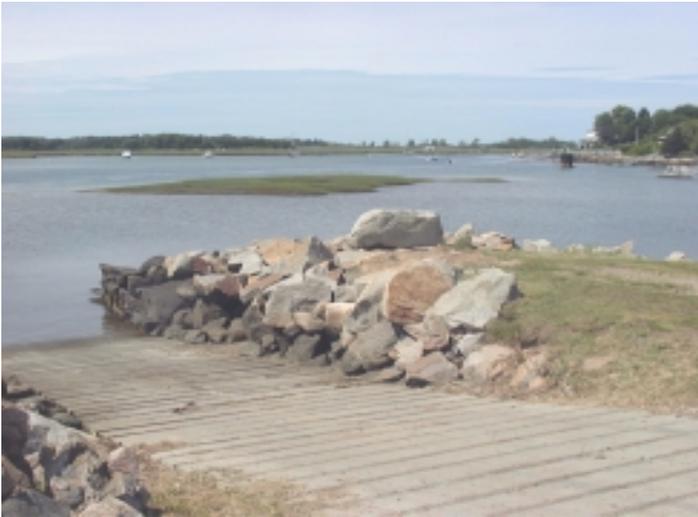
Quad	Site #	Watershed	Wetland Type	Restoration Code	Target Species	Access/Road	Ownership	Waypoint
Q-2	41	Annisquam River	Salt Marsh/Tidal Flat	FR	Estuarine	Corliss Landing	Municipal	112
<b>Notes</b>				<b>Photo</b>				
Portion of landing could be removed for restoration				<b>A.</b>

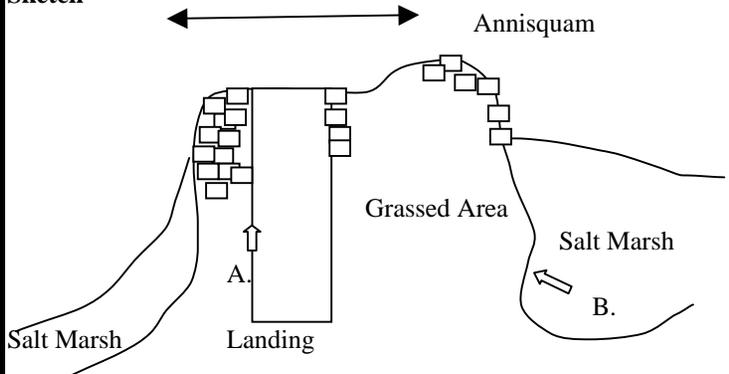
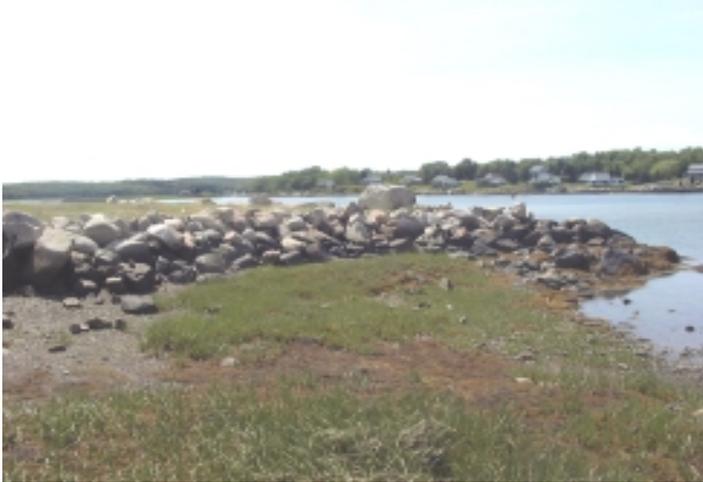
Salt marsh could be planted, tide flat created								
Restoration and continued use of site could coexist								
Historic structure								
<b>Sketch</b>				<b>B.</b>

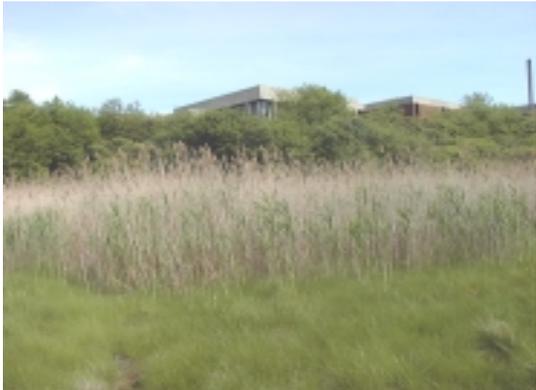
Quad	Site #	Watershed	Wetland Type	Restoration Code	Target Species	Access/Road	Ownership	Waypoint
Q-2	42	Mill River	Salt Marsh	IM, TR, OMWM	Estuarine	O'Maley School	Municipal	113
<b>Notes</b>				<b>Photo</b>				
Area is impacted by <i>Phragmites australis</i> growth				<b>A.</b>				
Litter ditch could reduce Phragmites salt marsh advance

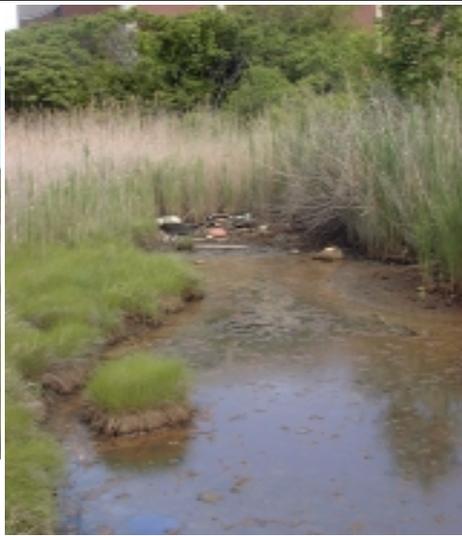
Stream has braided channels - not one defined channel				<b>B.</b>				
Approx. 1-3 acres of Phragmites

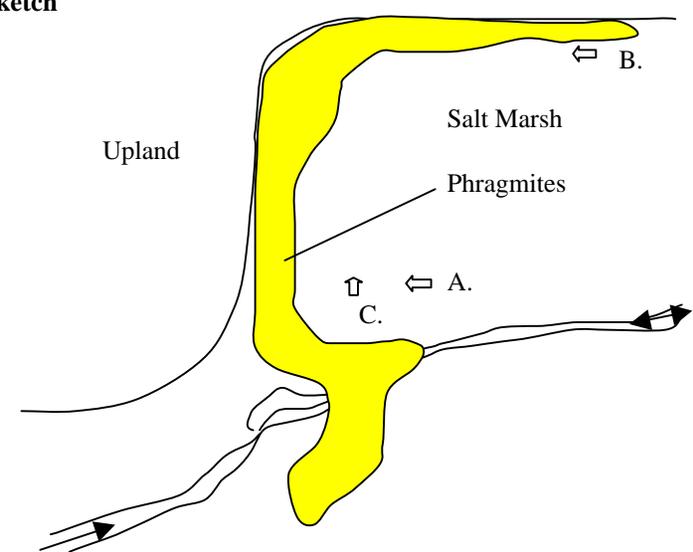
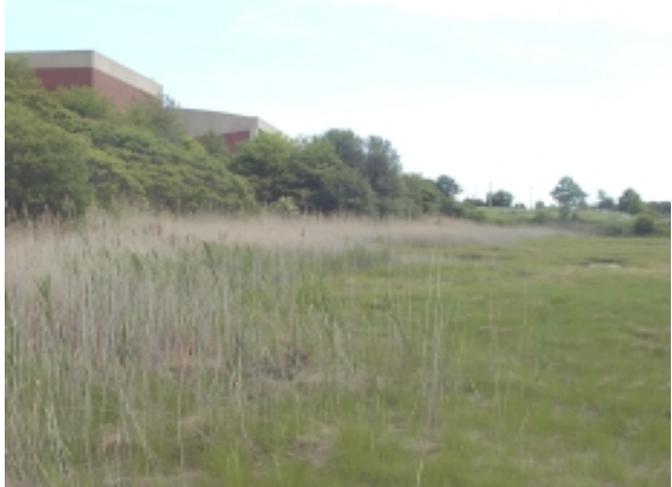
Removal or opening of tide gate needs to be considered downstream								
Site has restoration potential if salinities are high								
Very shallow creek area, if drained would provide habitat for shorebirds								
<b>Sketch</b>				<b>C.</b>

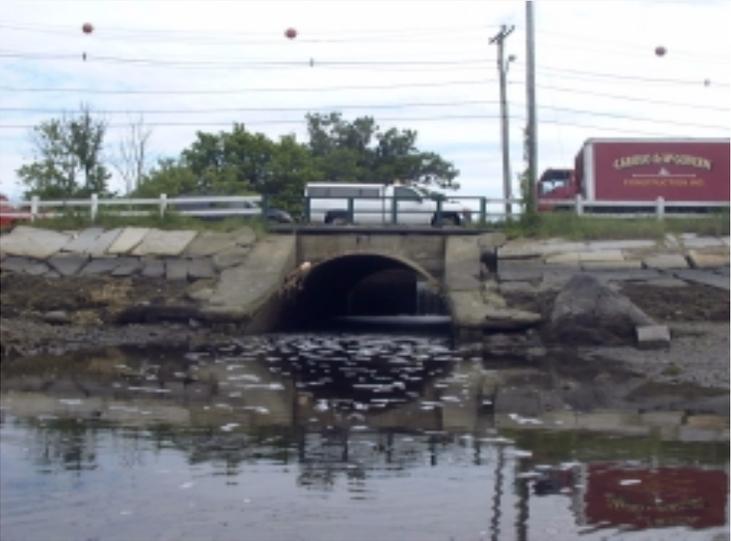
Quad	Site #	Watershed	Wetland Type	Restoration Code	Target Species	Access/Road	Ownership	Waypoint
Q-2	43	Mill River	Salt Marsh/Tidal Flat	CU	Anadromous/Estuarine	Washington St.	Municipal	114
<b>Notes</b>				<b>Photo</b>				
Project has been identified in the tidal restriction report				<p><b>A.</b></p>

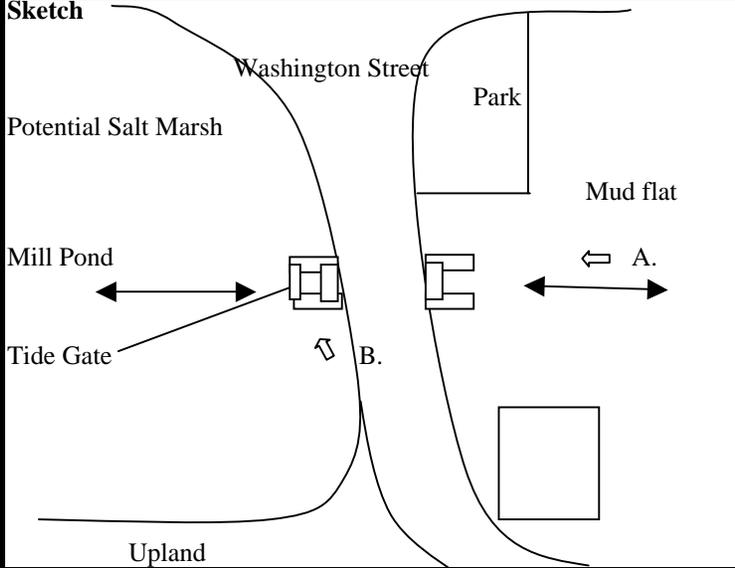
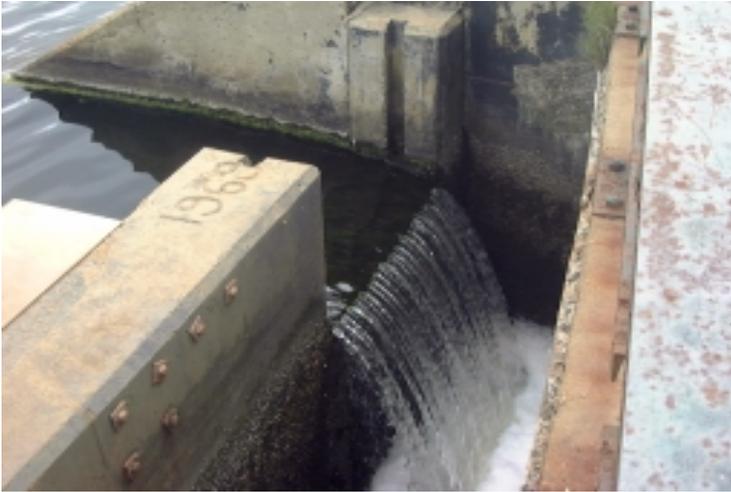
Opening the gate would create mudflat and salt marsh								
It may be possible to lower opening to allow same amount of retained water but it would be more saline (reduce <i>Phragmites australis</i> )								
Tide gate probably adversely effects anadromous and catadromous fish by restricting passage to certain tides								
Restoration of this site is going to effect upstream restoration projects								
<b>Sketch</b>				<b>B.</b>

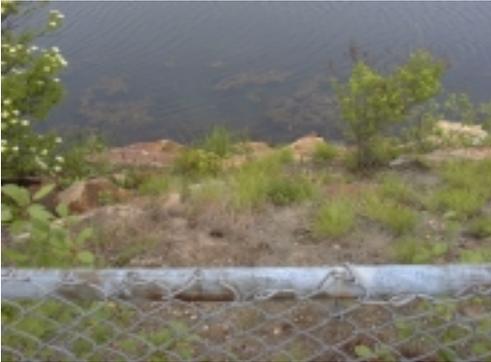
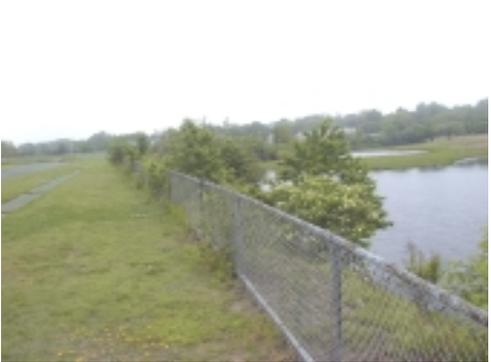
Quad	Site #	Watershed	Wetland Type	Restoration Code	Target Species	Access/Road	Ownership	Waypoint
Q-2	44	Mill River	Salt Marsh/Tidal Flat	FR, BMP	Estuarine	O'Maley School	Municipal	116
<b>Notes</b>				<b>Photo</b>				
Large fill removal potential				<div style="display: flex; flex-wrap: wrap;"> <div style="width: 50%; text-align: center;">A.</div> <div style="width: 50%; text-align: center;">B.</div> </div>

Toe of slope could be pulled back								
Should be done in conjunction with tide gate opening (site 43)								
Couple fill removal with BMP installation								
Transfer of upland to wetland								
Approx. 1-3 acre restoration potential								
<b>Sketch</b>

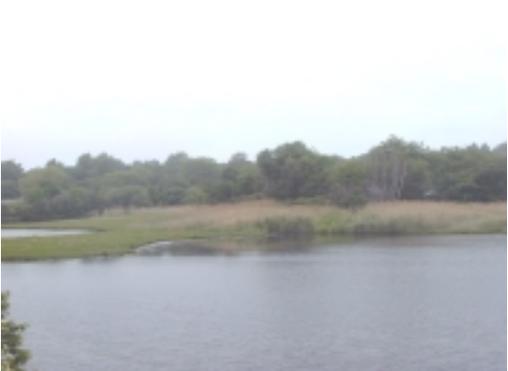
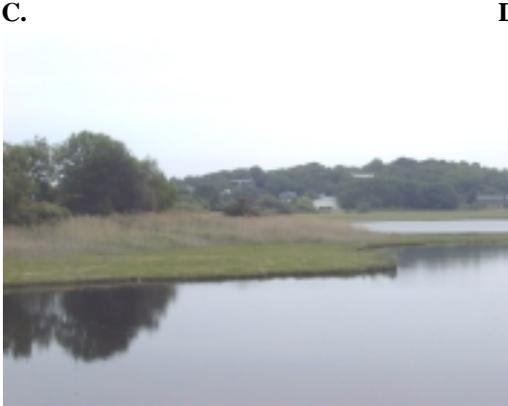
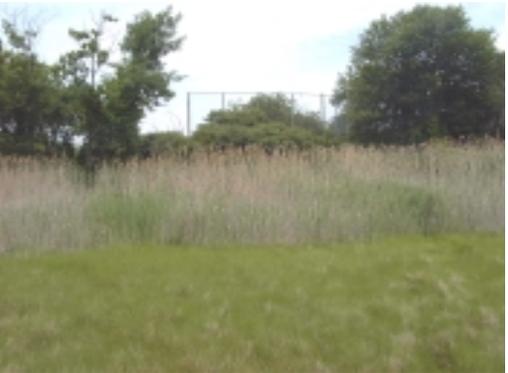
Quad	Site #	Watershed	Wetland Type	Restoration Code	Target Species	Access/Road	Ownership	Waypoint
Q-2	45	Mill River	Salt Marsh/Tidal Flat	FR, IM	Estuarine	Dr. Osman Babson Rd.	Municipal	NA
<b>Notes</b>				<b>Photo</b>				
Extensive Phragmites growth along Mill River				A.				
Ditching may reduce Phragmites in conjunction with tide gate opening				B.				
Re-alignment of ball fields could provide an opportunity for fill removal

Project could be done in conjunction with OWMM/Mosquito control								
<b>Sketch</b>

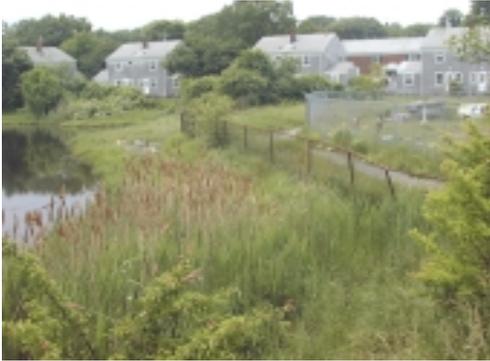
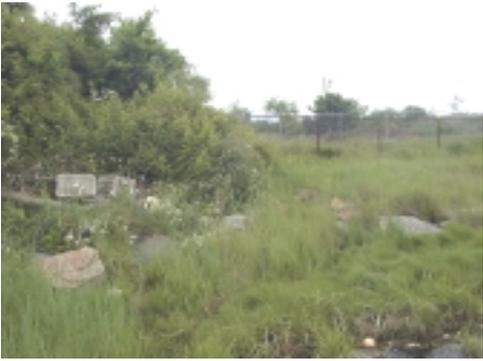
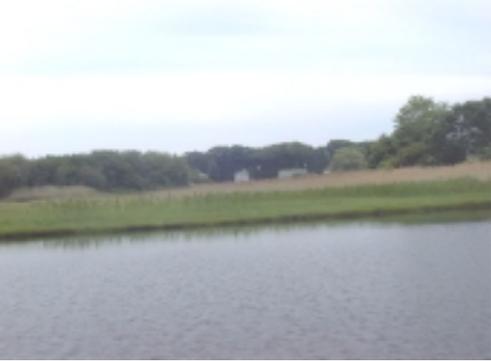
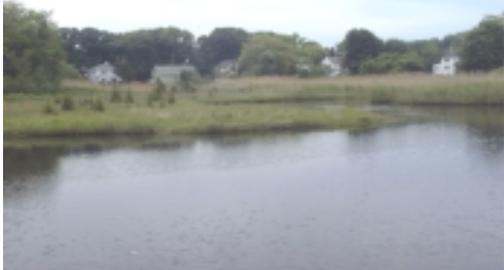
Quad	Site #	Watershed	Wetland Type	Restoration Code	Target Species	Access/Road	Ownership	Waypoint
Q-2	46	Mill River	Salt Marsh	IM, FR,TR	Estuarine	Dr. Osman Babsor	Unknown	117
<b>Notes</b>				<b>Photo</b>				
Transition zone <i>Phragmites</i> growth				A.				
Growth encouraged by alteration of tidal flow downstream				B.				
Stones litter wetland edge

Creek shallow, acts like a large salt panne system

Shallow creek area may revert to salt marsh with sufficient drainage				C.				
Approx. 3-5 acres of <i>Phragmites</i>				D.				
<b>Sketch</b>

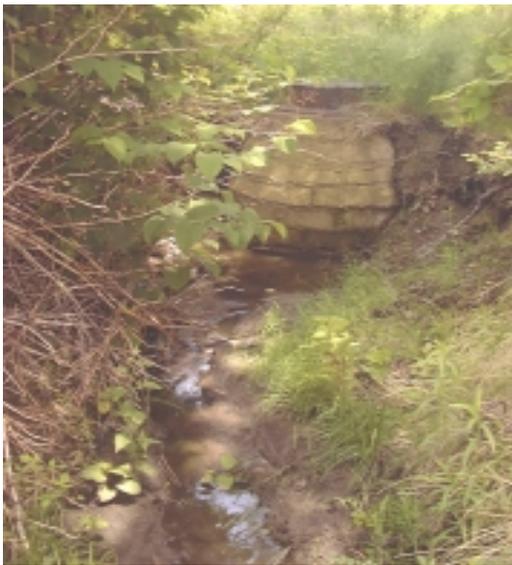
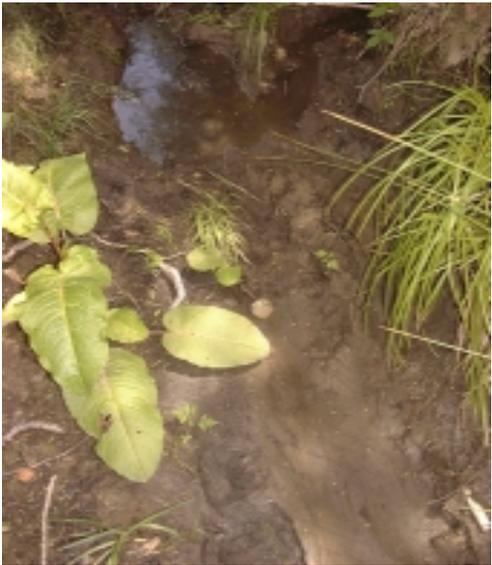
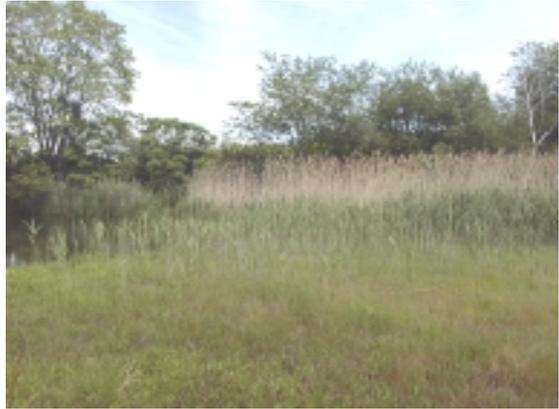
Quad	Site #	Watershed	Wetland Type	Restoration Code	Target Species	Access/Road	Ownership	Waypoint
Q-2	47	Mill River Trib.	Brackish Marsh	IM, BMP	Riverine	Poplar St.	Municipal	118
<b>Notes</b>				<b>Photo</b>				
Heavy sediment discharge - in-stream plume noted				<b>A.</b>				
Water seeps from base of concrete cistern				<b>B.</b>				
Stormwater discharge, watershed presumably DPW yard

Not known if a stream once existed on site

Good opportunity for stormwater BMP given ownership

Discharge of sediment and fresh water enhances Phragmites growth								
<b>Sketch</b>

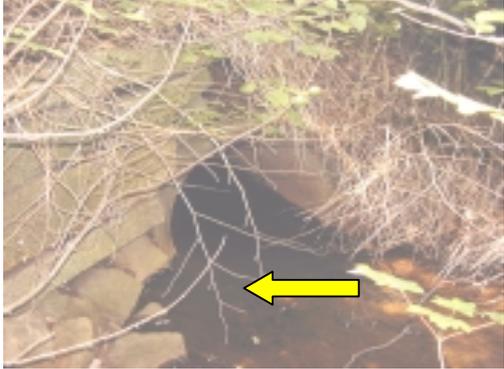
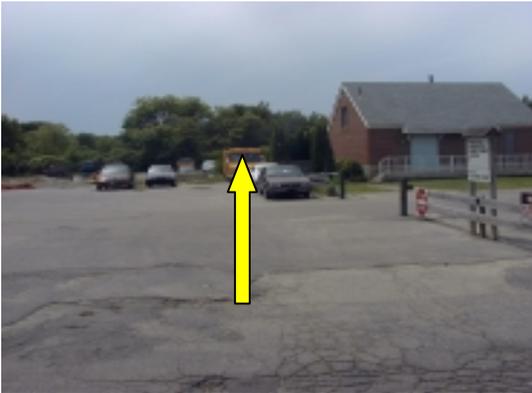
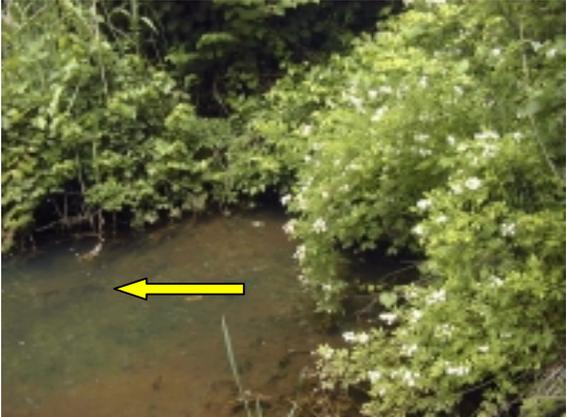
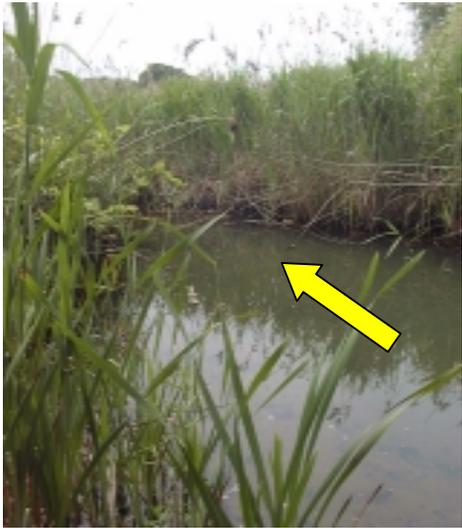
Quad	Site #	Watershed	Wetland Type	Restoration Code	Target Species	Access/Road	Ownership	Waypoint
Q-2	48	Mill River	Brackish Marsh	FR, BMP, DL	Anadromous/Catadromous	Poplar St.	Municipal	119
<b>Notes</b>				<b>Photo</b>				
Inlet, ~ 4' Concrete Culvert				A.				
Good base flow				B.				
Fill replaces potential/natural smelt spawning area

Partial daylight may be possible

Fill along bank upstream				D.				
Approx. 100 yards of daylight potential

Culvert discharges to salt marsh

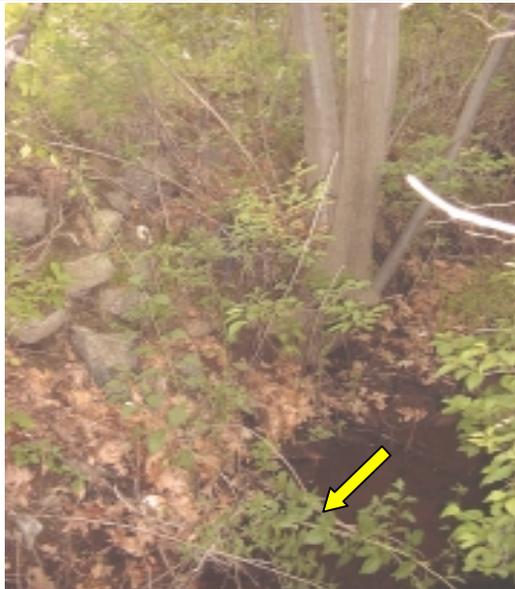
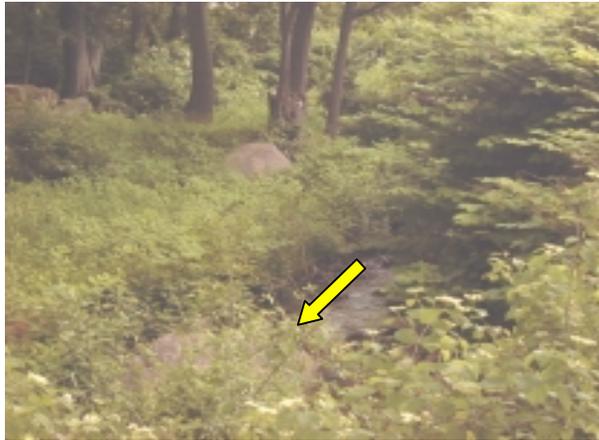
Quad	Site #	Watershed	Wetland Type	Restoration Code	Target Species	Access/Road	Ownership	Waypoint
Q-2	49	Mill River	Shrub Marsh	BE, BI, IM FR	Anadromous/Riverine	Poplar St.	Municipal	120
<b>Notes</b>				<b>Photo</b>				
Houses have lawn to stream edge				<p><b>A.</b></p>

DPW storage area comes to near stream edge								
Historic fill from DPW yard to stream edge								
Rubble and sand in stream								
Stream seems ditched due to linear shape								
Fence to stream edge, barrier to wildlife								
Clearing noted along stream								
Potential to pull back of toe of slope along DPW yard and recreate natural buffer and floodplain								
<b>Sketch</b>

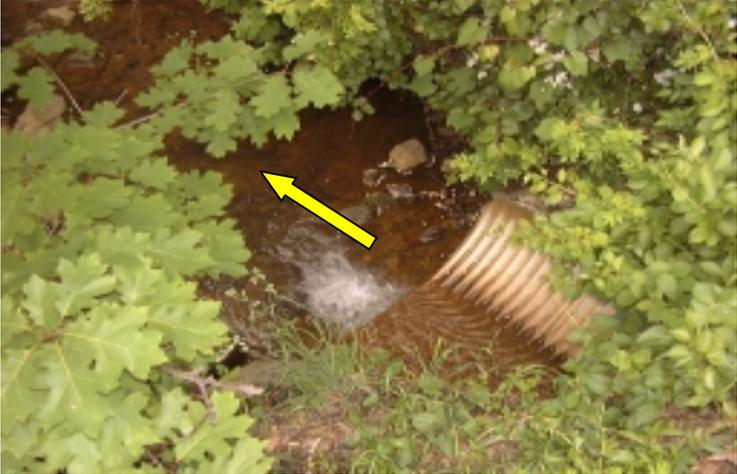
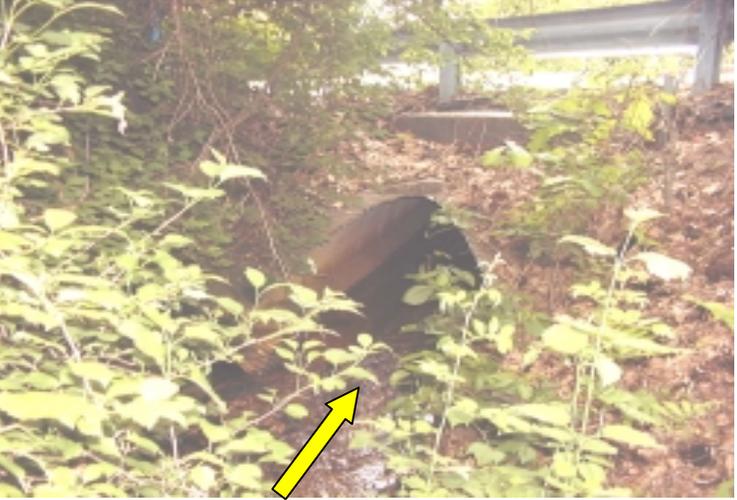
Quad	Site #	Watershed	Wetland Type	Restoration Code	Target Species	Access/Road	Ownership	Waypoint
Q-2	50	Mill River	Shrub Marsh	CU	Riverine	Cherry St.	Municipal	121
<b>Notes</b>				<b>Photo</b>				
Culvert set too high (downstream)				<b>A.</b>

Culvert size is adequate (3')								
Site priority should be considered in context with other adjacent sites (downstream)								
Leaf fill deposited on stream bank								
Anadromous potential limited, no headwater pond								
<b>Sketch</b>				<b>B.</b>

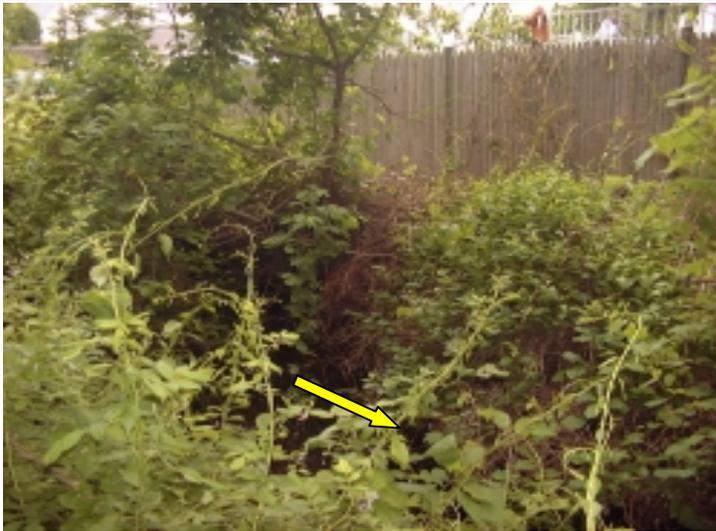
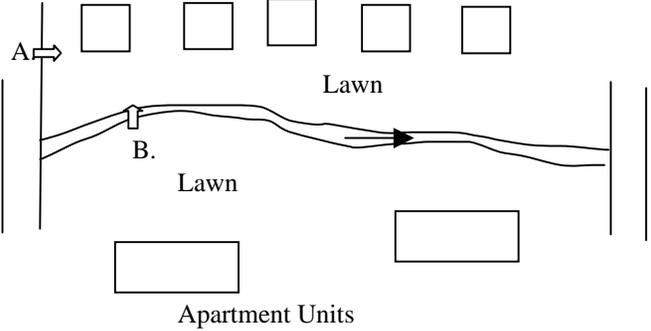
Quad	Site #	Watershed	Wetland Type	Restoration Code	Target Species	Access/Road	Ownership	Waypoint
Q-2	51	Mill River	Shrub Marsh	BE	Riverine	Poplar St.	Unknown/Private	122
<b>Notes</b>				<b>Photo</b>				
Dense residential development along river				<b>A.</b>

Lawn and fences reduce wildlife values								
Lawn debris seems to be thrown over fences in some areas								
Buffer could be enhanced along stream								
<b>Sketch</b>				<b>B.</b>
