# City of Gloucester Comprehensive River and Stream Habitat Restoration Report

2003

Tim Purinton

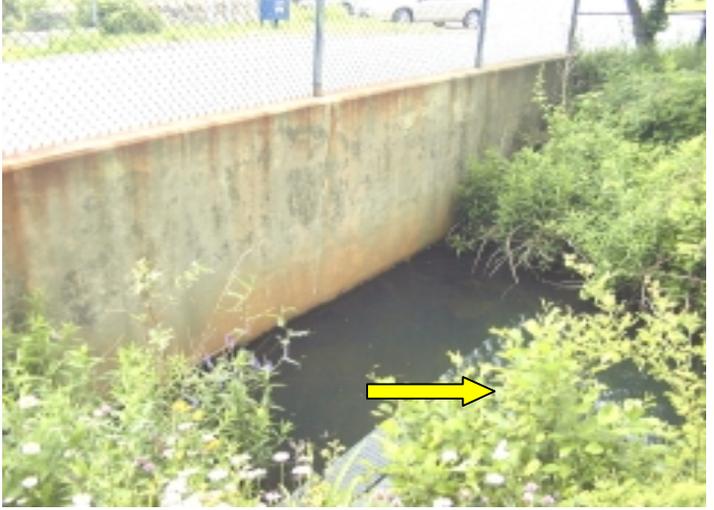
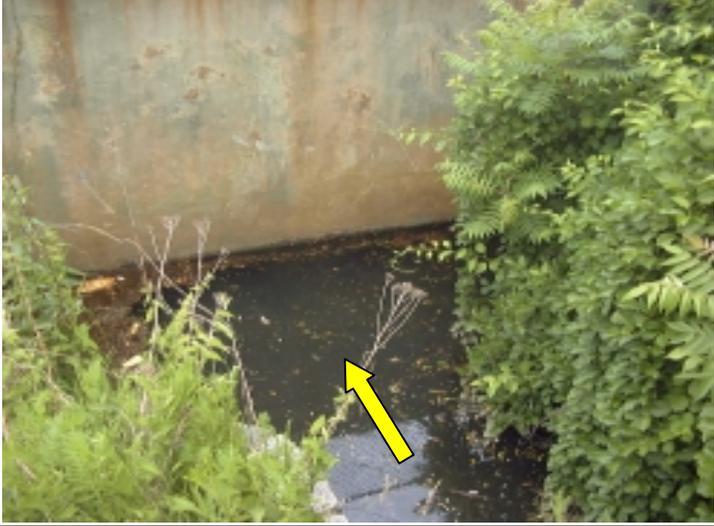
Quad	Site #	Watershed	Wetland Type	Restoration Code	Target Species	Access/Road	Ownership	Waypoint
Q-2	52	Mill River	Shallow Marsh Meadow/ Shrub Marsh	CU, BMP	Riverine	Poplar St.	Municipal	123
<b>Notes</b>				<b>Photo</b>				
Culvert opening not found				<p>A.</p>

Lack of flow at either side								
Culvert may be clogged or lack of flow may be because of downstream obstruction								
Site should be considered in light of potential fish passage								
Stream channelized above								
<b>Sketch</b>

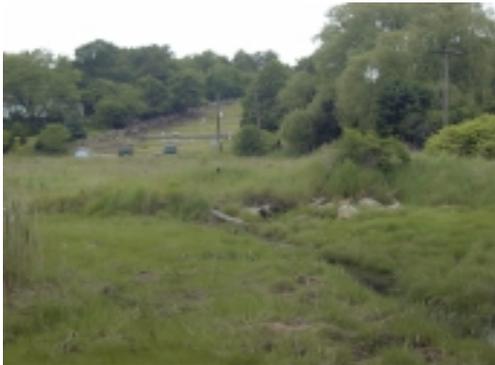
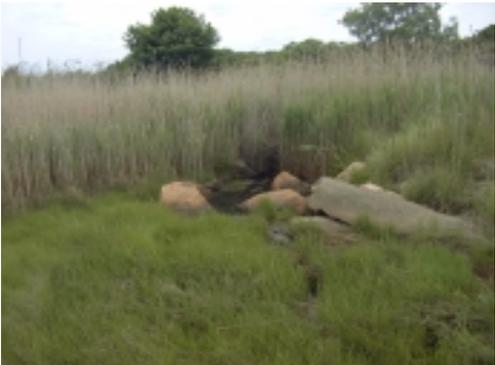
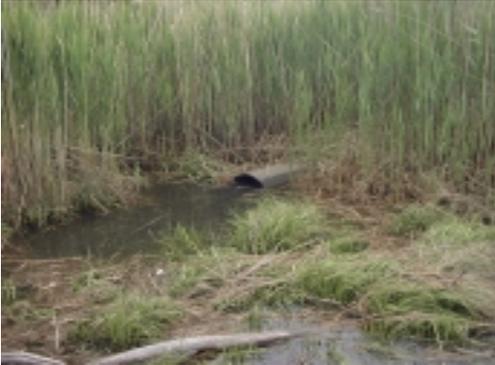
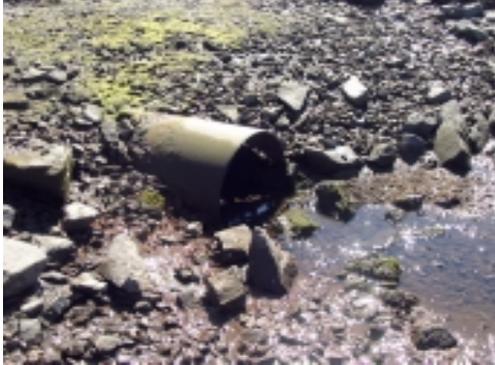
Quad	Site #	Watershed	Wetland Type	Restoration Code	Target Species	Access/Road	Ownership	Waypoint
Q-2	53	Annisquam River	Salt Marsh	CU, IM	Estuarine	Marsh Rd.	Private	124
<b>Notes</b>				<b>Photo</b>				
Salt marsh cut-off by Rte. 128				A.				
Approx. 10" steel culvert				B.				
Potential 1-5 acre restoration

Well developed high marsh on upstream side								
Removal of fill, without culvert upgrade could increase salt marsh								
Tidal flushing would reduce/stunt Phragmites								
Much of the Phragmites growth is result of stormwater from Rte. 128 - along bank								
<b>Sketch</b>				C.

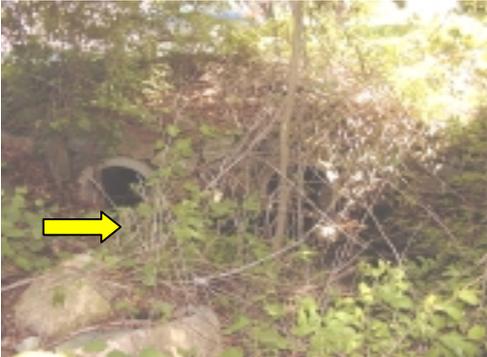
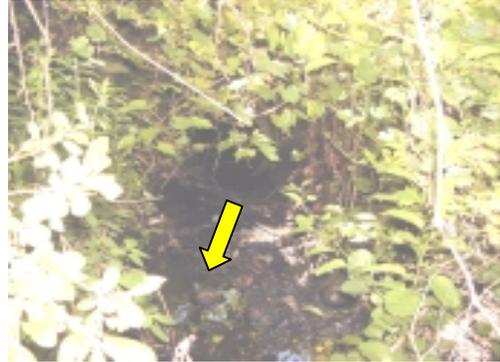
Quad	Site #	Watershed	Wetland Type	Restoration Code	Target Species	Access/Road	Ownership	Waypoint
Q-2	54	Annisquam River	Shrub Marsh	CU, DL	Riverine	Ferry St.	Public/Private	127
<b>Notes</b>				<b>Photo</b>				
Double culvert, 2' concrete				<b>A.</b>				
Steel excluder bars on upstream				<b>B.</b>				
Approx. 40' of daylight potential

Low flow stream

Headwater source seems to be the nursing home parking lot and associated stormdrains

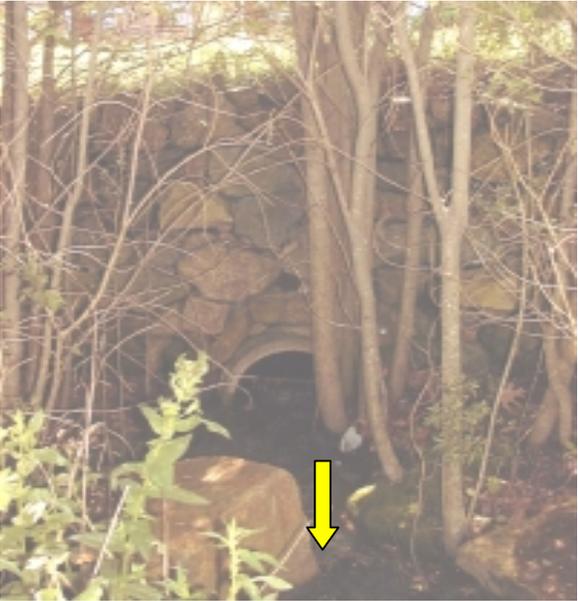
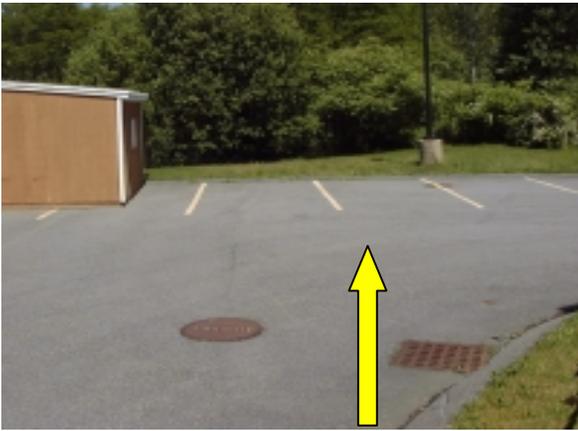
Quad	Site #	Watershed	Wetland Type	Restoration Code	Target Species	Access/Road	Ownership	Waypoint
Q-2	55	Annisquam River	Shrub Marsh	FR	Riverine	Ferry St.	Private	128
<b>Notes</b>				<b>Photo</b>				
Headwaters of stream altered and filled for development				<p>A.</p>

Good site for stormwater BMP as source water comes from parking lot								
Main source water is probably stormwater as no flow from culvert was noted								
<b>Sketch</b>

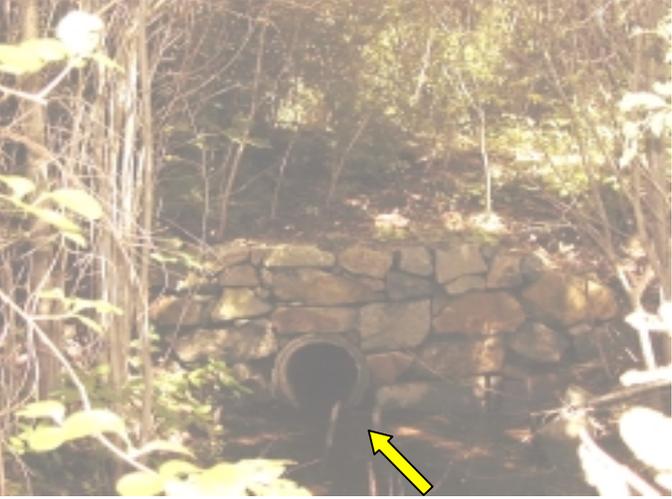
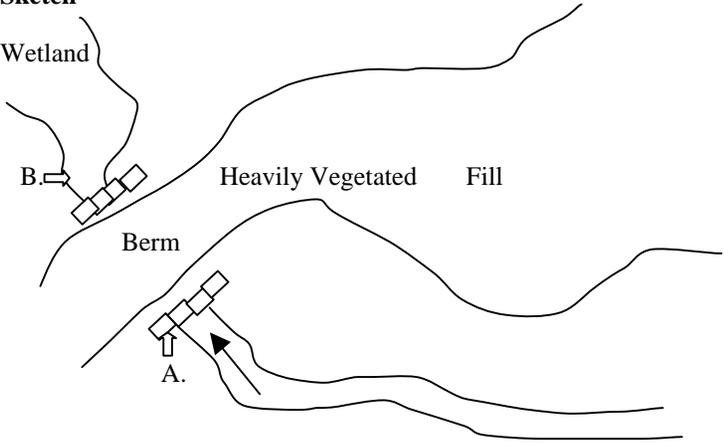
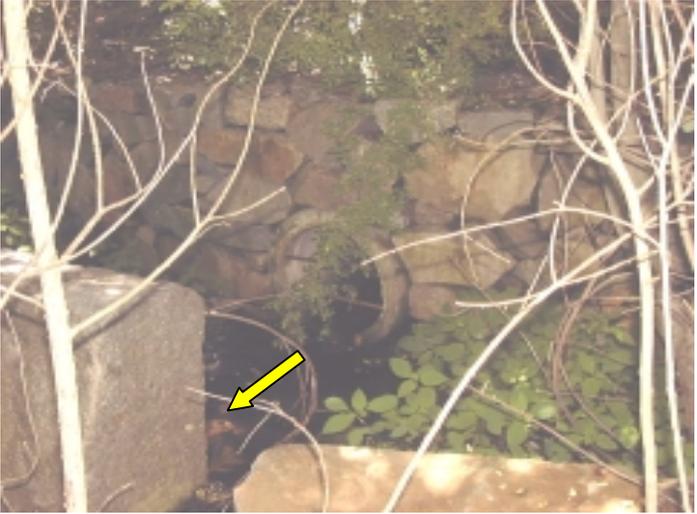
Quad	Site #	Watershed	Wetland Type	Restoration Code	Target Species	Access/Road	Ownership	Waypoint
Q-2	56	Annisquam River	Shrub Marsh	FR	Riverine	Ferry St.	Unknown	129
<b>Notes</b>				<b>Photo</b>				
Area is part of stormwater detention system				<b>A.</b>

2' concrete culvert								
Small amount of flow								
30' to 40' berm								
Stream converted to wetlands for stormwater retention/detention								
<b>Sketch</b>				<b>B.</b>

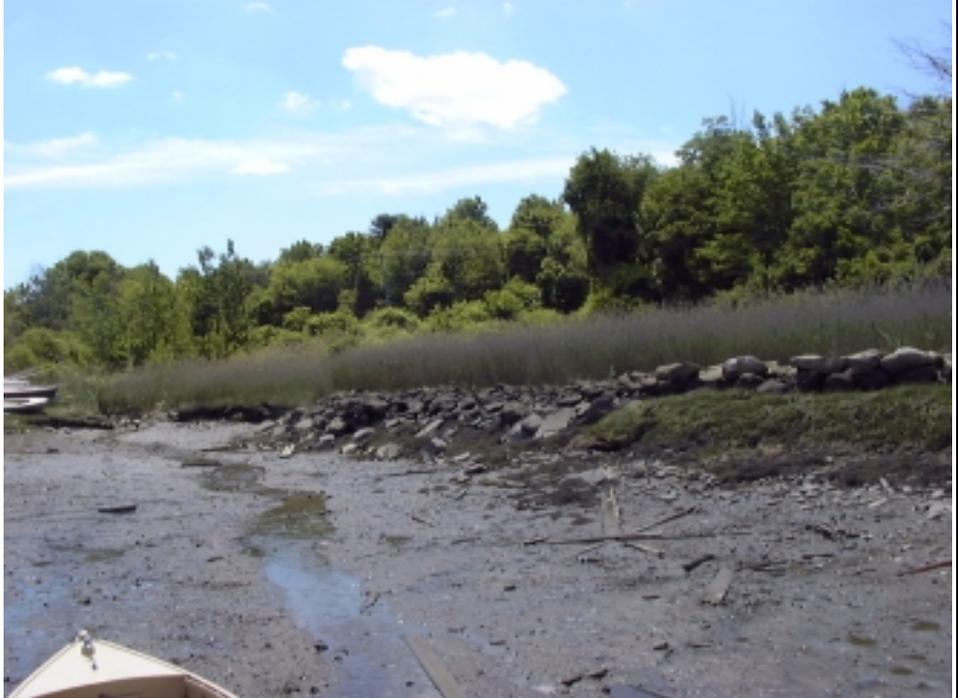
Quad	Site #	Watershed	Wetland Type	Restoration Code	Target Species	Access/Road	Ownership	Waypoint
Q-2	57	Annisquam River	Salt Marsh	IM, FR	Estuarine	Ferry St.	Private	130
<b>Notes</b>				<b>Photo</b>				
Fill along marsh and in the intertidal				A.				
<i>Phragmites australis</i> restricted to inside stonewall area

Fill removal may aid marsh sheet flow reducing <i>Phragmites</i>								
Stream has potential for smelt (if not already)								
According to boatyard owner <i>Phragmites</i> is advancing								
<b>Sketch</b>

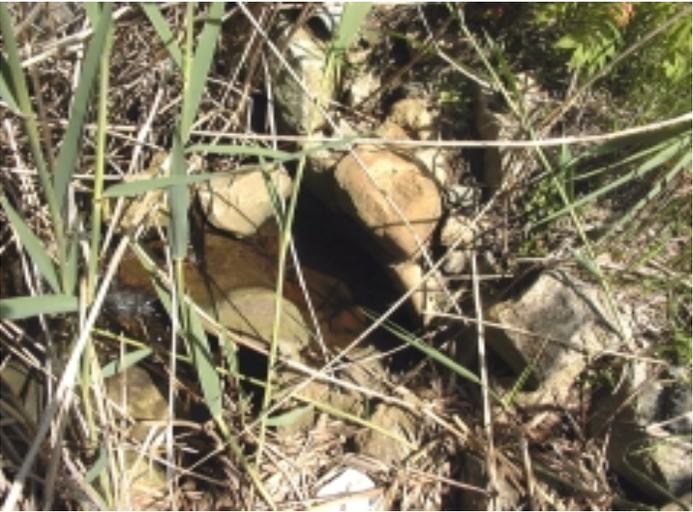
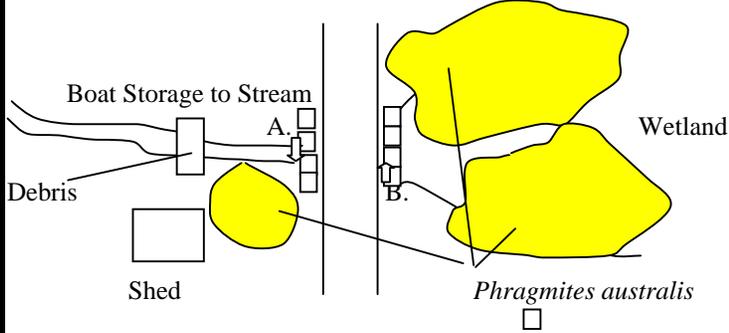
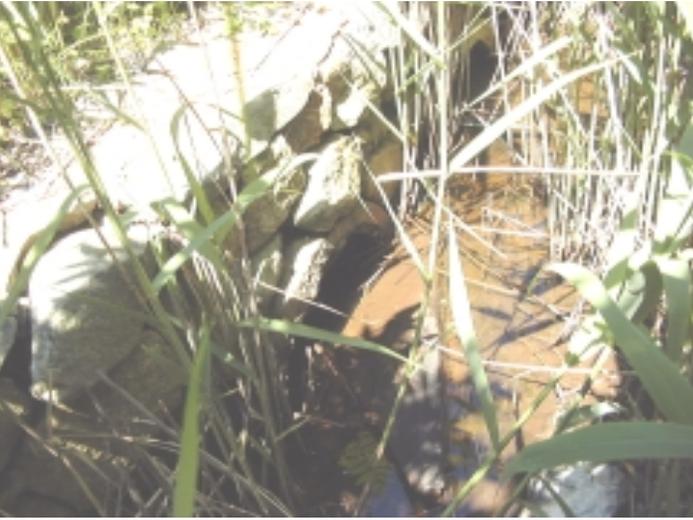
Quad	Site #	Watershed	Wetland Type	Restoration Code	Target Species	Access/Road	Ownership	Waypoint
Q-2	58	Annisquam River	Brackish Marsh	CU,TR	Anadromous/Estuarine	Ferry St.	Private	131
<b>Notes</b>				<b>Photo</b>				
Double 2' concrete culvert				<b>A.</b>

Headwall falling apart								
Japanese knotweed and Phragmites present								
One culvert blocked								
Stream has lots of trash, limited stream buffer								
Upstream residential activity near stream edge								
<b>Sketch</b>				<b>B.</b>

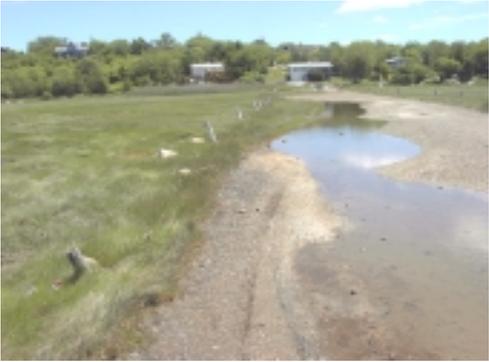
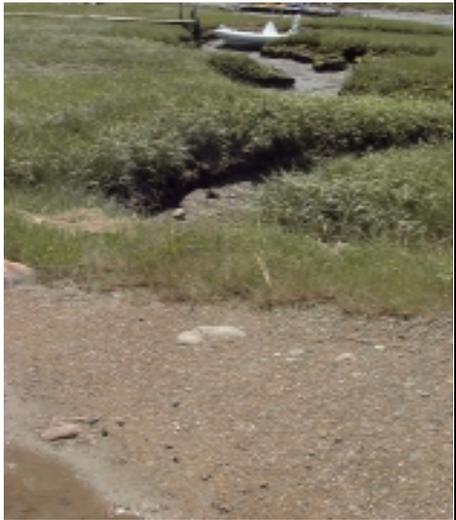
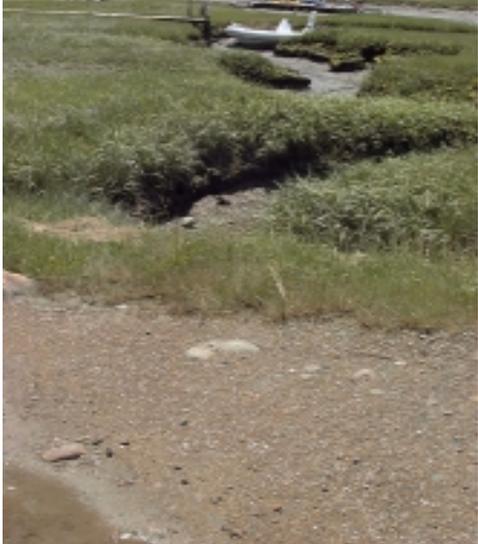
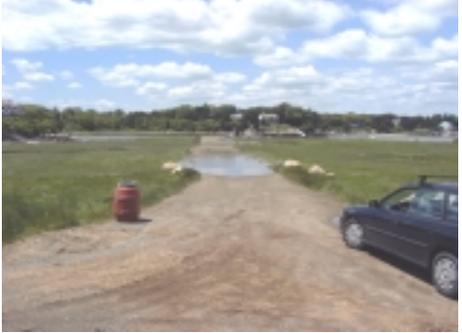
Quad	Site #	Watershed	Wetland Type	Restoration Code	Target Species	Access/Road	Ownership	Waypoint
Q-2	59	Annisquam River	Salt Marsh	FR	Estuarine	Perrywinkle Way	Private	132
<b>Notes</b>				<b>Photo</b>				
Old dirt/gravel causeway across marsh				A.				
Need for road not clear, replace with boardwalk				B.				
No culverts across road

Creeks on either side terminate at road - indicate need for culvert

Phragmites present on transition zone on upstream side of road

Road is approx. 30' in width								
<b>Sketch</b>

Easy restoration, grade elimination

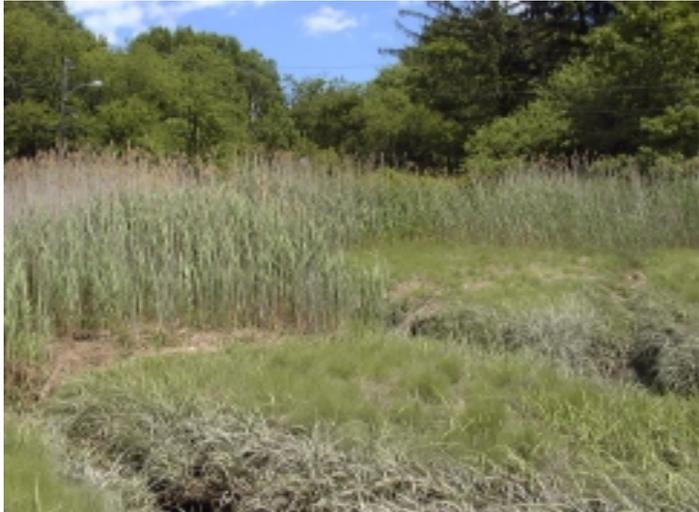
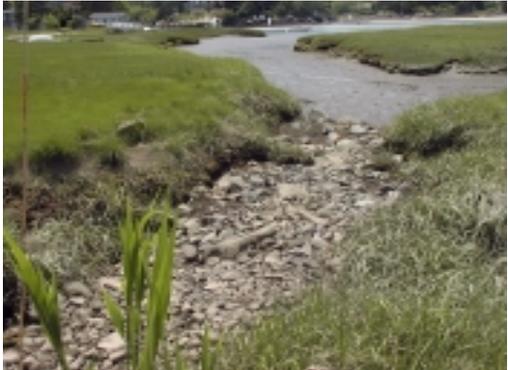
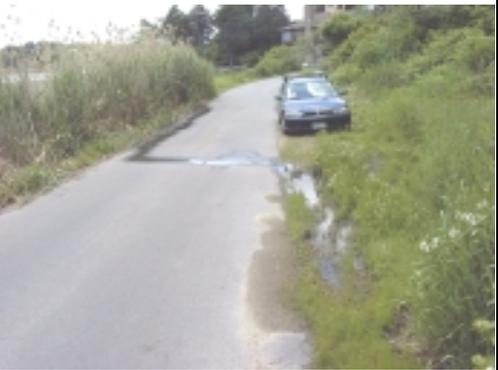
Quad	Site #	Watershed	Wetland Type	Restoration Code	Target Species	Access/Road	Ownership	Waypoint
Q-2	60	Annisquam River	Brackish Marsh	IM, FR, CU	Estuarine	Riverview Rd.	Public/Private	133
<b>Notes</b>				<b>Photo</b>				
Phragmites along transition zone				<p><b>A.</b></p>

No clear channel - stream ends at road								
Water runs across street								
Series of braided channels to road edge								
Creek section has been filled in with stone for about 40'								
Site may be better served as a mitigation project								
<b>Sketch</b>

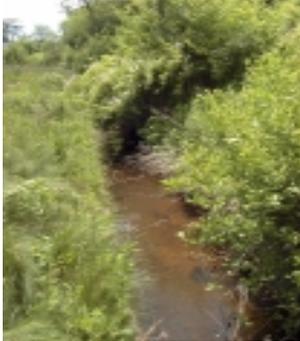
Quad	Site #	Watershed	Wetland Type	Restoration Code	Target Species	Access/Road	Ownership	Waypoint
Q-2	61	Mill River	Shallow Marsh Meadow	BI, FL	Anadromous/Catadromous	Poplar St.	Municipal	134
<b>Notes</b>				<b>Photo</b>				
Major water supply dam				A.

Very difficult engineering for fish ladder				B.

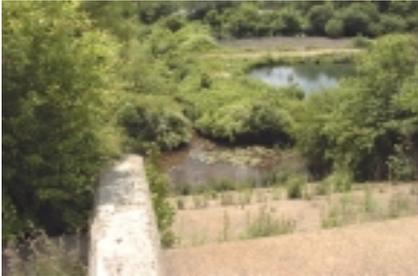
4' Arch culvert under berm				F.

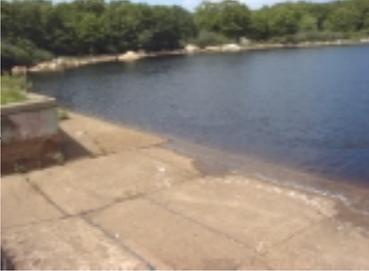
2' and 1' culverts discharging into stream downstream of berm				G.

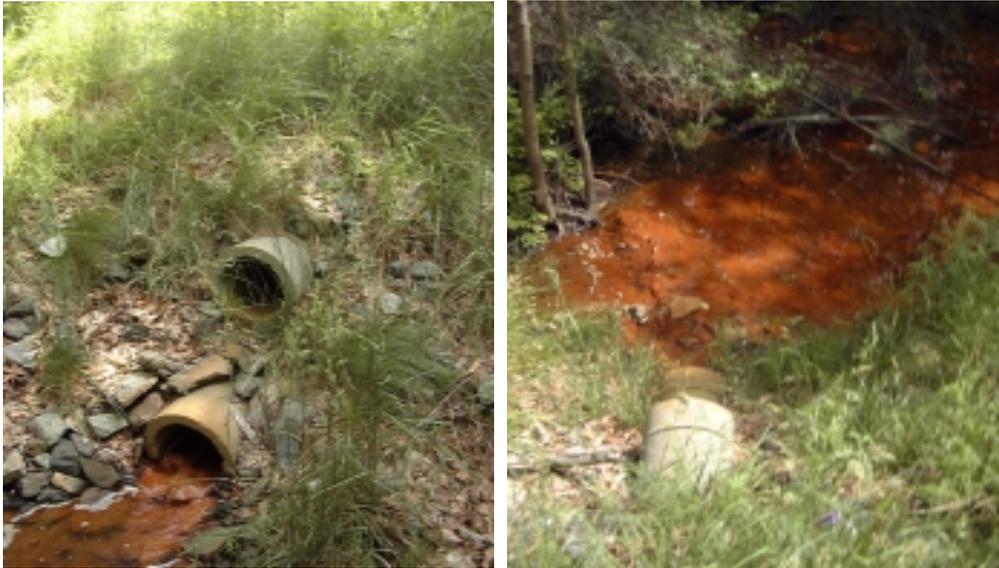
Quad	Site #	Watershed	Wetland Type	Restoration Code	Target Species	Access/Road	Ownership	Waypoint
Q-2	62	Babson Reservoir Trib.	Wooded Swamp Deciduous	BMP, FR	Riverine	Old Rockport Rd.	Unknown	135
<b>Notes</b>				<b>Photo</b>				
Stormwater detention system replaces stream				A.				
Culverts set on top of each other				B.				
Water quality is a concern since site drains to reservoir

Iron staining in water								
Detention area near natural transition between stream and wetland								
<b>Sketch</b>

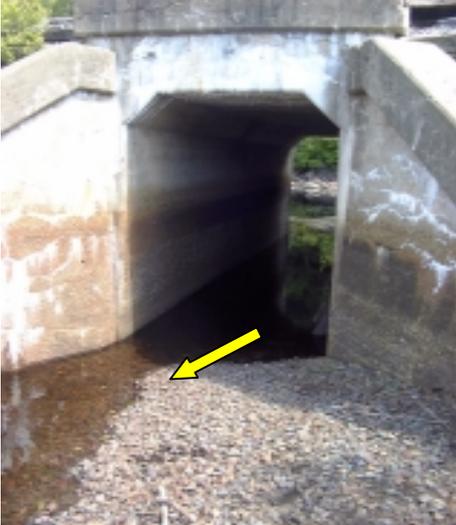
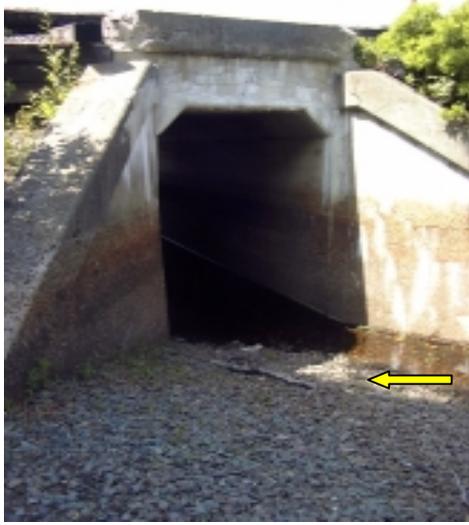
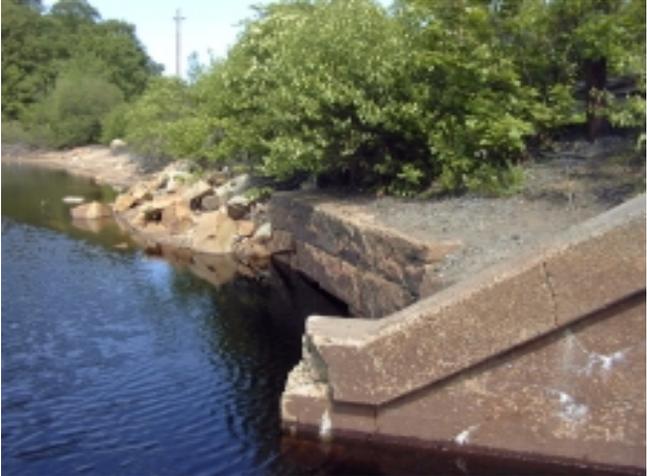
Quad	Site #	Watershed	Wetland Type	Restoration Code	Target Species	Access/Road	Ownership	Waypoint
Q-2	63	Alewife Brook	Open Water	FR	Riverine	Old Rockport Rd.	Public	136
<b>Notes</b>				<b>Photo</b>				
Stone from railbed has filled the outlet and inlet of the culvert almost restricting flow				<b>A.</b>				
Culvert size is good (5'x9')

Potential mitigation/enforcement issue				<b>B.</b>

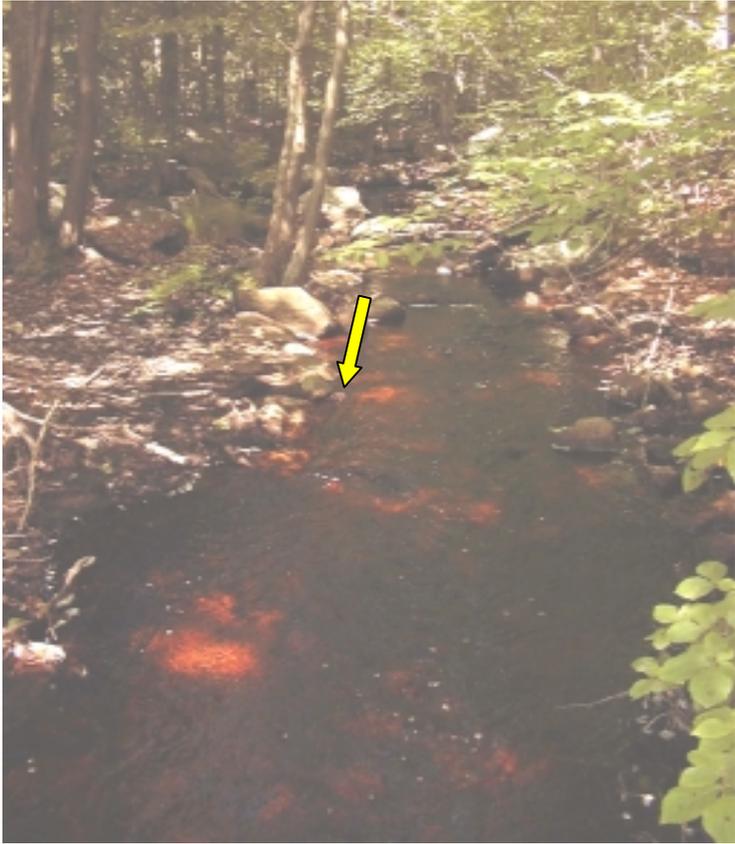
Quad	Site #	Watershed	Wetland Type	Restoration Code	Target Species	Access/Road	Ownership	Waypoint
Q-2	64	Alewife Brook	Wooded Swamp Mixed Trees	S	Riverine	Old Rockport Rd.	Unknown	137
<b>Notes</b>				<b>Photo</b>				
Stream has excellent canopy and pool and riffle system				A.

Watershed is relatively undisturbed								
Water quality seems good								
Stream may hold some native trout								
Snags in stream increase habitat potential								
Approx. 1/2 mile of healthy stream								
Stream 4'-5' wide and has good base flow								
<b>Sketch</b>								
<p>Relatively Undisturbed Watershed</p>

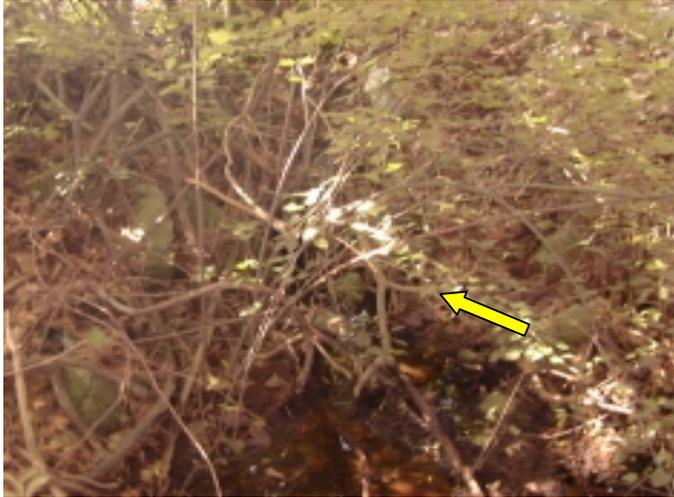
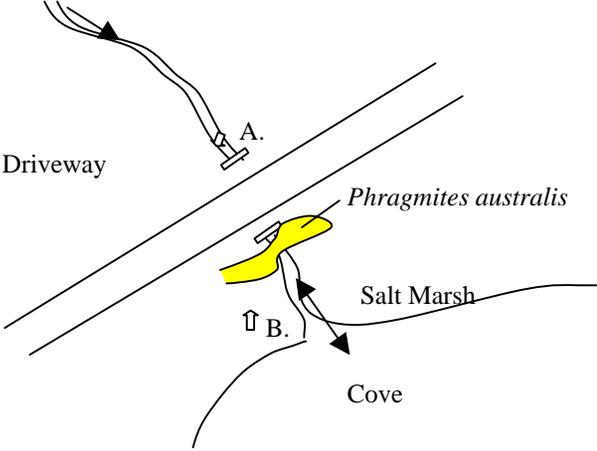
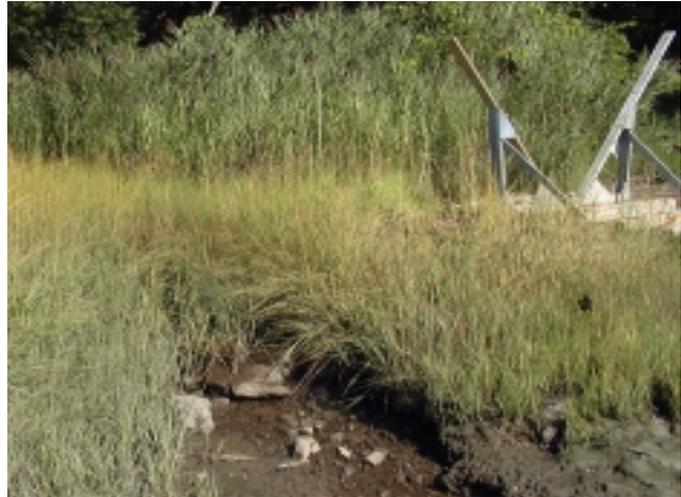
Quad	Site #	Watershed	Wetland Type	Restoration Code	Target Species	Access/Road	Ownership	Waypoint
Q-2	65	Sheep Pond	Brackish Marsh	CU, FL	Anadromous/Catadromous	Dennison St.	Municipal	225
<b>Notes</b>				<b>Photo</b>				
12" metal culvert blocked at outlet				<b>A.</b>				
Potential for fish passage to Sheep Pond, alewife and eel

Short run from Goose Cove to Sheep Pond								
Flow in stream regulated by dam configuration								
Pocket of Phragmites at outlet along bank								
If pond upstream has alewife potential project should have elevated priority status								
<b>Sketch</b>				<b>B.</b>

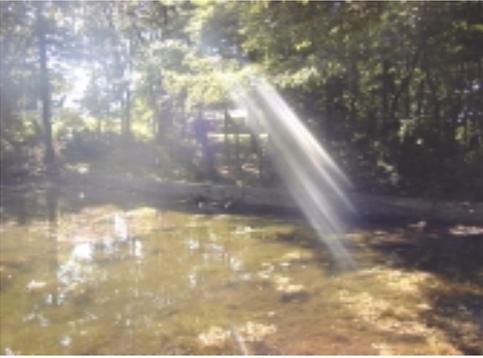
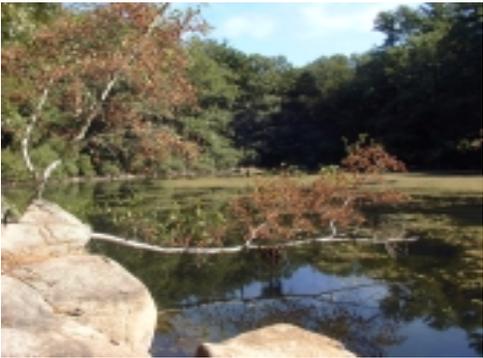
Quad	Site #	Watershed	Wetland Type	Restoration Code	Target Species	Access/Road	Ownership	Waypoint					
Q-2	66	Sheep Pond	Open Water	FL, DR	Anadromous/Catadromous	Dennison St.	Unknown	226					
<b>Notes</b>				<b>Photo</b>									
Dam in poor shape				<b>A.</b>									
Not a clear point of discharge from dam/spillway				<b>B.</b>									
Approx. 3' thick concrete retaining wall acting as dam

Pond size is small but may have some habitat value for alewife

Wetlands below dam feed by weep at dam base				<b>C.</b>									
Pond may be too shallow to support alewife

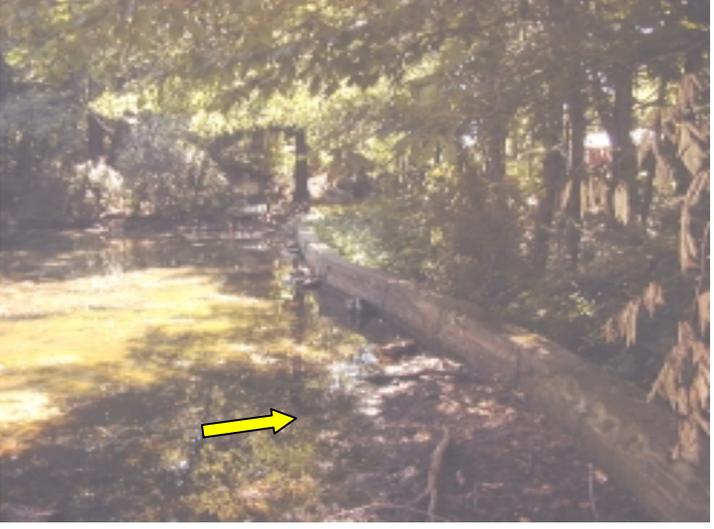
If pond has alewife potential project should have elevated priority status													
<b>Sketch</b>

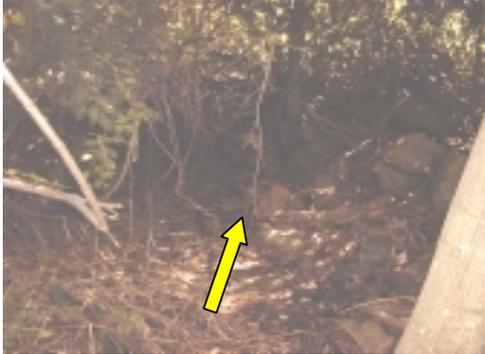
Quad	Site #	Watershed	Wetland Type	Restoration Code	Target Species	Access/Road	Ownership	Waypoint
Q-2	67	Goose Cove	Shrub Swamp/Brackish Marsh	CU, FR	Estuarine	Washington St.	Unknown	227
<b>Notes</b>				<b>Photo</b>				
Area may have been extension of Goose Cove salt marsh				A.				
Culvert not found upstream/downstream				B.				
Wetlands seem filled in below Rte. 127.

Heavy sediment buildup

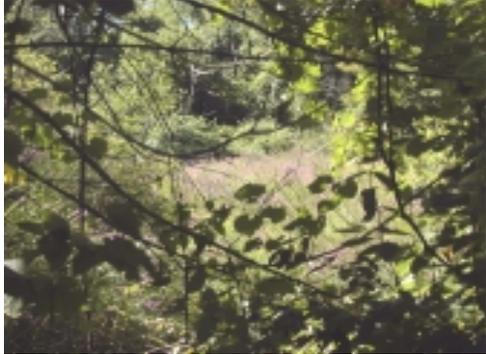
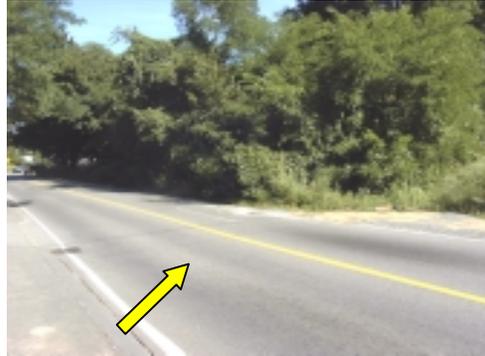
Upstream wetlands impacted by invasive species				C.				
Downstream wetlands, large stand of <i>Phragmites australis</i> present				D.				
Upstream wetlands may be restored by allowing tidal flow from cove to flush the area

Portion of stream bank downstream filled

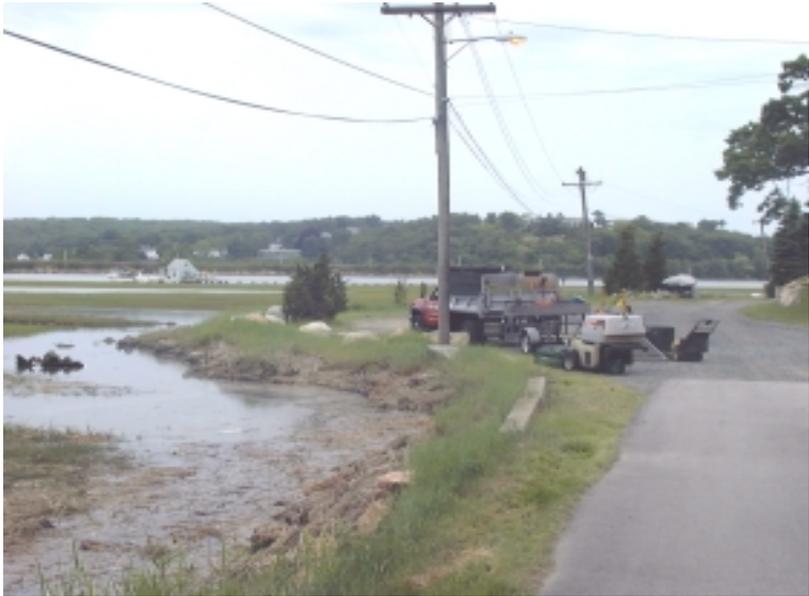
Quad	Site #	Watershed	Wetland Type	Restoration Code	Target Species	Access/Road	Ownership	Waypoint
Q-3	1	Annisquam River	Salt Marsh	FR	Estuarine	Wolf Hill Rd.	Unknown	125
<b>Notes</b>				<b>Photo</b>				
Approx. 2 to 3' elevation difference between upland and wetland				A.				
Turn around could be reduced in favor of salt marsh restoration

Area may be privately held								
<b>Sketch</b>

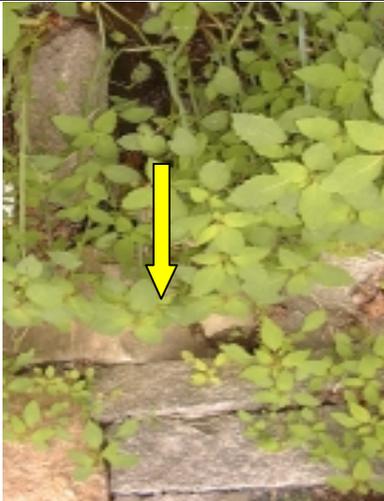
Quad	Site #	Watershed	Wetland Type	Restoration Code	Target Species	Access/Road	Ownership	Waypoint
Q-3	2	Annisquam River	Brackish Marsh	DL	Anadromous/Estuarine	Trevel Cove Rd.	Unknown	126
<b>Notes</b>				<b>Photo</b>				
Small stream flows under house				A.

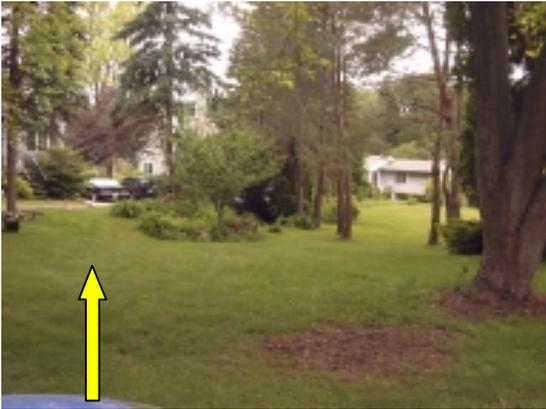
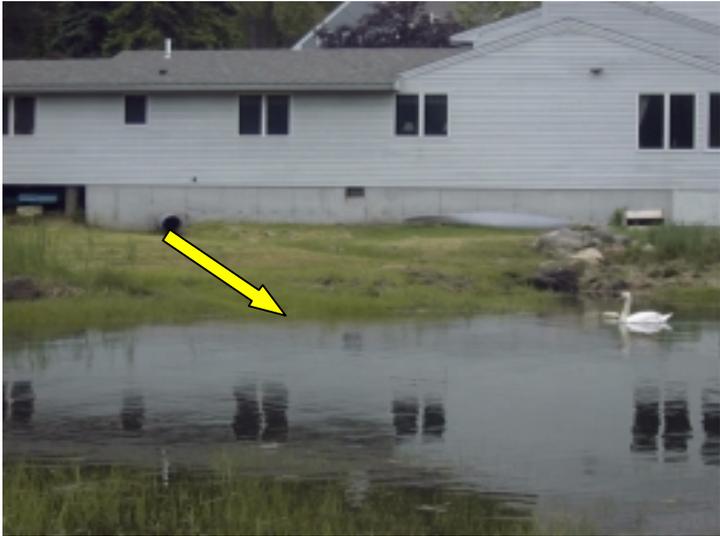
B.

Upstream box culvert collapsed								
Stream culverted before outlet for approx. 100'								
House re-replaces salt/fresh water interface								
<b>Sketch</b>				C.

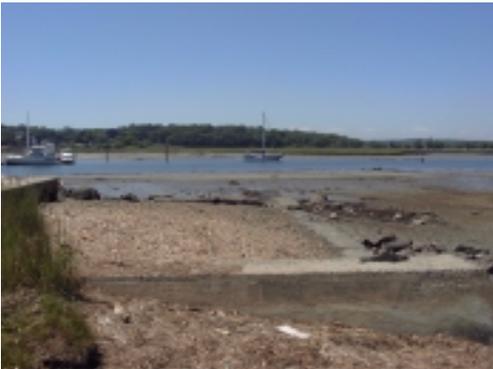
Quad	Site #	Watershed	Wetland Type	Restoration Code	Target Species	Access/Road	Ownership	Waypoint
Q-3	3	Blynman Canal	Salt Marsh	FR	Estuarine	High School	Unknown	138
<b>Notes</b>				<b>Photo</b>				
Approx. 50' x 25' fill area				<b>A.</b>				
Appears to be an old concrete foundation (swimming pool)

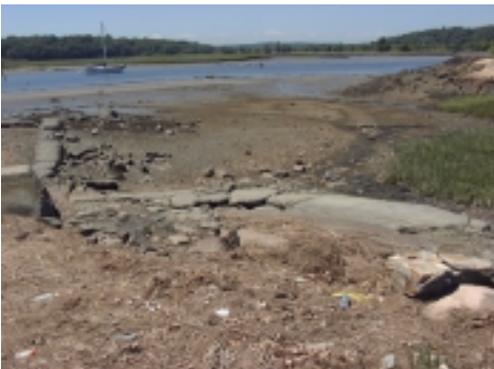
High marsh restoration site				<b>B.</b>				
Mudflat could be improved to encourage shellfish, area disturbed

Bituminous, concrete and stone fill

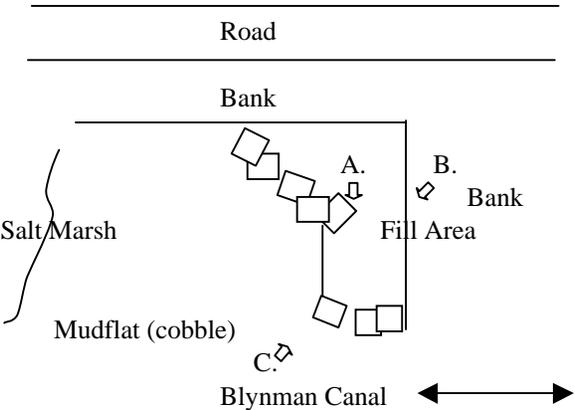
Need to alter elevation and re-vegetate								
Site could be done in terms of high school area enhancements								
<b>Sketch</b>				<b>C.</b>

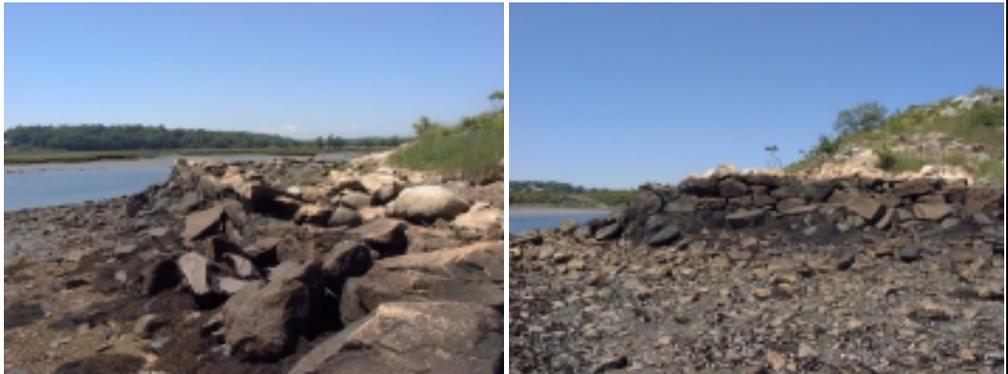
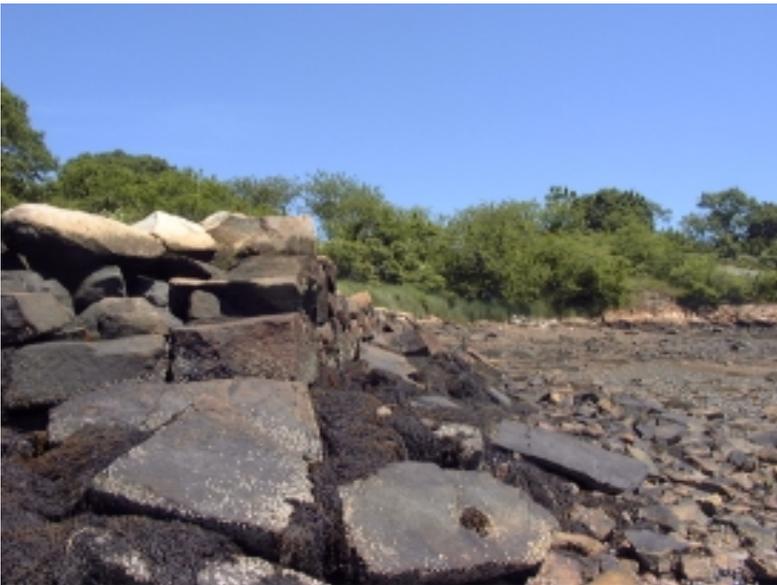
Quad	Site #	Watershed	Wetland Type	Restoration Code	Target Species	Access/Road	Ownership	Waypoint
Q-3	4	Blynman Canal	Salt Marsh/Tidal Flat	FR	Estuarine	High School	Unknown	139
<b>Notes</b>				<b>Photo</b>				
Historic fill area, probably a pier				<b>A.</b>				
Structure composed of granite blocks				<b>B.</b>				
Potential for salt marsh and tide pool restoration

3' to 4' elevation change from natural contours								
Site is a barrier to public access

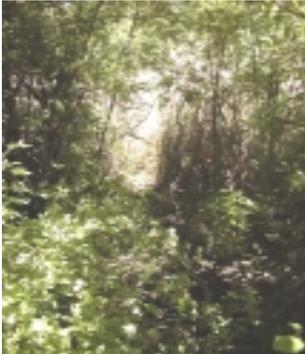
Quad	Site #	Watershed	Wetland Type	Restoration Code	Target Species	Access/Road	Ownership	Waypoint
Q-3	6	Emerald Forest	Wooded Swamp Deciduous/Shrub Swamp	IM, FR, TR, BE	Riverine	Railroad Ave.	Public/Private	141
<b>Notes</b>				<b>Photo</b>				
Drainage problems exist, good opportunity to dovetail restoration with infrastructure change				A.				
Flow towards Railroad Ave.				B.				
Many trails exist inside "forest"				C.				
Area predominantly wetland, with possible vernal pool habitat

No clear stream channel, series of pools

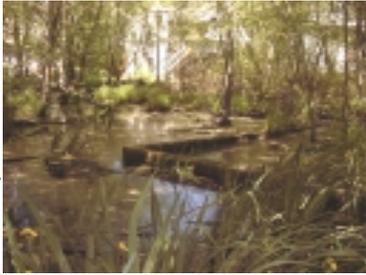
Area heavily impacted by invasive								
Fill removal opportunities exist for more water storage								
Old berm runs through center of thicket								
Old foundation noted (see photo D.)								
<b>Sketch</b>				D.

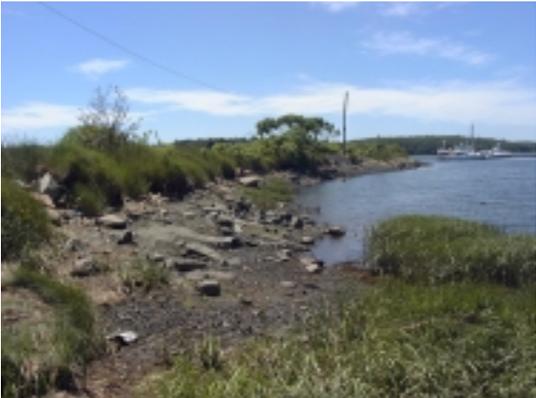
Quad	Site #	Watershed	Wetland Type	Restoration Code	Target Species	Access/Road	Ownership	Waypoint
Q-3	7	Annisquam River	Salt Marsh	FR, IM, BMP	Estuarine	Whittemore St.	Unknown	142
<b>Notes</b>				<b>Photo</b>				
Area could be improved for smelt (limited potential)				A.				
Opportunity for fill removal along slope to encourage salt marsh				B.				
Land privately held

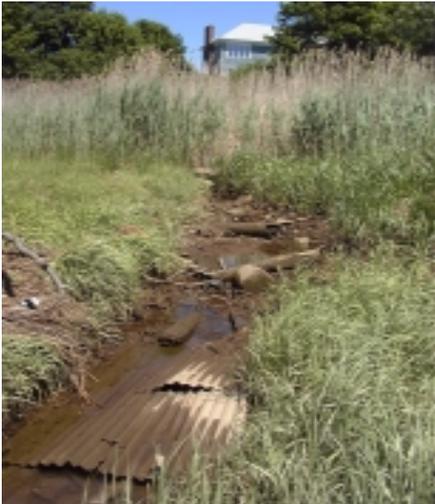
BMP possible at stream discharge								
8" steel culvert provides site with stormwater discharge

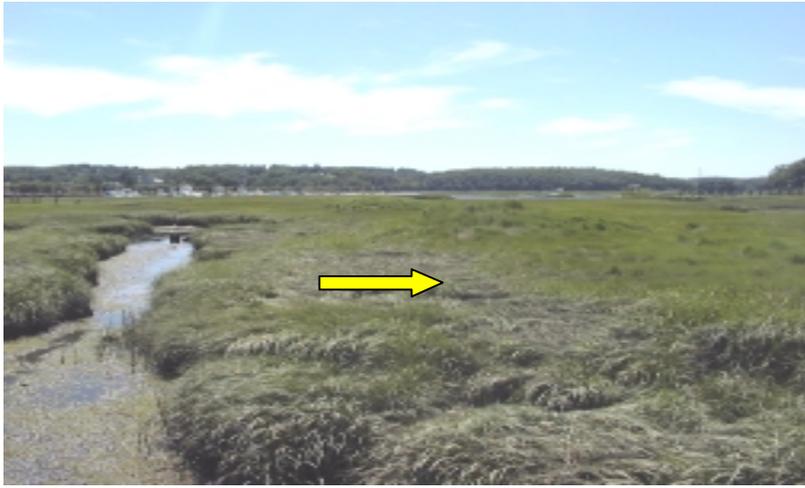
Quad	Site #	Watershed	Wetland Type	Restoration Code	Target Species	Access/Road	Ownership	Waypoint
Q-3	8	Annisquam River	Salt Marsh	IM, BE	Estuarine	Rte. 128	Unknown	143
<b>Notes</b>				<b>Photo</b>				
Gutter ditch could be excavated to retreat advance of <i>Phragmites australis</i>				<p><b>A.</b></p>

Spoils left on the marsh from prior activity (vegetated with salt marsh grasses)								
Arrow in picture A shows spoil pile								
Deep panne has habitat value								
Phragmites stand approximately 300' x 300'								
Connection of two ditches would increase tidal flow to wetland and may reduce Phragmites								
<b>Sketch</b>

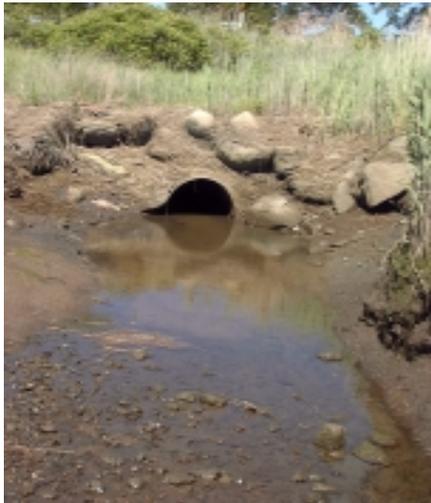
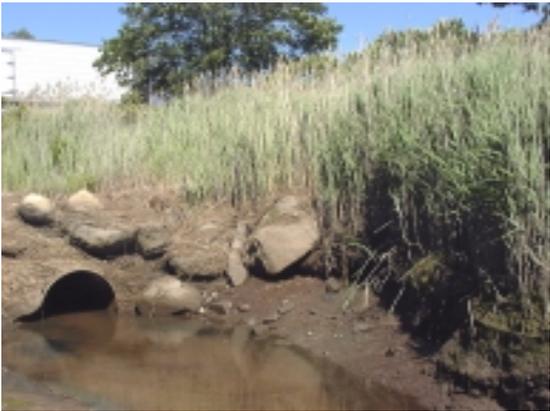
Quad	Site #	Watershed	Wetland Type	Restoration Code	Target Species	Access/Road	Ownership	Waypoint
Q-3	9	Annisquam River	Salt Marsh	BMP, DL	Anadromous/Estuarine	Rte. 128	State/Public	144
<b>Notes</b>				<b>Photo</b>				
3' Steel culvert at outlet, discharge below Friendly's Parking Lot				<b>A.</b>		<b>B.</b>		
Area below culvert is potential smelt spawning habitat (may exist)

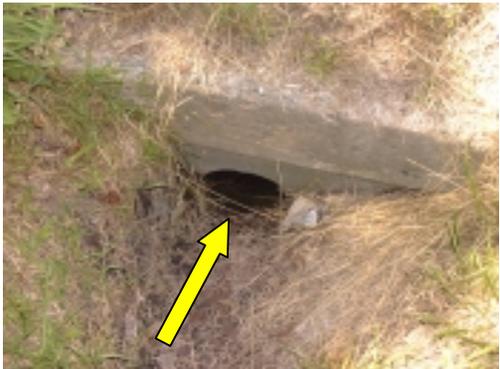
Heavy tide wrack build up along bank								
Area has high potential for stormwater BMP								
Rotary probably on filled tideland								
Creek at culvert outlet approx. 15' wide								
Area still a public landing								
Formally CSO discharge site								
<b>Sketch</b>				<b>C.</b>

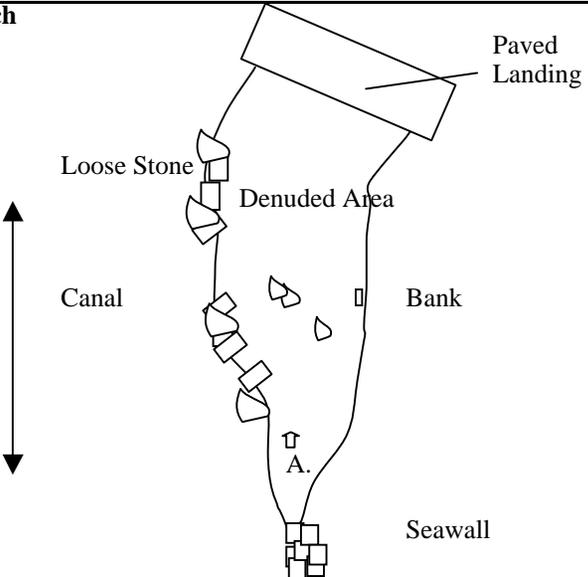
Quad	Site #	Watershed	Wetland Type	Restoration Code	Target Species	Access/Road	Ownership	Waypoint
Q-3	10	Blyman Canal	Salt Marsh	IM	Estuarine	High School	Municipal	145
<b>Notes</b>				<b>Photo</b>				
Adjacent to town landing				A.				
Area degraded - does not support vegetation

Area not a productive viable mudflat								
Degraded zone could have soil amendments and elevation change to support vegetation								
Area subject to wave action due to high boat traffic								
Approx. 200' in length and 75' wide								
<b>Sketch</b>

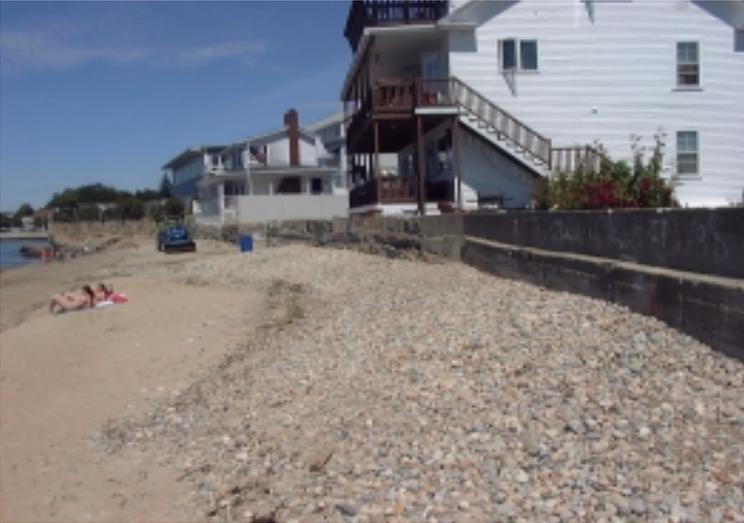
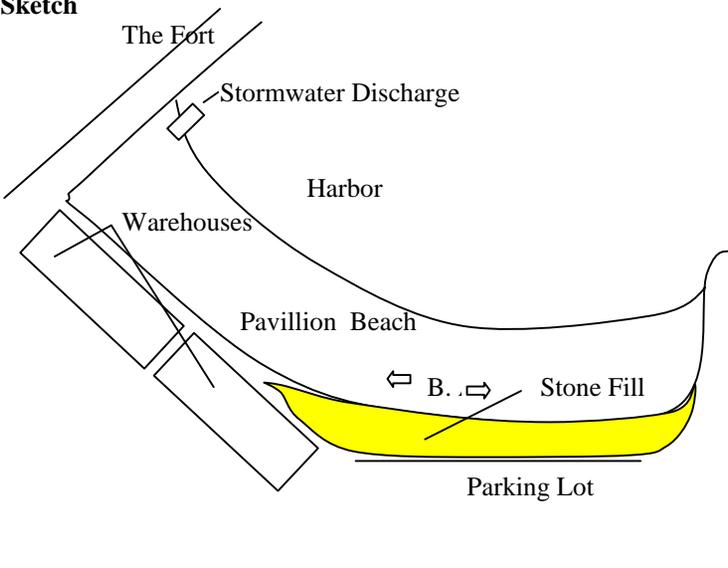
Coastal bank highly degraded, no vegetative buffer								
Planting plan could be developed								
Area has intensive use may be difficult to improve conditions								
No buffer between warehouses and beach								
<b>Sketch</b>				<b>B.</b>

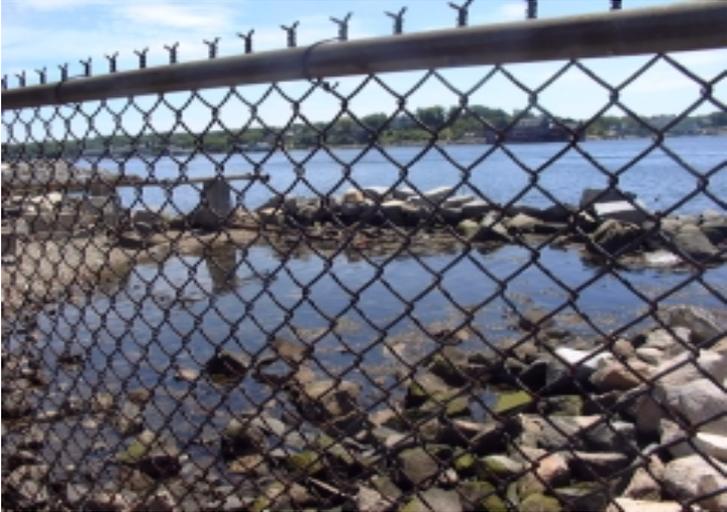
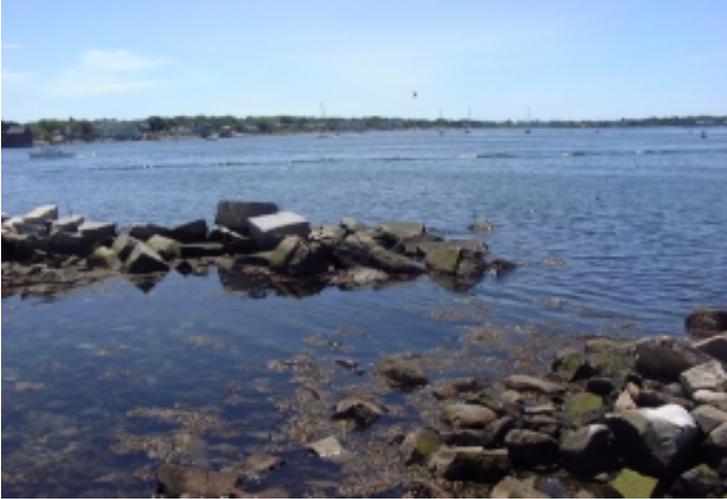
Disturbed rocky shore line								
Opportunity for a tide pool restoration/creation								
Manipulation of grades and configuration of rocks could improve habitat for juvenile fish								
Private ownership may reduce opportunity for restoration								
<b>Sketch</b>				<b>B.</b>

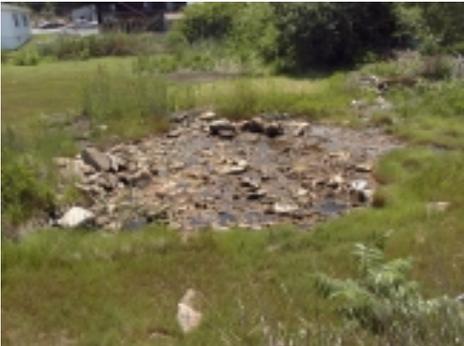
Quad	Site #	Watershed	Wetland Type	Restoration Code	Target Species	Access/Road	Ownership	Waypoint
Q-3	14	Saratoga Creek	Salt Marsh	CU, BE, FR, IM	Estuarine	Atlantic Ave.	Private	149
<b>Notes</b>								
Salt marsh blocked from regular tidal flow				A.				
Poorly functioning culvert or culverts

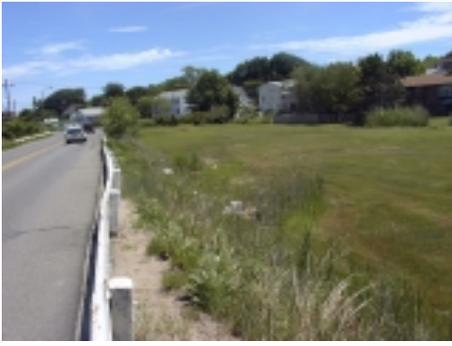
High marsh vegetation found in impacted area				B.				
Two culverts found on downstream side

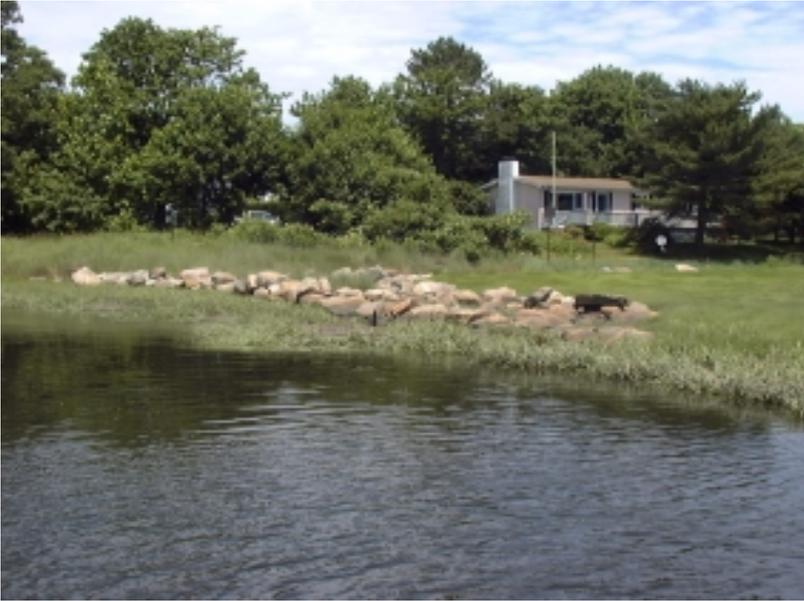
Quad	Site #	Watershed	Wetland Type	Restoration Code	Target Species	Access/Road	Ownership	Waypoint
Q-3	15	Saratoga Creek	Salt Marsh	FR	Estuarine	Rio Dr.	Unknown	150
<b>Notes</b>				<b>Photo</b>				
Old stone based pier				<p>A.</p>

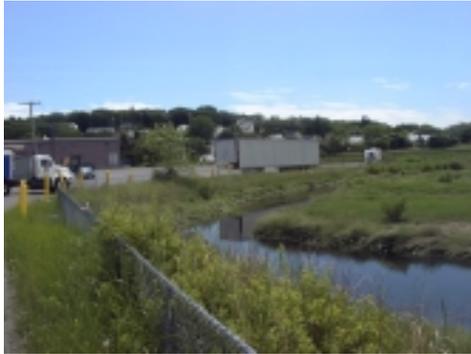
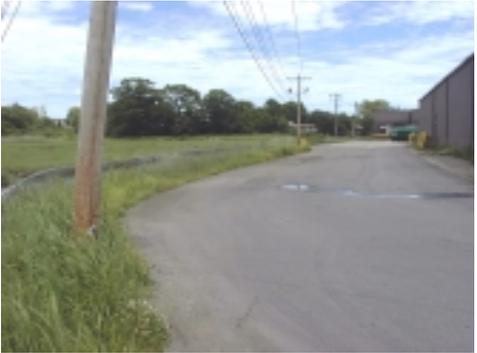
Quad	Site #	Watershed	Wetland Type	Restoration Code	Target Species	Access/Road	Ownership	Waypoint												
Q-3	16	Saratoga Creek	Salt Marsh	FR, BMP	Estuarine	Atlantic Ave.	Private	151												
<b>Notes</b>				<b>A.</b>		<b>B.</b>														
Site already permitted for redevelopment

Parking lot area could be reduced and salt marsh created																				
Need study for parking spaces should be done																				
No stormwater infrastructure																				
Could create public access point for small water craft																				
In depressions in pavement pannes are being formed																				
Site has high potential																				
<b>Sketch</b>				<b>C.</b>		<b>D.</b>
