# City of Gloucester Comprehensive River and Stream Habitat Restoration Report

2003

Tim Purinton

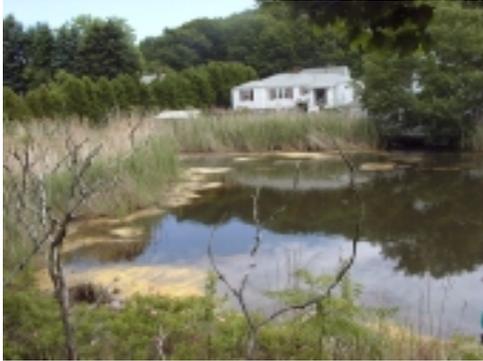
Quad	Site #	Watershed	Wetland Type	Restoration Code	Target Species	Access/Road	Ownership	Waypoint
Q-3	17	Saratoga Creek	Salt Marsh	FR, BMP	Estuarine	Atlantic Ave.	Unknown	152
<b>Notes</b>				<b>Photo</b>				
Salt/brackish pond acts like a stormwater detention area				A.				
Area surrounded by Phragmites				B.				
Minimal hydrologic connection with abutting salt marsh

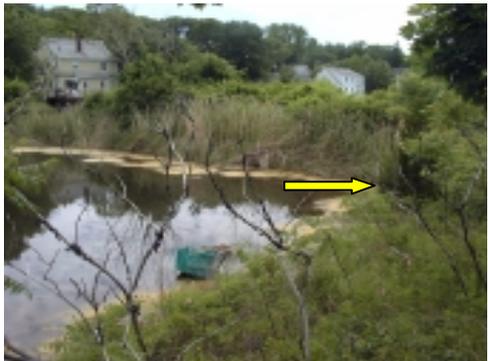
Berm acts to reduce tidal flow

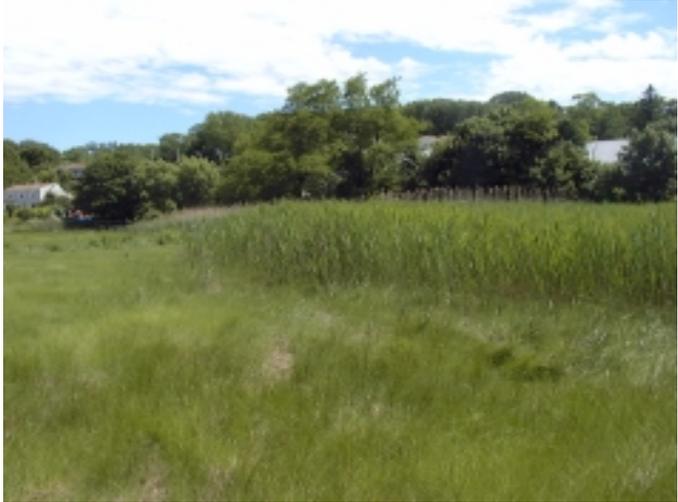
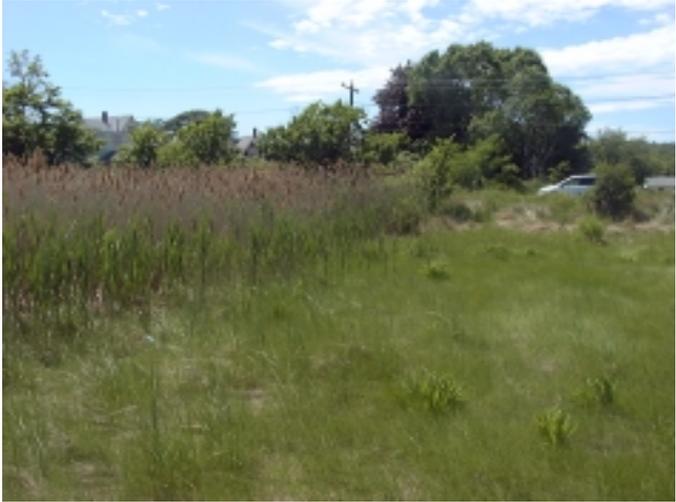
Quad	Site #	Watershed	Wetland Type	Restoration Code	Target Species	Access/Road	Ownership	Waypoint
Q-3	18	Saratoga Creek	Salt Marsh	IM	Estuarine	Hartz St.	Unknown	153
<b>Notes</b>				<b>Photo</b>				
Large area of Phragmites growth

A.				
Ditch configuration could be changed to assist in tidal flow								
Project should be considered in context of watershed restoration								
Culvert under Hartz street does not affect site								
Anecdotal evidence suggests Phragmites is expanding								
Area of potential (or actual) smelt spawning (esp. above Hartz St.)								
<b>Sketch</b>

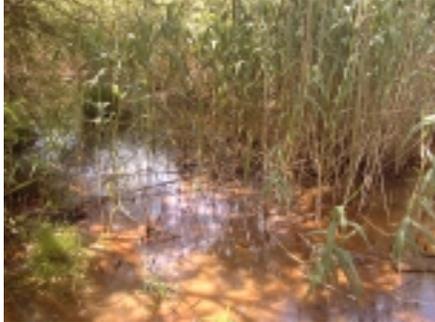
Quad	Site #	Watershed	Wetland Type	Restoration Code	Target Species	Access/Road	Ownership	Waypoint
Q-3	19	Saratoga Creek	Salt Marsh	CR, IM	Estuarine	Rte. 128 Extention	Unknown/Multiple	154
<b>Notes</b>				<b>Photo</b>				
Historic connection from Saratoga Creek to the harbor				<b>A.</b>

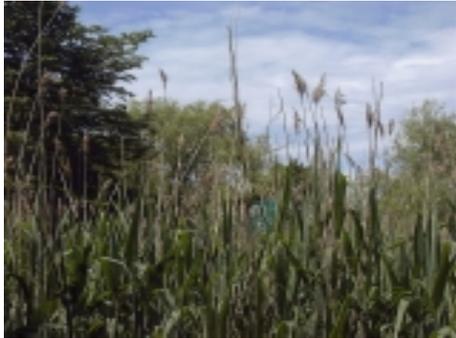
Area impacted by lack of tidal flow and invasive species				<b>B.</b>

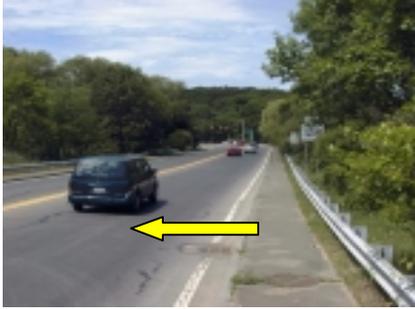
Culvert found under Rte. 128 extension, in poor condition				<b>C.</b>

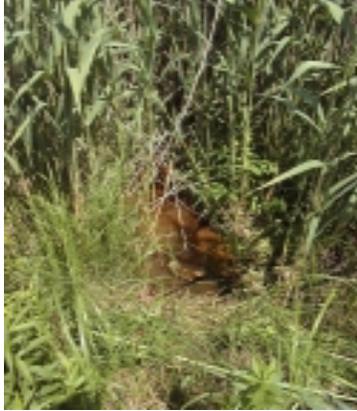
Defined creek system not found in fresh marsh				<b>D.</b>

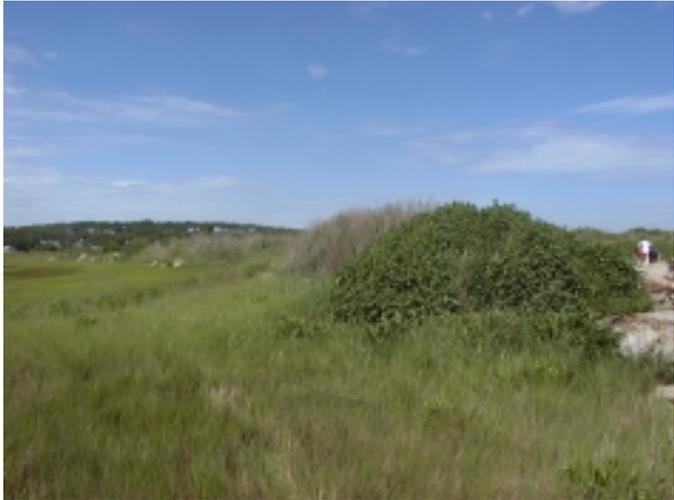
Quad	Site #	Watershed	Wetland Type	Restoration Code	Target Species	Access/Road	Ownership	Waypoint
Q-3	20	Good Harbor Beach	Salt Marsh	FR	Estuarine	Thatcher Rd.	Municipal	155
<b>Notes</b>				<b>Photo</b>				
Debris from beach cleaning (wrack, sand, etc.) and possibly from parking lot expansion				<b>A.</b>				
Berm is approx. 5 to 6' in height and approx. 200 yards in length

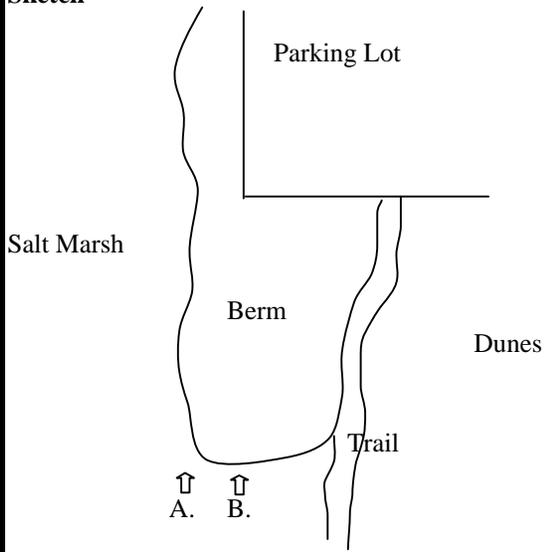
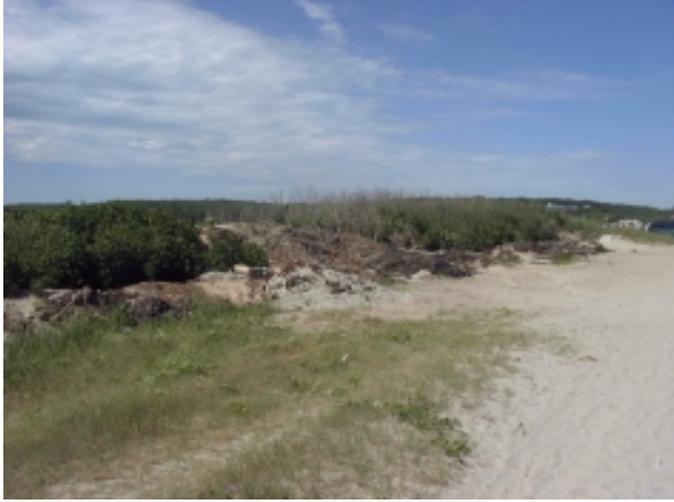
Berm encroaches on high marsh								
Management issue								
<b>Sketch</b>				<b>B.</b>

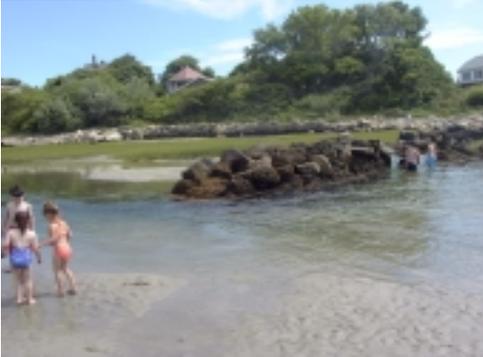
Quad	Site #	Watershed	Wetland Type	Restoration Code	Target Species	Access/Road	Ownership	Waypoint
Q-3	21	Good Harbor Beach	Salt Marsh/Tidal Flat	FR	Estuarine	Nautilus Rd.	Unknown	156
<b>Notes</b>				<b>Photo</b>				
Old stone pier extends into stream channel and restricts tidal flow				<b>A.</b>				
Second pier is parallel stream				<b>B.</b>				
Approx. 4' wide and extends approx. 50' from shore

Stone pier could be partially breeched

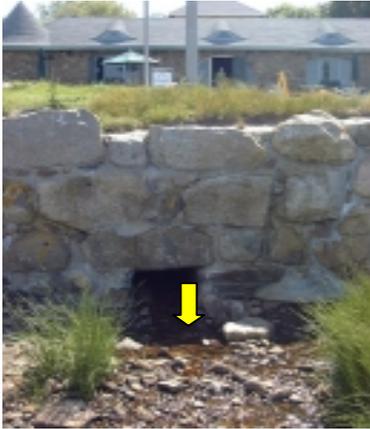
Quad	Site #	Watershed	Wetland Type	Restoration Code	Target Species	Access/Road	Ownership	Waypoint
Q-3	22	Good Harbor	Salt Marsh/Shrub Swamp	DL, FR	Anadromous/Catadromous	Nautilus Rd.	Private	157
<b>Notes</b>				<b>Photo</b>				
Low flow discharge				A.

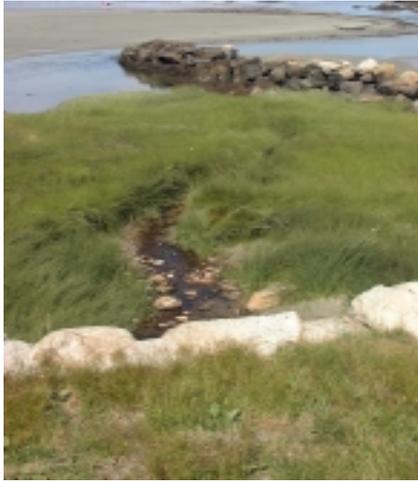
Approx. 1.5' culvert up and downstream				B.

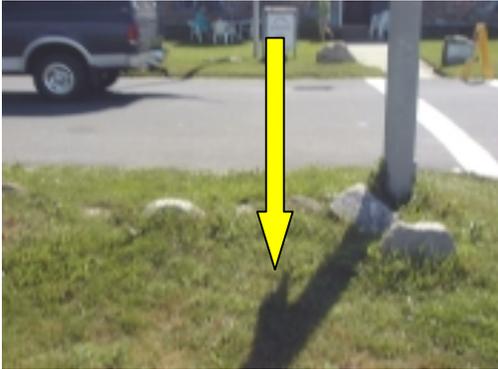
Upstream culvert is grated with concrete baffle to reduce/retard flow				C.

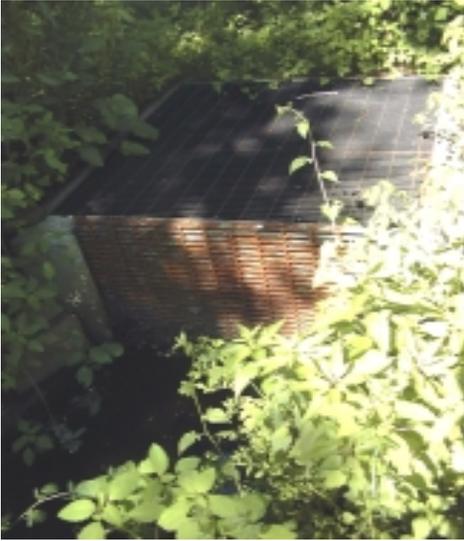
Stream flows under beach club				D.

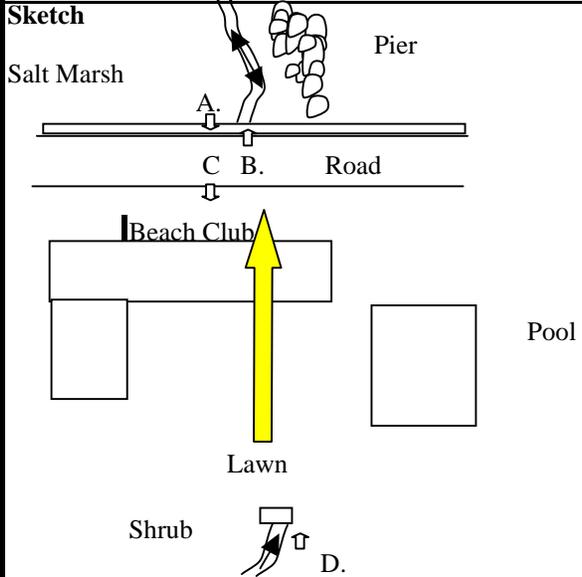
Historic eel run								
Source of watershed - golf course ponds								
Fill area replaces native smelt spawning area								
<b>Sketch</b>

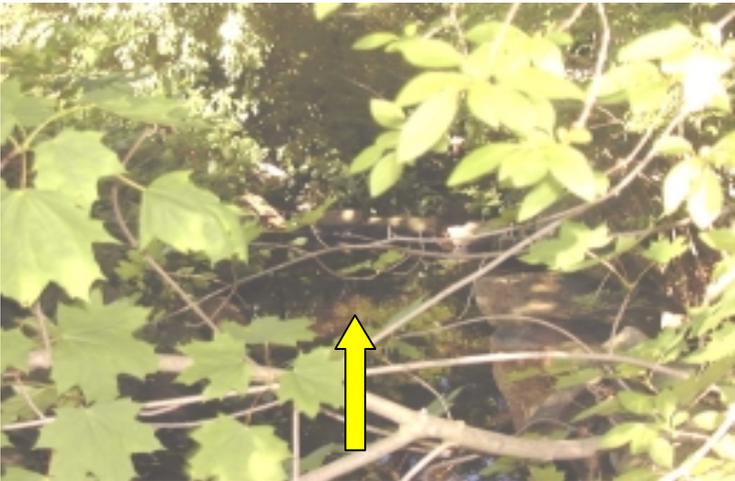
Quad	Site #	Watershed	Wetland Type	Restoration Code	Target Species	Access/Road	Ownership	Waypoint	
Q-3	23	Good Harbor	Shrub Swamp	FR, BE	Catadromous	Atlantic Ave.	Private	158	
<b>Notes</b>				<b>Photo</b>					
Source water - golf course pond				<b>A.</b>

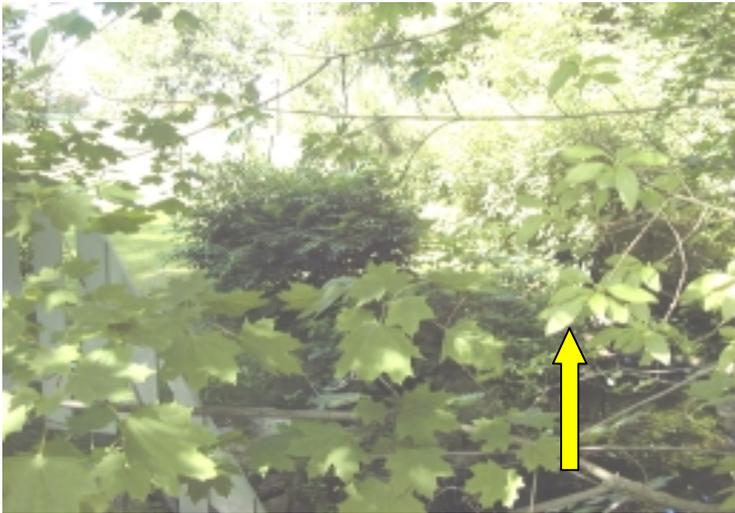
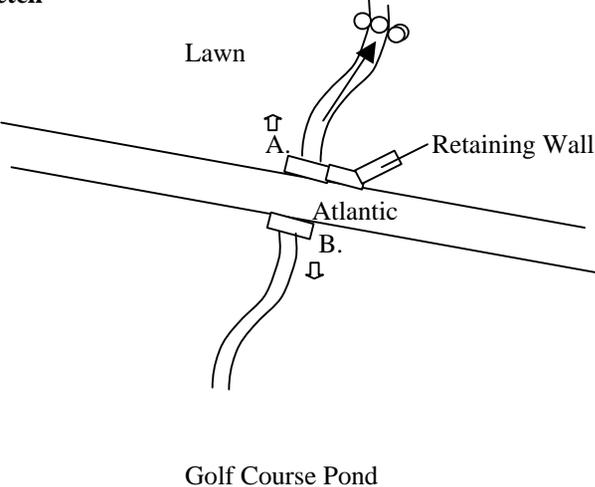
Stone dam in stream acts as an impediment									
Downstream lawn to near stream edge-need for increased buffer									
Not much vegetative buffer along headwater pond									
Minimal disturbance									
Site should be considered in context of eel potential									
<b>Sketch</b>				<b>B.</b>

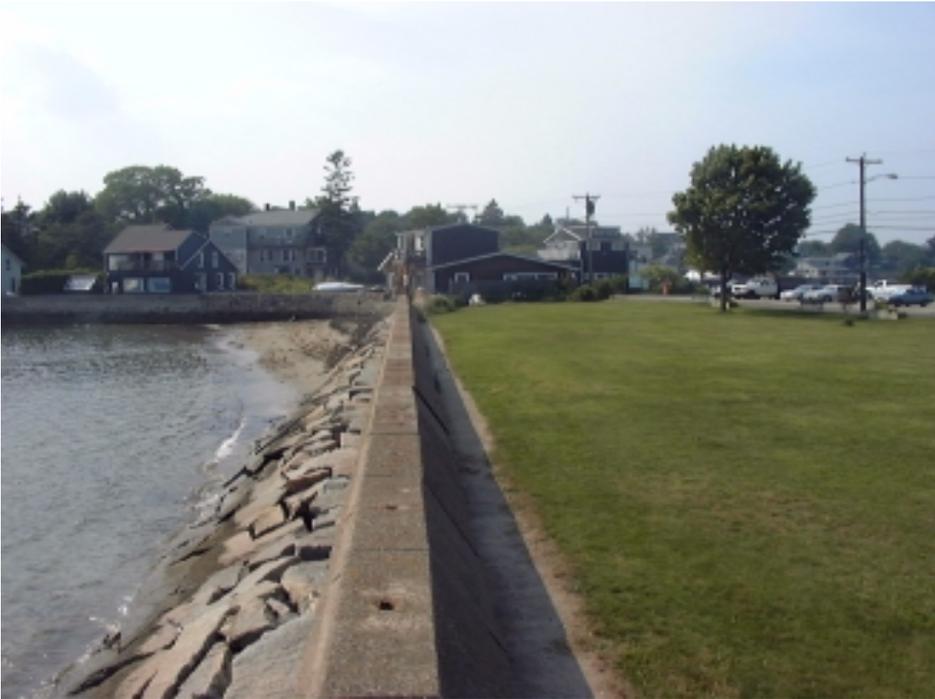
Quad	Site #	Watershed	Wetland Type	Restoration Code	Target Species	Access/Road	Ownership	Waypoint
Q-3	24	Wonson Cove	Salt Marsh	FR	Estuarine	Rocky Neck	Municipal	159
<b>Notes</b>				<b>Photo</b>				
Potential to connect to Wonson Cove on opposite side of road				<b>A.</b>

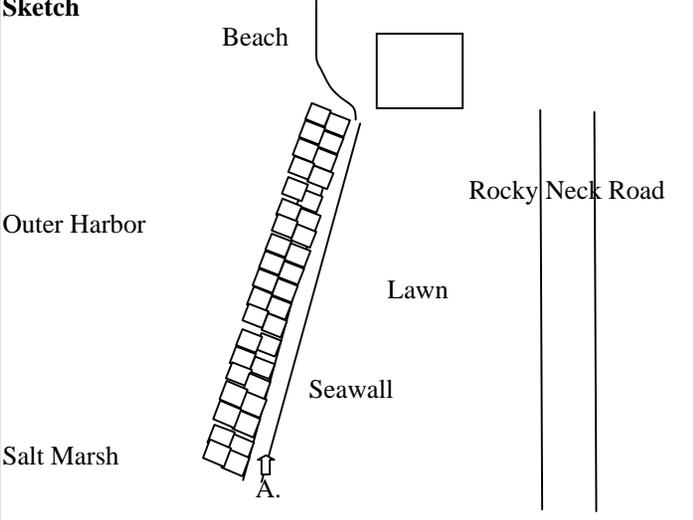
Limited habitat value								
Need to determine if neck was once an island								
Seawall replaces natural coastal bank								
Low priority site								
<b>Sketch</b>

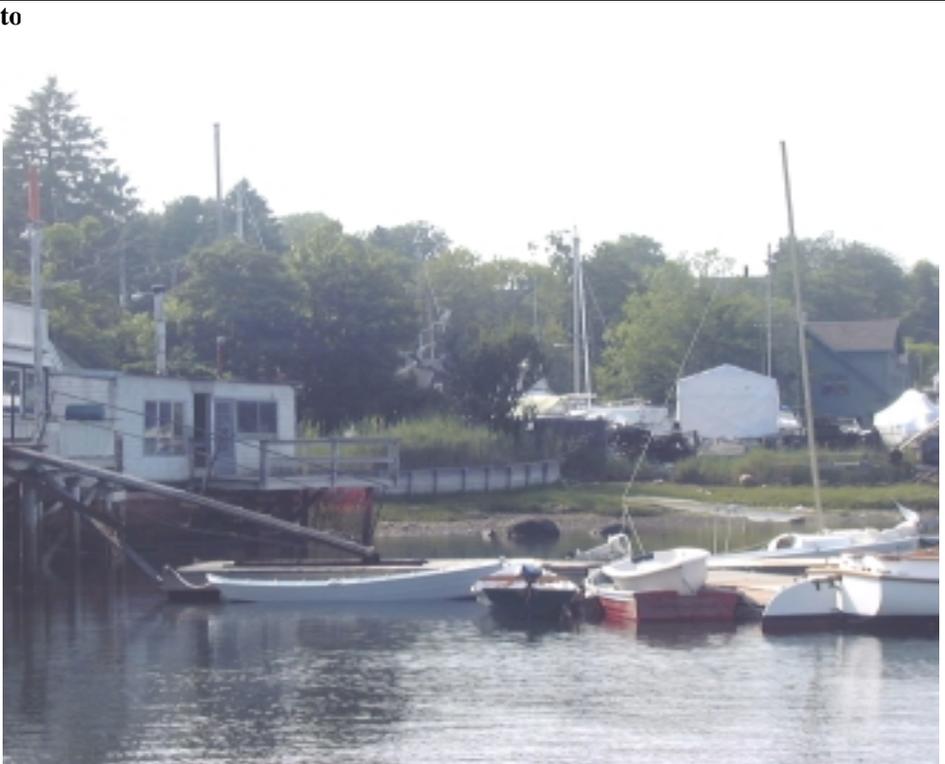
Quad	Site #	Watershed	Wetland Type	Restoration Code	Target Species	Access/Road	Ownership	Waypoint
Q-3	25	Smith Cove	Salt Marsh	FR, BE, IM	Estuarine	Rocky Neck	Unknown	160
<b>Notes</b>				<b>Photo</b>				
Small pocket marsh				<p><b>A.</b></p>

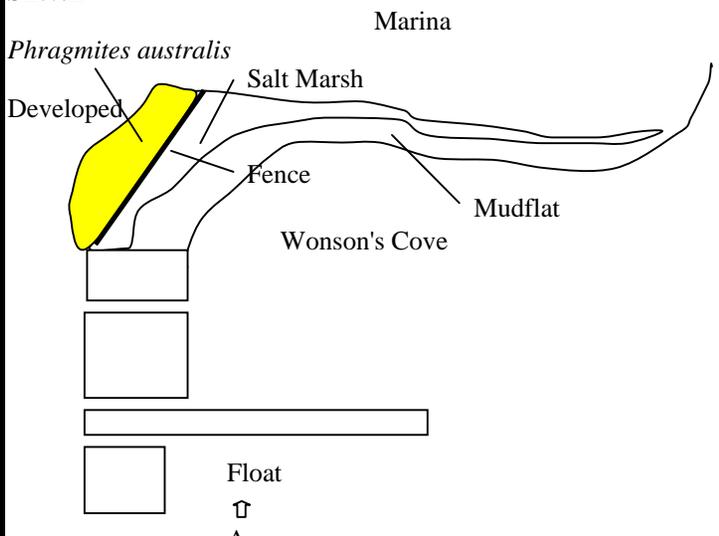
Phragmites advance limited by fence								
Salt marsh present below fence line								
Area heavily developed								
Vestigial marsh								
Not a high priority								
Simple removal of fence may allow tidal water to raise salinities and limit/stunt Phragmites								
<b>Sketch</b>				<b>B.</b>

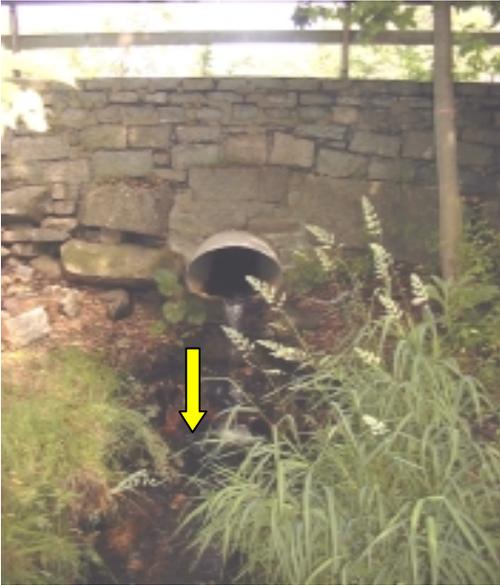
Quad	Site #	Watershed	Wetland Type	Restoration Code	Target Species	Access/Road	Ownership	Waypoint
Q-3	26	Day's Pond	Open Water	CU, FR, BE, RR, BMP	Catadromous	Eastern Ave.	Municipal	161
<b>Notes</b>				<b>Photo</b>				
Upper Day's Pond				<b>A.</b>				
High potential to enhance eel passage

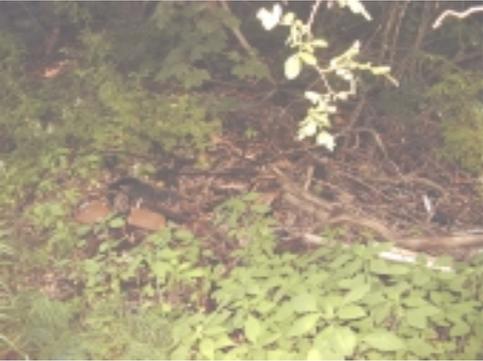
Pond probably too small for alewives				<b>B.</b>				
Culvert elliptical, approx. 2' x 3'

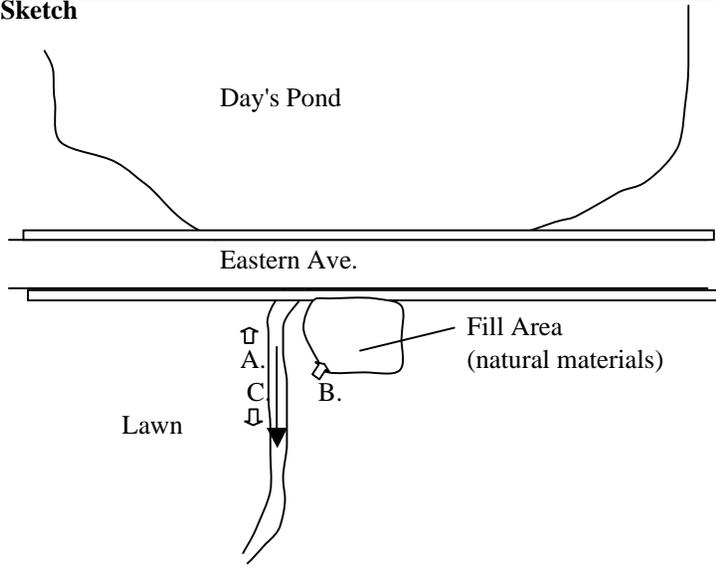
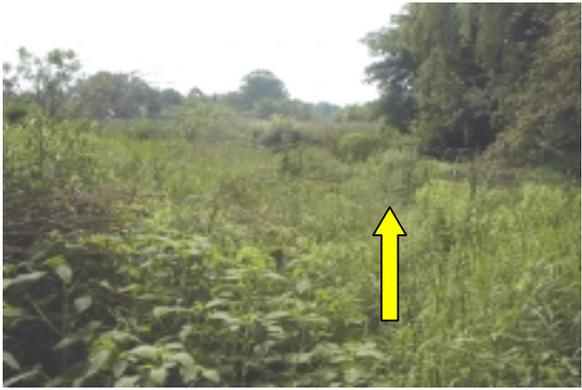
Stream impacted by stormwater								
Simple roughed ramp below culvert may enhance overall efforts								
to restore Day's Pond by enhancing eel passage								
Area below pond may be restored for smelt								
Large area of fill beside stream below road								
2-3' elevation drop from culvert to stream (less in high water)								
Site should be considered in context with lower Day's Pond								
<b>Sketch</b>				<b>C.</b>

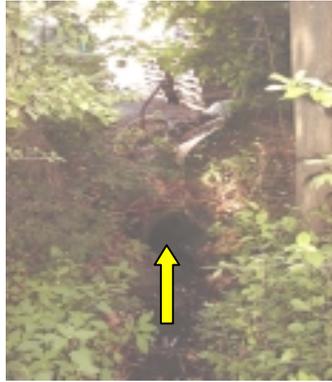
Quad	Site #	Watershed	Wetland Type	Restoration Code	Target Species	Access/Road	Ownership	Waypoint
Q-3	27	Day's Pond	Open Water	DL	Riverine	Eastern Ave.	Private	162
<b>Notes</b>				<b>Photo</b>				
Upstream 2' culvert, minimal flow				<b>A.</b>

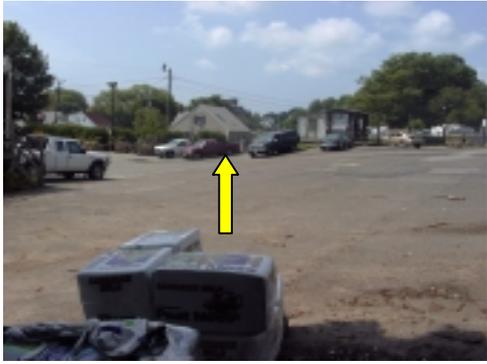
Daylight section approx. 100 to 200'				<b>B.</b>

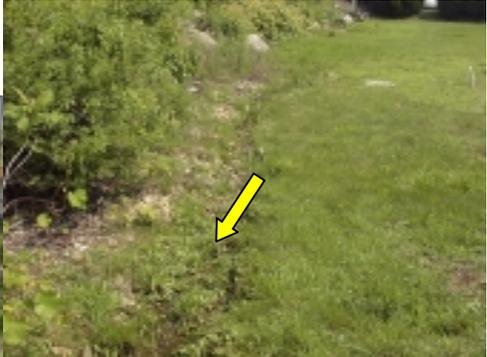
Stream outlet not clearly defined, culvert has disintegrated				<b>D.</b>

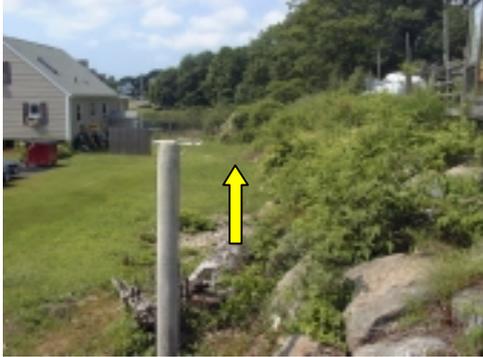
Outlet stream filters through wetlands prior to entering pond				<b>C.</b>

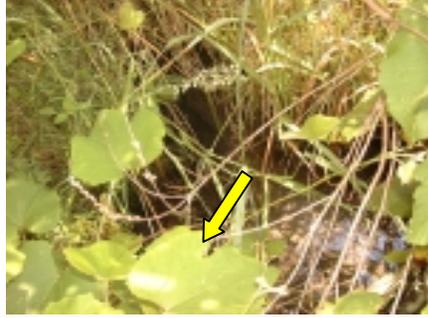
Difficult to daylight stream as it will impact access, parking and storage - partial daylighting may be possible				<b>E.</b>

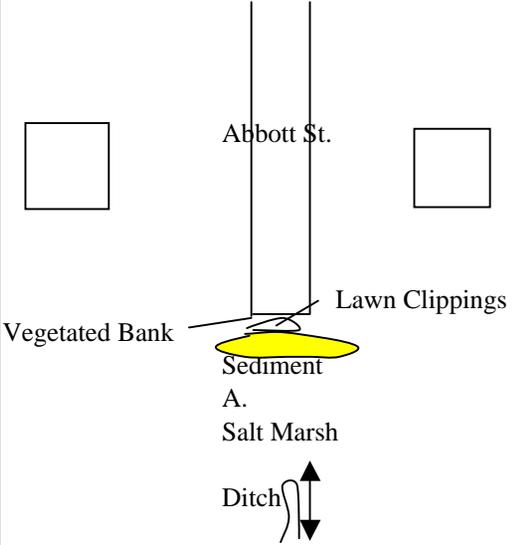
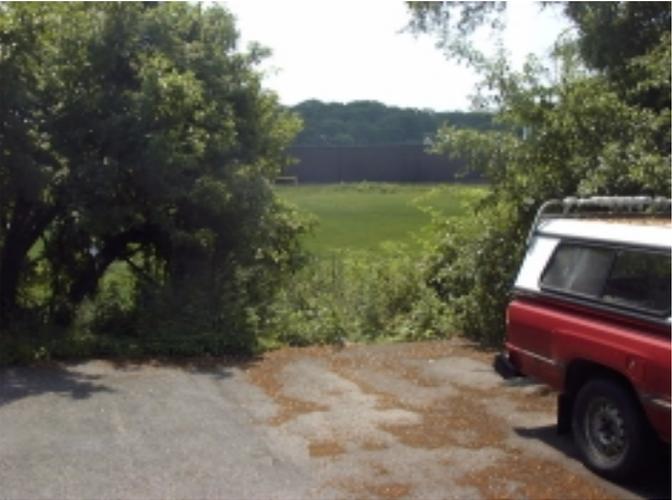
Stormwater has resulted in sediment plume on marsh								
Discharge from a 1' corrugated plastic culvert								
Perhaps up to 5 yards of built up sediment								
Lawn and grass clippings have also been dumped over bank								
Canopy of trees along vegetated bank probably reduces Phragmites								
<b>Sketch</b>				<b>B.</b>

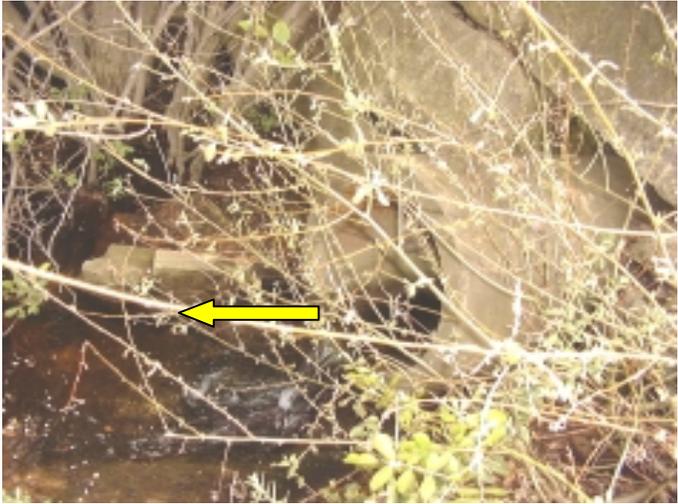
Quad	Site #	Watershed	Wetland Type	Restoration Code	Target Species	Access/Road	Ownership	Waypoint
Q-3	29	Unnamed	Shrub Swamp	DL	Riverine	Pond Rd.	Unknown	164
<b>Notes</b>				<b>Photo</b>				
Appears that a pond is cut in half by a road, road not found but shown on topographic maps				<b>A.</b>				
Stream reduced to stormwater catch basins discharging to pond

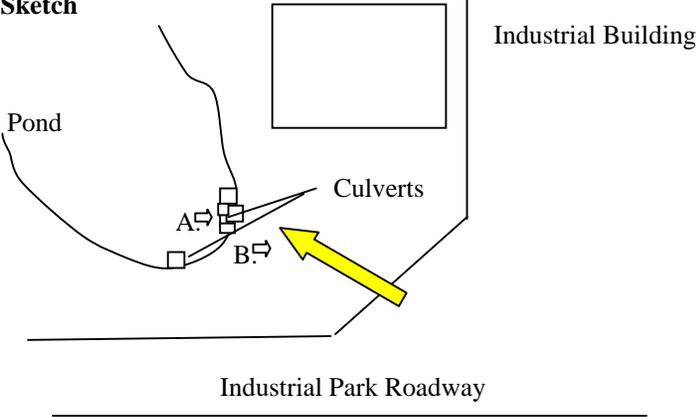
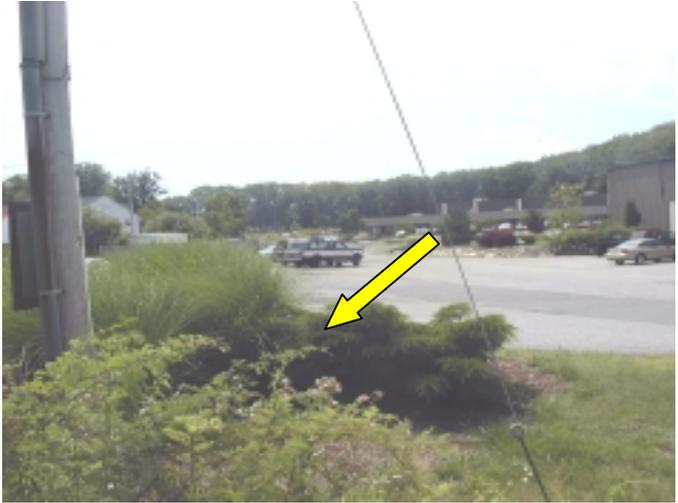
Strong flow from culvert in dry weather indicates that a stream may have been filled								
Stream not found								
Dense development upstream (industrial park)								
Pond may be large enough to support alewife - further study needed								
<b>Sketch</b>				<b>B.</b>

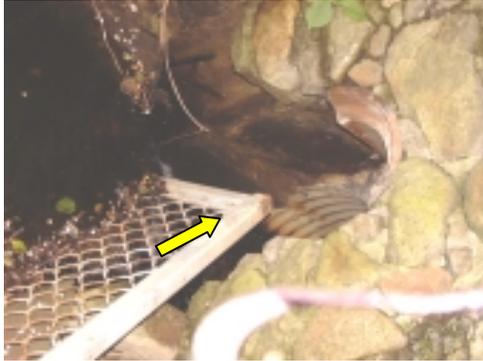
Quad	Site #	Watershed	Wetland Type	Restoration Code	Target Species	Access/Road	Ownership	Waypoint
Q-3	30	Unnamed	Shrub Swamp	CU, FL	Anadromous/Catadromous	Pond Rd.	Unknown	165
<b>Notes</b>				<b>Photo</b>				
Culvert drops significantly from upstream to downstream				<b>A.</b>				
Culvert seems undersized

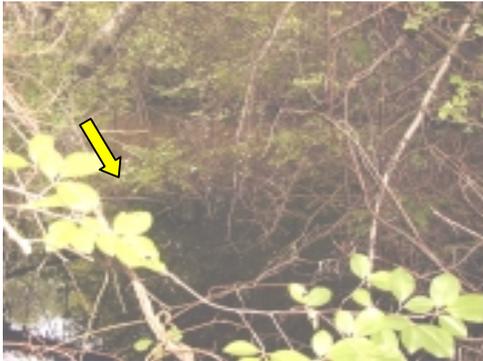
~3' Galvanized culvert at outlet, ~2.5' ceramic upstream				<b>B.</b>				
Debris upstream of road

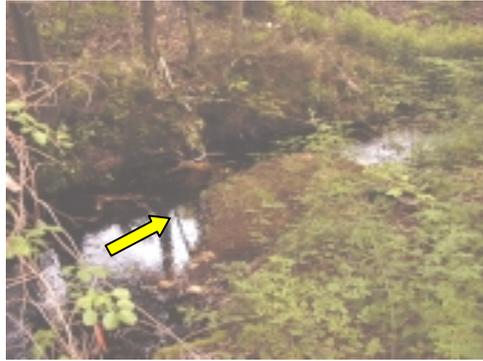
Site could be improved in light of alewife passage - further study needed				<b>C.</b>

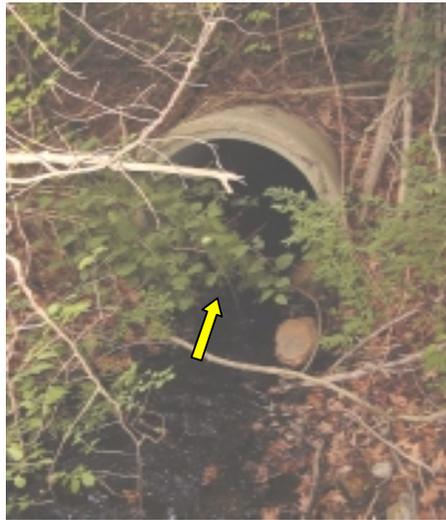
Quad	Site #	Watershed	Wetland Type	Restoration Code	Target Species	Access/Road	Ownership	Waypoint
Q-3	31	Unnamed	Shrub Swamp	DL, BE	Anadromous/Catadromous	Pond Rd.	Unknown	166
<b>Notes</b>				<b>Photo</b>				
4' Concrete culvert				<b>A.</b>				
Opportunity to daylight section of creek

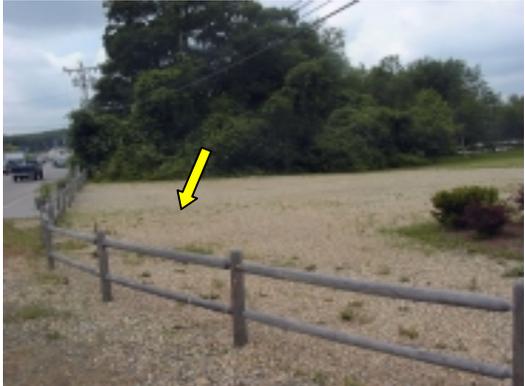
Approx. 200-300' of daylight opportunity				<b>B.</b>				
Stormwater impacts site (sediment in stream downstream side)

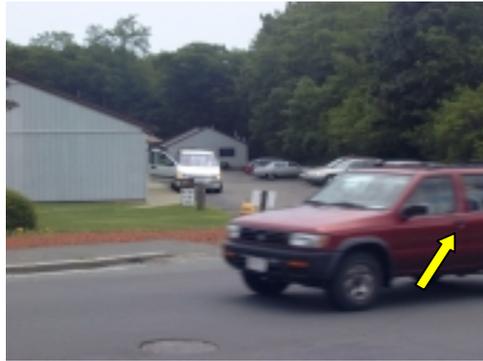
Paved swale at downstream outlet				<b>C.</b>				
Site should be looked at in light of alewife passage potential

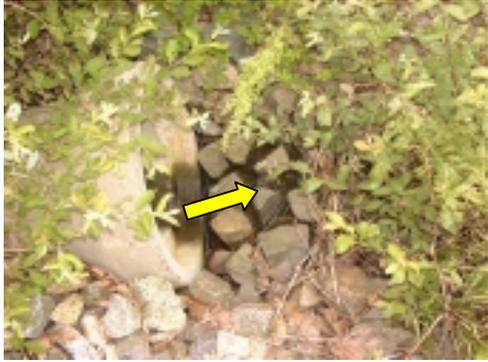
Quad	Site #	Watershed	Wetland Type	Restoration Code	Target Species	Access/Road	Ownership	Waypoint
Q-3	32	Unnamed/Cape Pond	Shrub Swamp	DL, CU	Riverine	Witham St.	Unknown	167
<b>Notes</b>								
Series of drainage culverts				A.				
30-40' of daylighting potential

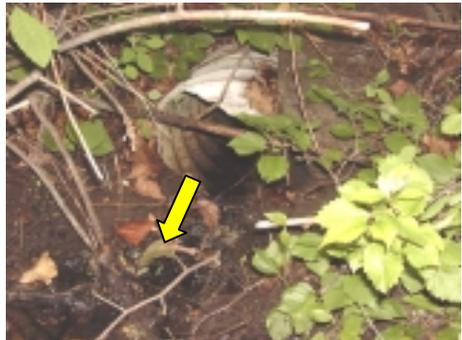
Outlet culvert at C 2'				B.				
Passage to Cape Pond of alewives not likely due to lack of significant flow

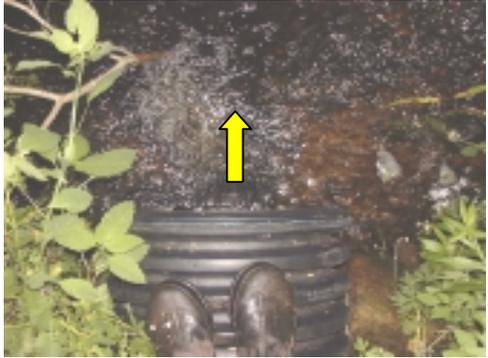
Area seems to be altered from construction of adjacent development				C.

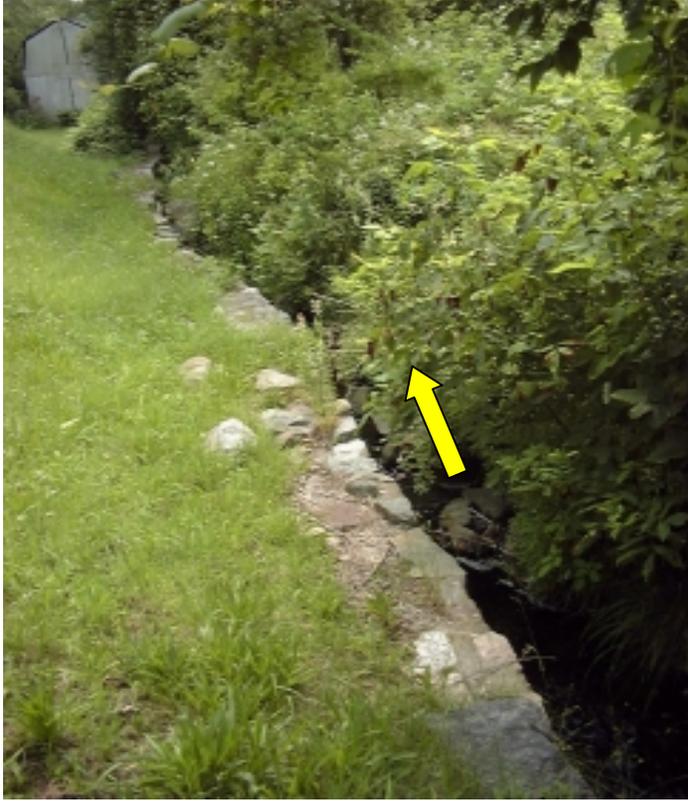
Quad	Site #	Watershed	Wetland Type	Restoration Code	Target Species	Access/Road	Ownership	Waypoint
Q-3	33	Unnamed	Shrub Swamp	BE, BI	Riverine	Witham St.	Private	168
<b>Notes</b>				<b>Photo</b>				
3' culvert properly sized				A.				
Bridge on private drive does not restrict the natural flow of water

Opportunity to recreate natural bank and enhance smelt spawning habitat								
Low priority								
<b>Sketch</b>

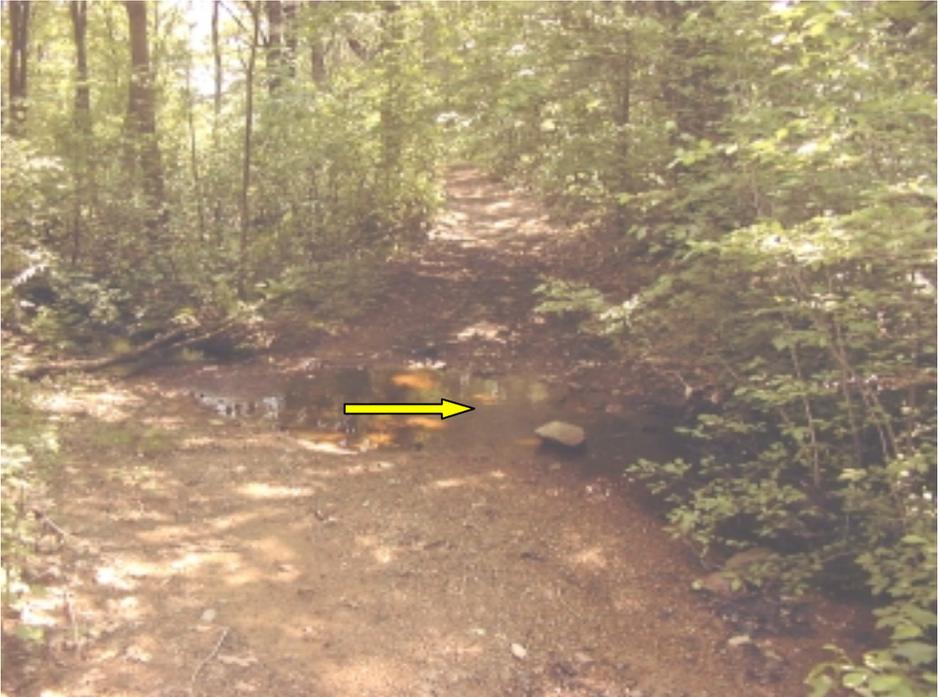
Quad	Site #	Watershed	Wetland Type	Restoration Code	Target Species	Access/Road	Ownership	Waypoint
Q-3	34	Unnamed	Wooded Swamp Deciduous	BE	Riverine	Cape Pond Cart Path	Unknown	169
<b>Notes</b>				<b>Photo</b>				
Bridge may reduce sedimentation impacts				A.				
Area impacted by motorized traffic

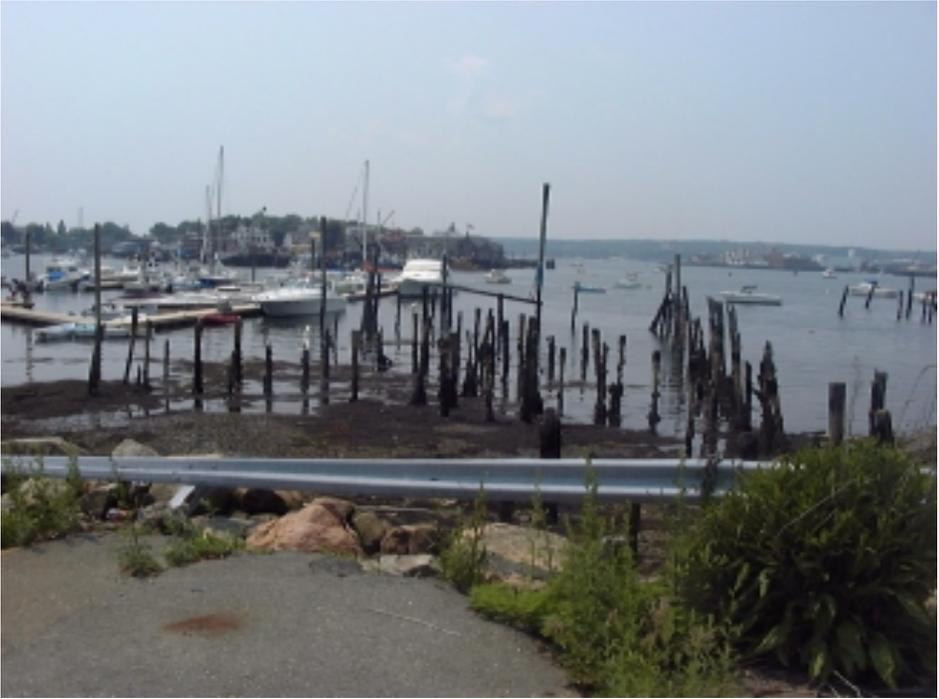
Quad	Site #	Watershed	Wetland Type	Restoration Code	Target Species	Access/Road	Ownership	Waypoint
Q-3	35	Inner Harbor	Rocky Intertidal Shore	FR	Estuarine	East Main St.	Private	170
<b>Notes</b>				<b>Photo</b>				
Removal of posts would reduce amount of wrack caught in area				A.				
Habitat enhancement may be limited by post removal

Restoration may be more of a cleanup than a restoration								
<b>Sketch</b>

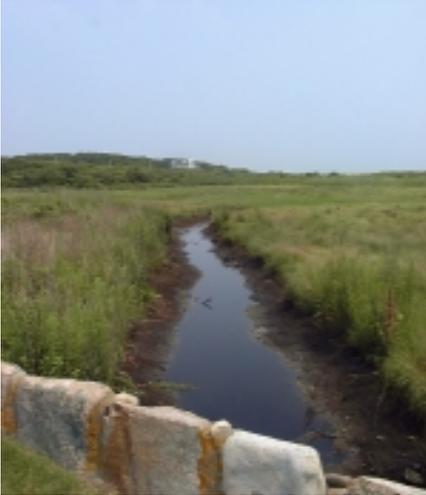
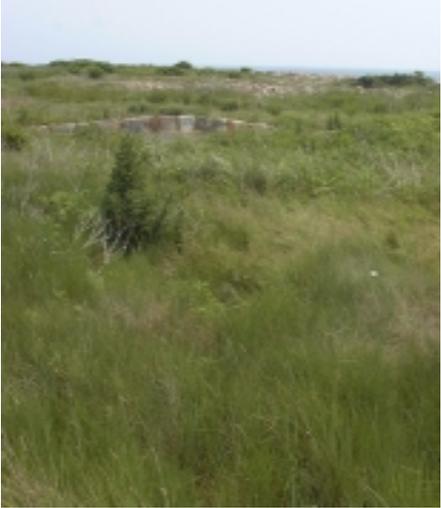
Quad	Site #	Watershed	Wetland Type	Restoration Code	Target Species	Access/Road	Ownership	Waypoint
Q-3	36	Outer Harbor	Salt Marsh	DL, FR, IM	Estuarine	Eastern Point Blvd.	Private	171
<b>Notes</b>				<b>Photo</b>				
Project soon to be restored by Mass Audubon				<b>A.</b>				
Site tidally restricted, invasive species present in restricted marsh				<b>B.</b>				
New culvert and creek are planned to be installed

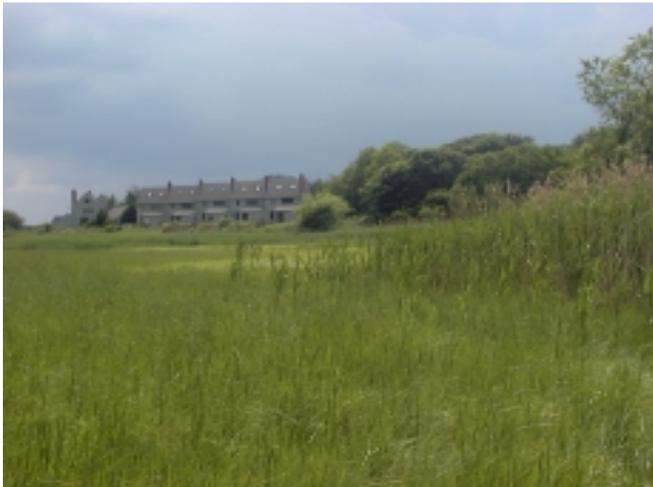
Quad	Site #	Watershed	Wetland Type	Restoration Code	Target Species	Access/Road	Ownership	Waypoint
Q-3	37	Good Harbor Marsh	Salt Marsh	IM	Estuarine	Witham St./Thatcher Rd.	Unknown	NA
<b>Notes</b>				<b>Photo</b>				
Good Harbor back marsh				A.				
Area impacted at perimeter by <i>Phragmites australis</i>

Ditch along Nugent Farm edge halts spread of Phragmites								
Opportunities for OMWM/restoration to reduce Phragmites								
Historical connection to Saratoga Beach, Rockport via main creek (see arrow below)								
Restoration should be done in context of entire marsh system								
Main <i>Phragmites australis</i> growth areas shown below (approx. location)								
<b>Sketch</b>				B.

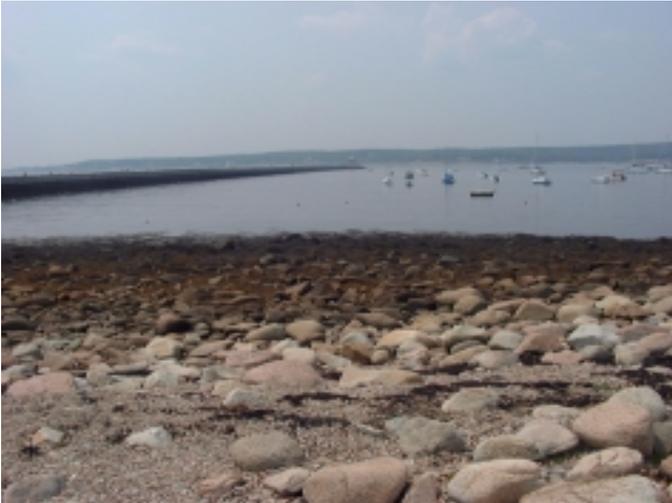
Coast appears to have been filled, rock is uniform in shape								
Re-alignment of stones could be done to enhance retention of water for tide pool habitat								
Tide pools are juvenile fish habitat								
Area sheltered by breakwater								
<b>Sketch</b>				<b>B.</b>

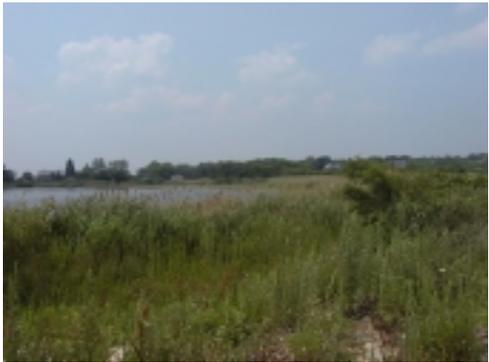
Quad	Site #	Watershed	Wetland Type	Restoration Code	Target Species	Access/Road	Ownership	Waypoint
Q-3	39	Niles Pond	Brackish Marsh	IM	Catadromous	Niles Pond Rd.	Private	173
<b>Notes</b>				<b>Photo</b>				
Proposed restoration plan to reduce <i>Phragmites australis</i> exists and in the permit phase				<b>A.</b>				
Pond may be optimum <i>Phragmites</i> habitat due to periodic coastal breaches of the bank

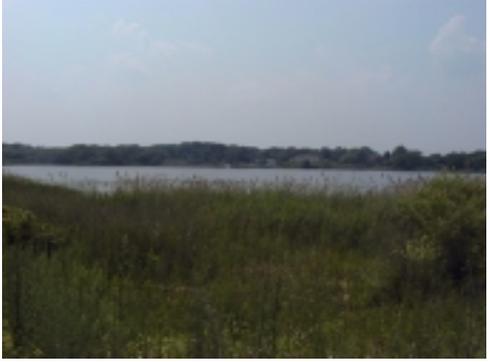
Need to determine rate of <i>Phragmites</i> advance				<b>B.</b>				
Opportunities to achieve productive eel habitat should be considered without changing the hydrology and ecology of the pond

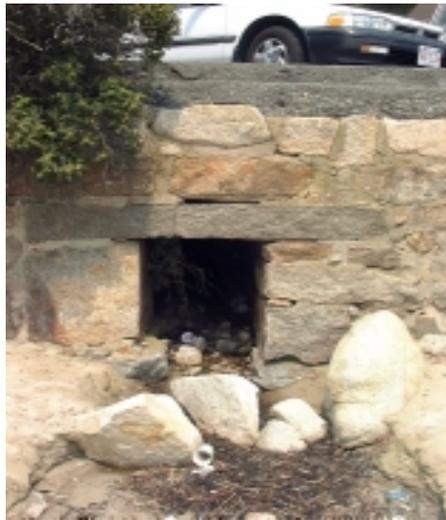
Quad	Site #	Watershed	Wetland Type	Restoration Code	Target Species	Access/Road	Ownership	Waypoint
Q-3	40	Niles Beach	Coastal Beach	CU, DL, BMP	Riverine	E. Main St.	Public/Private	174, 175
<b>Notes</b>				<b>Photo</b>				
Small stream discharges to Niles Beach				A.

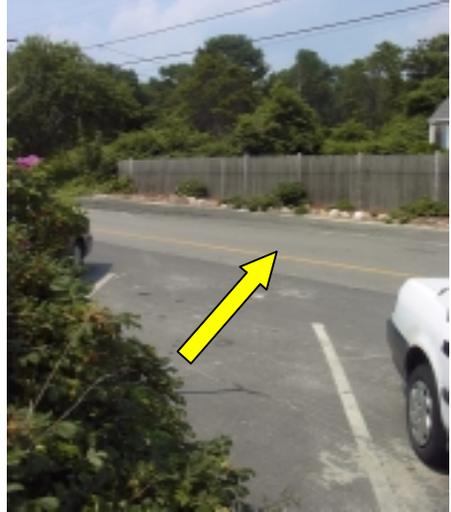
Slight seep noted at time of site visit				B.

Area drains from open parcel above								
Source of stream difficult to determine - due dense undergrowth								
Site would may benefit from a stormwater BMP due to discharge to bathing beach								
1.5' culvert inside 3' x 3' granite box culvert								
<b>Sketch</b>				C.

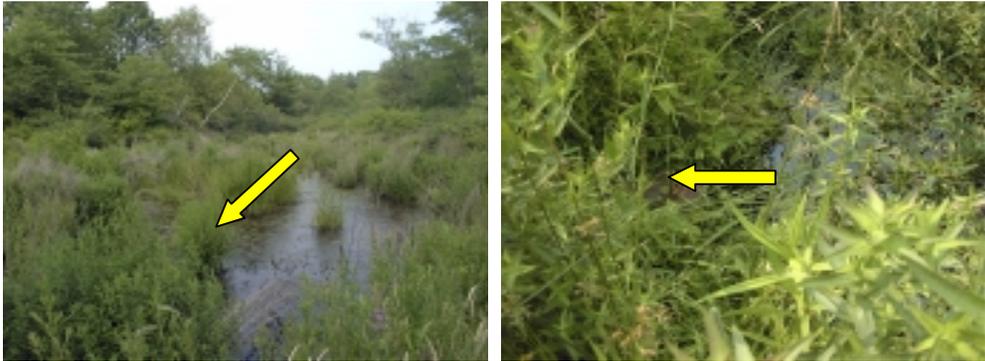
Quad	Site #	Watershed	Wetland Type	Restoration Code	Target Species	Access/Road	Ownership	Waypoint
Q-3	41	Unnamed	Shrub Swamp/Deep Marsh	CU	Riverine	Ledge Rd.	Municipal	176
<b>Notes</b>				<b>Photo</b>				
Culvert restricts flow but creates wetland complex upstream				A.				
Wetland area should not be disturbed as increased drainage would probably reduce wildlife values

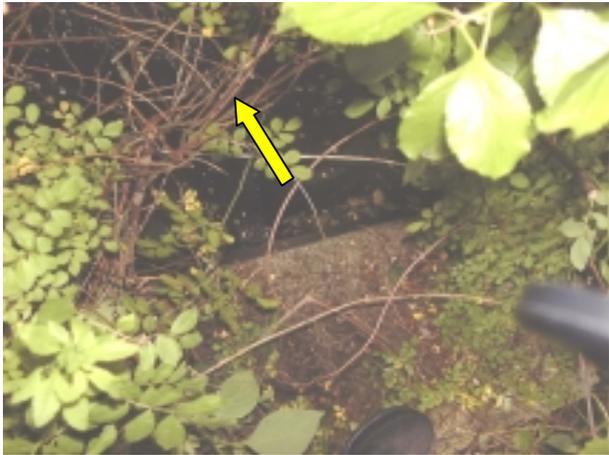
Wetland area is hummocky with open water habitat

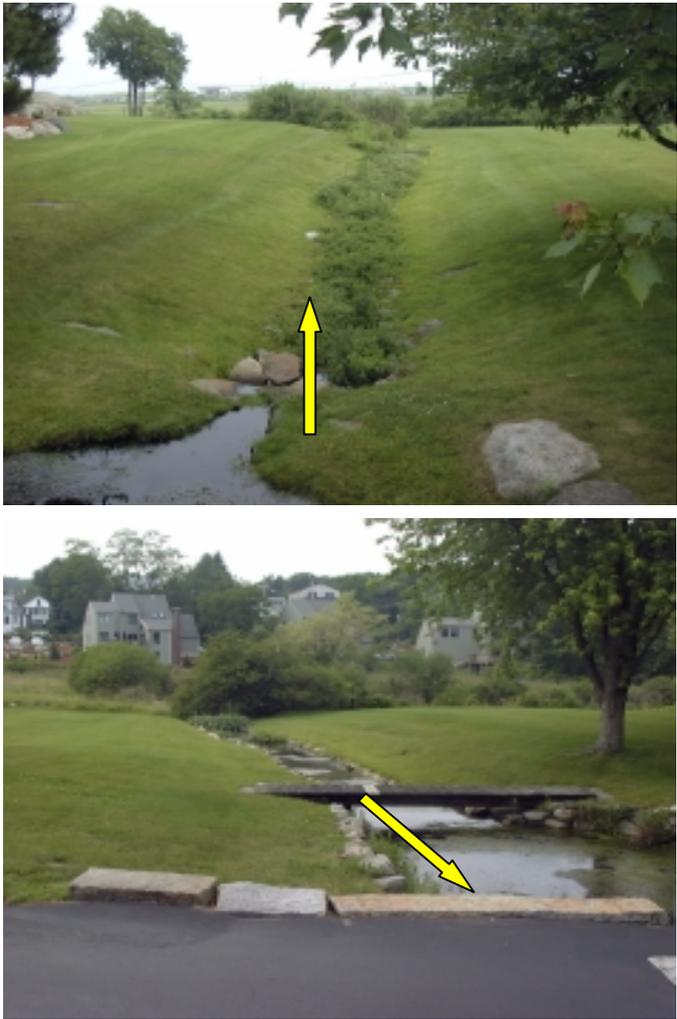
Quad	Site #	Watershed	Wetland Type	Restoration Code	Target Species	Access/Road	Ownership	Waypoint
Q-3	43	Good Harbor	Open Water	BE	Riverine	Old Nugent Farm	Private	178
<b>Notes</b>				<b>Photo</b>				
No vegetated buffer				A.				
Lawn may contain fertilizers and pesticides

Granite bridge sized correctly								
Stone obstruction 5' down form bridge								
Area may be eel habitat (small headwater pond)								
Education to homeowners/association could result in vegetated buffer along stream corridor								
Heavy stand of <i>Phragmites australis</i> below lawn area								
<b>Sketch</b>				B.

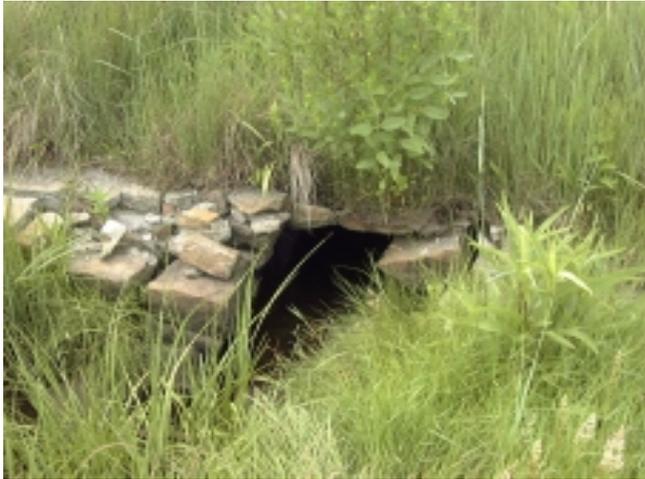
Quad	Site #	Watershed	Wetland Type	Restoration Code	Target Species	Access/Road	Ownership	Waypoint
Q-3	44	Good Harbor	Brackish Marsh	CU	Estuarine	Thatcher Rd.	Public/Private	179
<b>Notes</b>				<b>Photo</b>				
Degraded 3' x 2' granite box culvert				<b>A.</b>

Improvement of flow may enhance potential eel run								
Phragmites area at least 100' in length along road								
Significant elevation drop from either side of road								
Flow enhancement may mean channel improvement upstream								
				<b>B.</b>

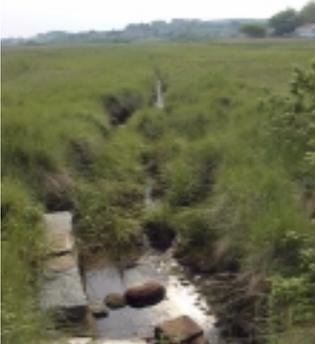
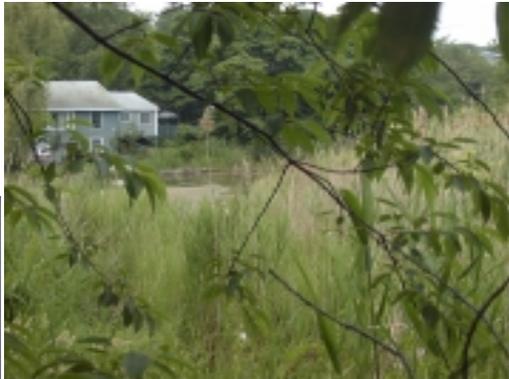
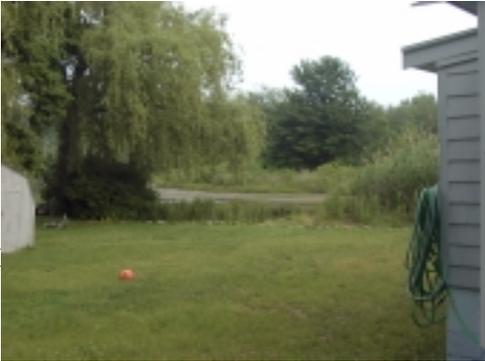
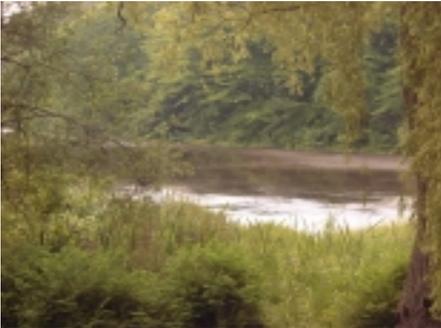
</p>					
Formally tidally influenced									
Brackish pools have been formed which are good shorebird feeding areas, lots of exposed mudflats									
Culvert at Witham St. is a 3.5' granite box culvert, set slightly too high									
Ponds may have alewife potential, habitat should be checked									
Further hydrologic studies should be done to determine potential for restoration									
Concrete culvert 2.5' by Rockport line at photo station E.									
<b>Sketch</b>				<p>B.
