# City of Gloucester Comprehensive River and Stream Habitat Restoration Report

2003

Tim Purinton

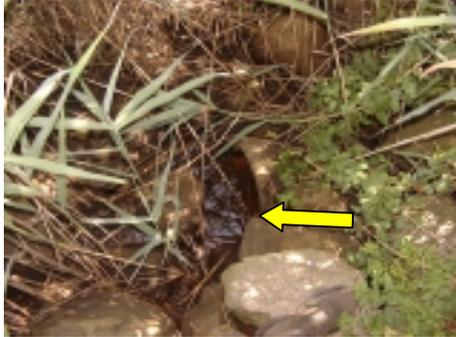
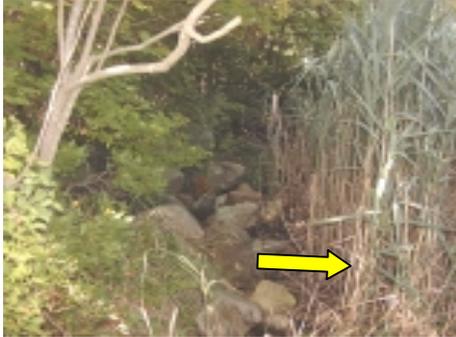
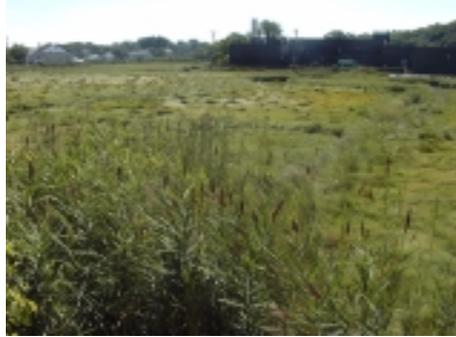
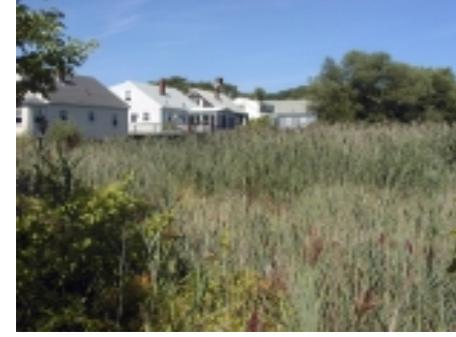
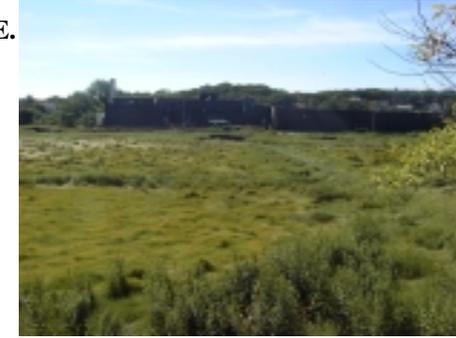
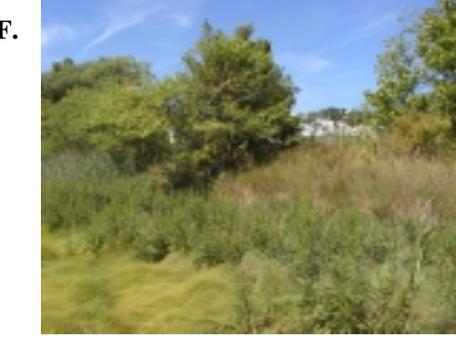
Quad	Site #	Watershed	Wetland Type	Restoration Code	Target Species	Access/Road	Ownership	Waypoint
Q-3	46	Day's Pond	Brackish Marsh	FR, CU, DR	Estuarine	Abott Rd.	Unknown	228
<b>Notes</b>				<b>A.</b>		<b>B.</b>		
6' high vegetated berm impounds wetland

Wetland area heavily vegetated by <i>Phragmites australis</i>								
One 12-16" metal culvert drains wetland behind berm								
Wetland probably was formally salt marsh								
Some salt marsh still exists in the Lower Day's Pond impoundment								
Nearby development along Abbott St. and opposite side								
Partial berm/dam removal would probably result in salt marsh restoration								
<b>Sketch</b>				<b>C.</b>		<b>D.</b>

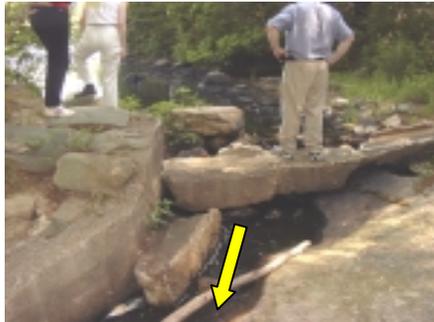
Quad	Site #	Watershed	Wetland Type	Restoration Code	Target Species	Access/Road	Ownership	Waypoint
Q-4	1	West Pond	Open Water	FL, DR	Catadromous	Lake Rd.	Private	180
<b>Notes</b>				<b>A.</b>				
Minimal flow over spillway during summer site investigation

Limited anadromous fish potential due to configuration of stream outlet at the ocean								
Dam removal should be considered to return natural flow								
Habitat values of natural stream with associated wetlands vs. pond should be studied further								
Dam length approx. 150'								
Significant elevation drop from pond level to dam base								
Dam removal/repair should be considered in light of safety as well as a positive exchange of habitat values								
<b>Sketch</b>				<b>B.</b>

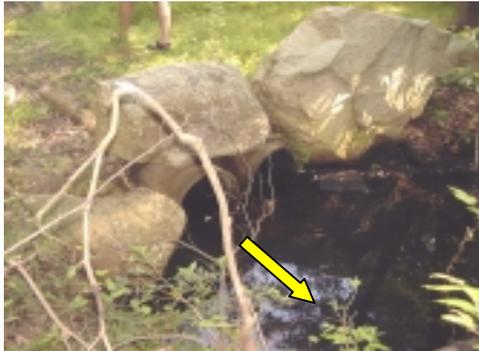
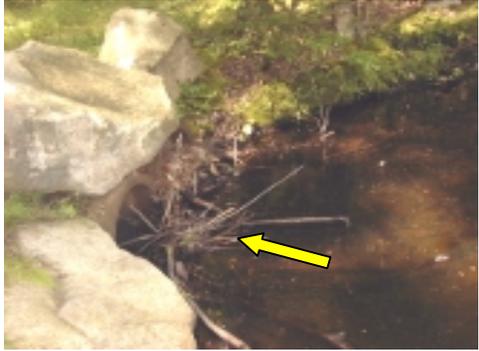
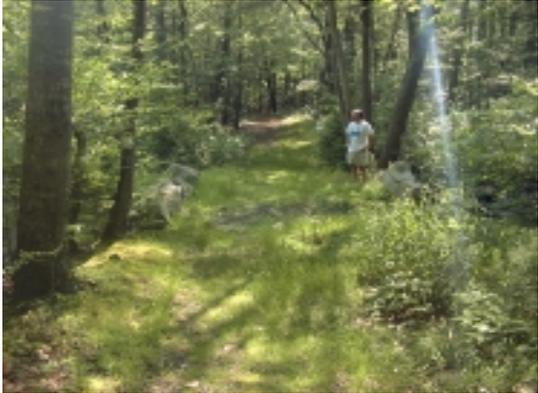
Quad	Site #	Watershed	Wetland Type	Restoration Code	Target Species	Access/Road	Ownership	Waypoint
Q-4	2	West Pond	Wooded Swamp Deciduous	CU,FR	Riverine	Cart Path (Englewood)	Municipal	181
<b>Notes</b>				<b>Photo</b>				
Two ~1.5' culverts retard water flow and create upstream wetlands				<b>A.</b>				
Culverts may be set too high				<b>B.</b>				
1-2' elevation change from upstream to downstream

Wetland system well developed above								
Grass road, little stormwater impacts

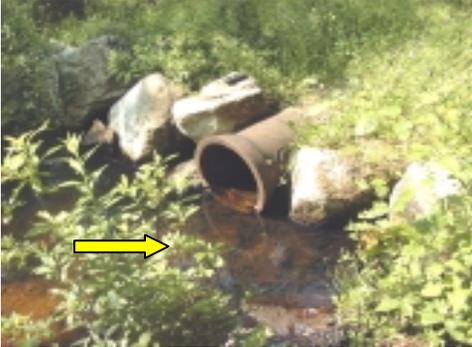
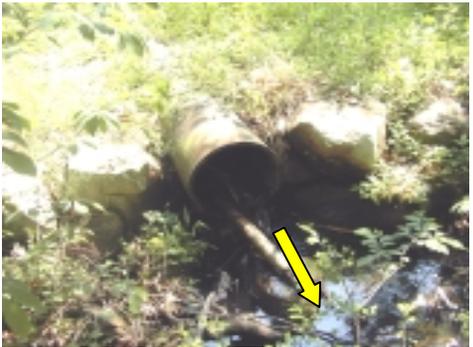
Quad	Site #	Watershed	Wetland Type	Restoration Code	Target Species	Access/Road	Ownership	Waypoint
Q-4	3	West Pond	Wooded Swamp Deciduous	CU,FR	Riverine	Cart Path (Englewood Rd.)	Municipal	182
<b>Notes</b>				<b>Photo</b>				
One 16 to 18" culvert, exposed at ground level				<b>A.</b>				
Culvert set too high, restricts flow and creates wetlands above				<b>B.</b>				
Low priority/minimal disturbance

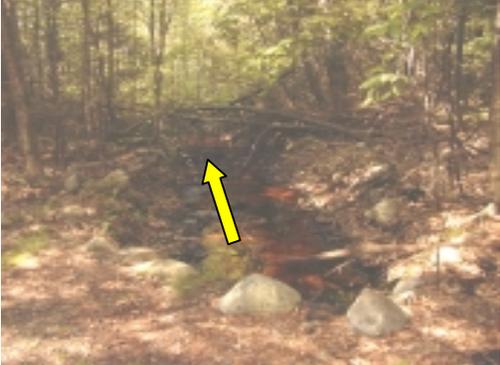
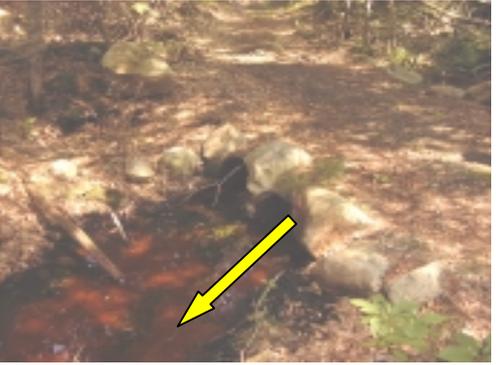
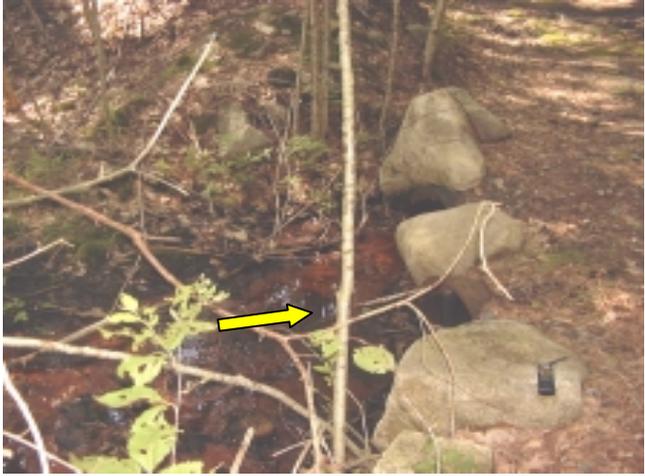
Quad	Site #	Watershed	Wetland Type	Restoration Code	Target Species	Access/Road	Ownership	Waypoint
Q-4	4	West Pond	Wooded Swamp Deciduous	CU,FR	Riverine	Cart Path (Englewood Rd.)	Municipal	183
<b>Notes</b>				<b>Photo</b>				
Stream channelized on both sides, upstream and downstream				<p>A.

</p>				
Two 16-18" culverts								
Stream alteration may be a component of the dump closure drainage plan								
<b>Sketch</b>

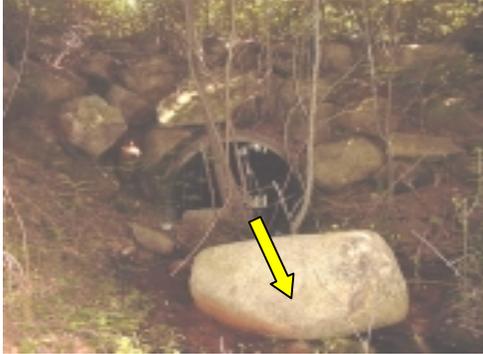
Quad	Site #	Watershed	Wetland Type	Restoration Code	Target Species	Access/Road	Ownership	Waypoint
Q-4	5	West Pond	Wooded Swamp Deciduous	CU, DL	Riverine	Landfill Access Rd.	Municipal	184
<b>Notes</b>				<b>Photo</b>				
Area drains detention area for dump				<b>A.</b>				
Limited restoration potential, but clearly stream disturbance

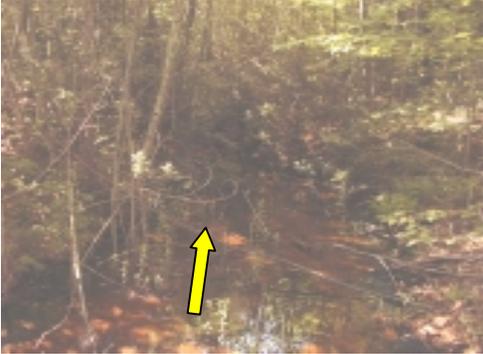
Closure requirements may not allow restoration of stream				<b>B.</b>				
Trees growing in stream indicate low or sporadic flow

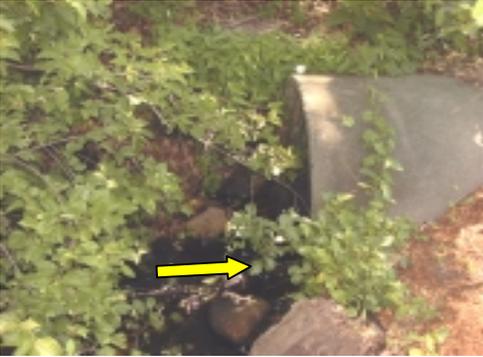
Quad	Site #	Watershed	Wetland Type	Restoration Code	Target Species	Access/Road	Ownership	Waypoint
Q-4	6	West Pond	Shrub Swamp	CU, BE	Riverine/Catadromous	Hesperus Ave.	Municipal	185
<b>Notes</b>				<b>A.</b>				
3' concrete culvert set 4-6" too high

~70' culvert length								
Culvert may be undersized given periodic pond overflows								
Lawn extends to near stream edge upstream and downstream								
<b>Sketch</b>				<b>B.</b>

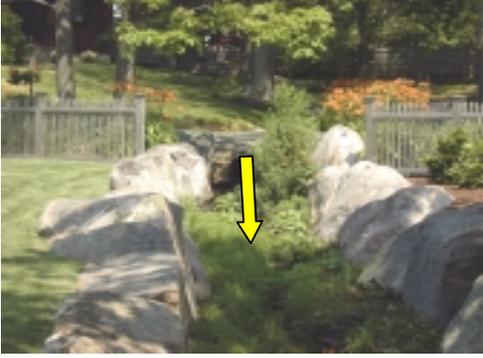
Quad	Site #	Watershed	Wetland Type	Restoration Code	Target Species	Access/Road	Ownership	Waypoint
Q-4	7	West Pond	Shrub Swamp	BE, CR	Riverine/Catadromous	Hesperus Circle	Private	186
<b>Notes</b>				<b>Photo</b>				
Stream highly altered				<b>A.</b>				
18" culvert set too high

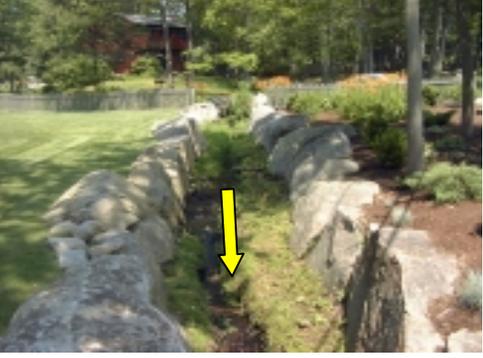
Stream channelized with large stone, provides little natural floodplain or a natural buffer				<b>B.</b>				
3'x2' granite box culvert falling apart

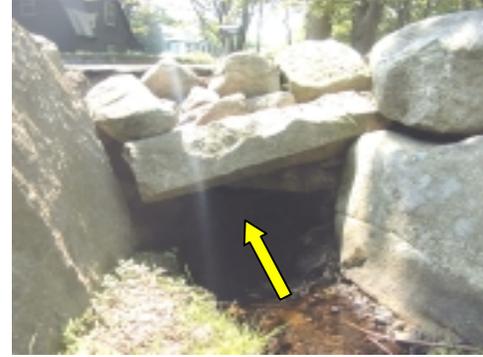
Area has limited anadromous fish potential due to configuration of outlet at ocean				<b>C.</b>				
Lawn extends to stream edge

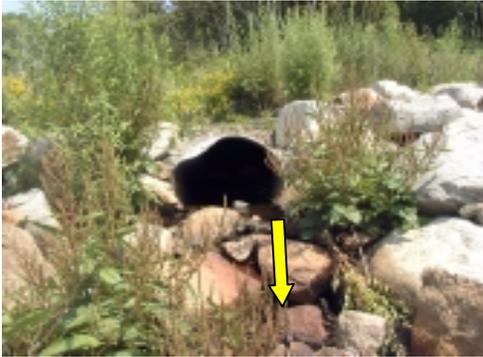
Quad	Site #	Watershed	Wetland Type	Restoration Code	Target Species	Access/Road	Ownership	Waypoint
Q-4	8	West Pond	Rocky Intertidal Shore	FL, DL	Riverine/Catadromous	Flume Rd.	Public/Private	187
<b>Notes</b>				<b>Photo</b>				
Steep drop from stream to mean tide level				A.				
Streambed not present in shifting cobble shoreline				B.				
Elevation difference reduces potential for anadromous fish enhancement

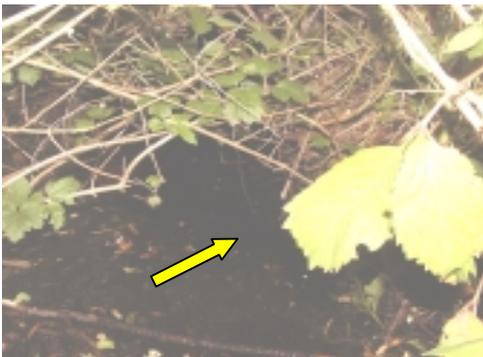
3' aluminum culvert

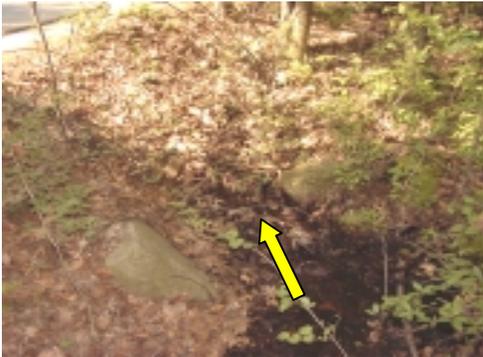
Quad	Site #	Watershed	Wetland Type	Restoration Code	Target Species	Access/Road	Ownership	Waypoint
Q-4	9	Rafes Chasm Creek	Wooded Swamp Deciduous	CU, BE	Riverine/Catadromous	Hesperus Ave.	Public/Private	188
<b>Notes</b>				<b>Photo</b>				
Small collapsed culvert, 16" steel				<b>A.</b>				
Collapsed culvert may create wetlands upstream				<b>B.</b>				
Downstream lawn to near stream edge

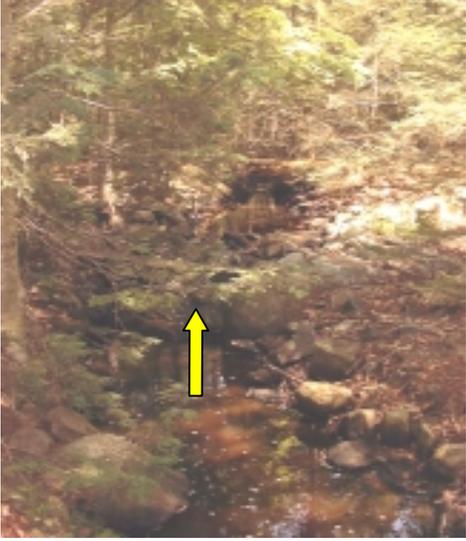
Quad	Site #	Watershed	Wetland Type	Restoration Code	Target Species	Access/Road	Ownership	Waypoint
Q-4	11	Norman's Woe Creek	Wooded Swamp Mixed Trees	BI	Riverine/Catadromous	Hesperus Ave.	Municipal	189
<b>Notes</b>				<b>Photo</b>				
Channelized section of creek				A.				
Reduction of stream side wetlands by reducing natural floodplain

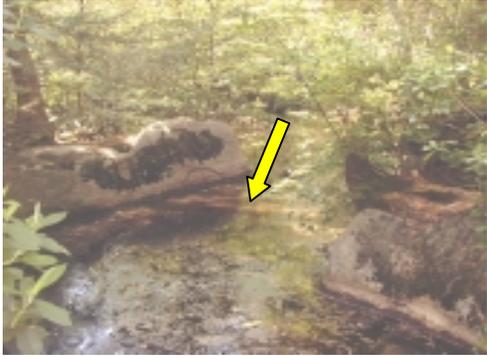
More deepwater habitat seems to have been created				B.				
Berm on either side of creek may be from dredging

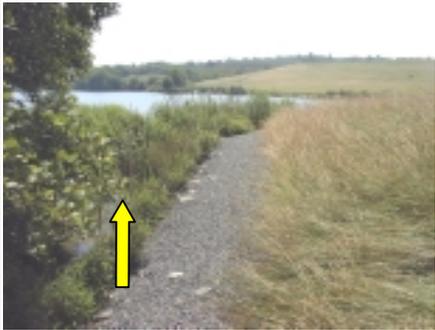
Quad	Site #	Watershed	Wetland Type	Restoration Code	Target Species	Access/Road	Ownership	Waypoint
Q-4	12	Norman's Woe Creek	Shallow Marsh Meadow/Wooded Swamp Deciduous	DL, BE	Riverine/Catadromous	Landfill Access Rd.	Municipal	191
<b>Notes</b>				<b>Photo</b>				
Area altered due to dump closure				<b>A.</b>				
Fringe of playing fields directly abut stream edge and wetlands

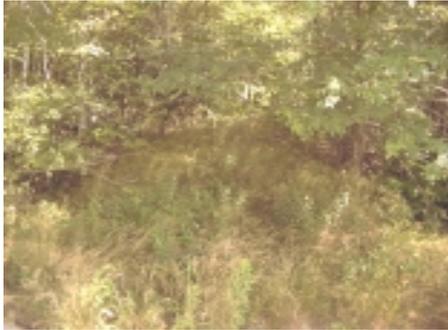
3' Corrugated culvert under old road				<b>B.</b>				
Road may not be a necessary and could be removed to restore wetlands

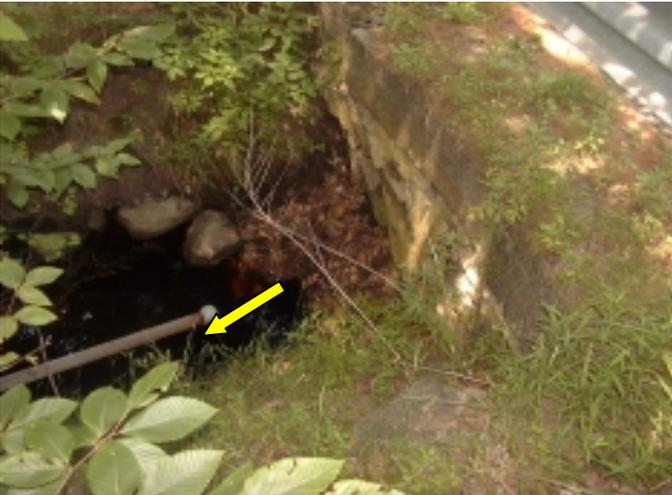
Quad	Site #	Watershed	Wetland Type	Restoration Code	Target Species	Access/Road	Ownership	Waypoint					
Q-4	13	Norman's Woe Creek	Wooded Swamp Mixed Trees	CU	Riverine	Western Ave.	Municipal	192					
<b>Notes</b>				<b>Photo</b>									
Culvert not found, slumped into stream bed													
Upstream no clearly defined stream channel													
New culvert set at proper inlet height may reduce wetland area upstream													
<b>Sketch</b>				<b>A.</b>

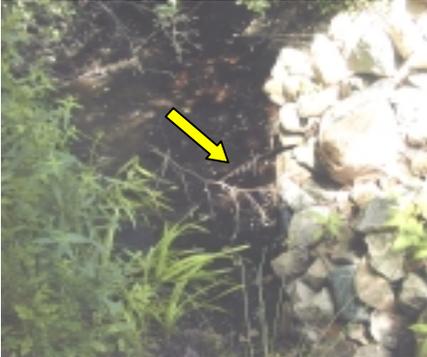
Quad	Site #	Watershed	Wetland Type	Restoration Code	Target Species	Access/Road	Ownership	Waypoint
Q-4	14	Norman's Woe Creek	Shallow Marsh Meadow/Wooded Swamp Deciduous	CU, DL	Riverine	Landfill Access Rd.	Municipal	193
<b>Notes</b>				<b>Photo</b>				
One 16" black corrugated plastic culvert				<b>A.</b>				
Outlet of culvert not found				<b>B.</b>				
Section of stream buried for about 80-100'

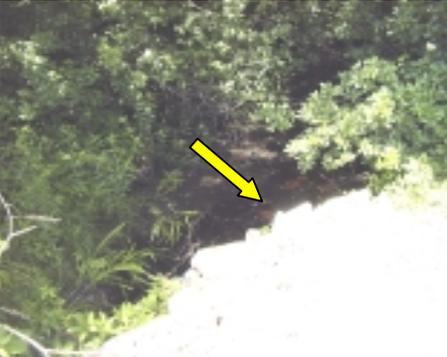
Culvert under main access road to playing fields

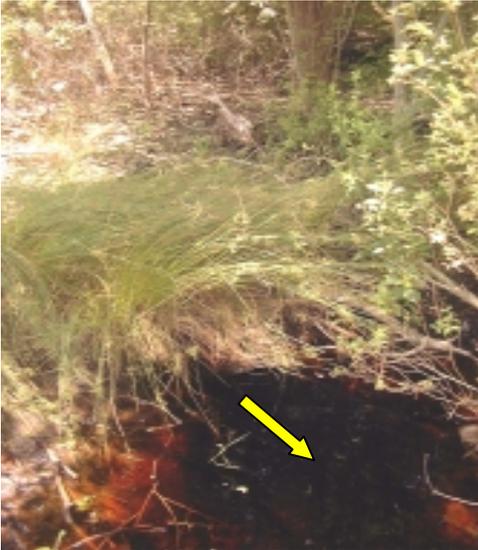
Quad	Site #	Watershed	Wetland Type	Restoration Code	Target Species	Access/Road	Ownership	Waypoint
Q-4	15	Norman's Woe Creek	Wooded Swamp Deciduous	DL	Riverine	Landfill Access Rd.	Municipal	194
<b>Notes</b>				<b>Photo</b>				
12" degraded culvert				<b>A.</b>				
Purpose of culvert installation not clear

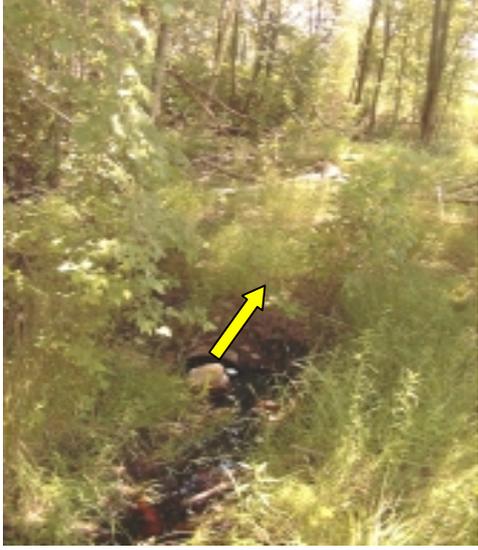
100-150' of culvert or culverted stream				<b>B.</b>				
Berm seen along culvert ridge

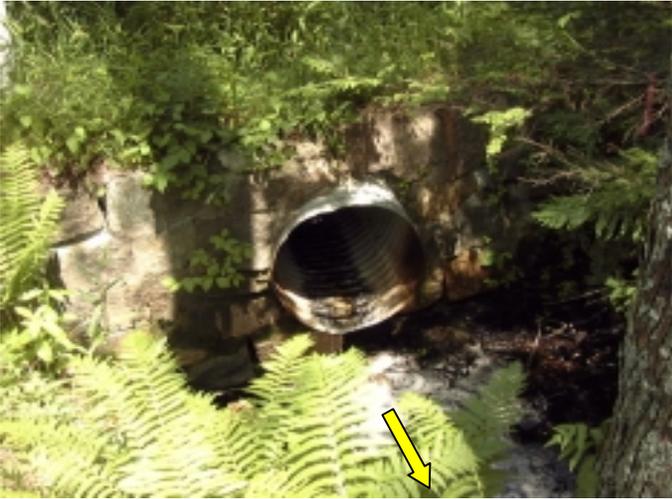
Quad	Site #	Watershed	Wetland Type	Restoration Code	Target Species	Access/Road	Ownership	Waypoint
Q-4	17	Clark Pond	Wooded Swamp Deciduous	CU	Riverine	Magnolia Ave.	Municipal	196
<b>Notes</b>				<b>Photo</b>				
Brook is dry below				<b>A.</b>				
3' corrugated culvert, set too high

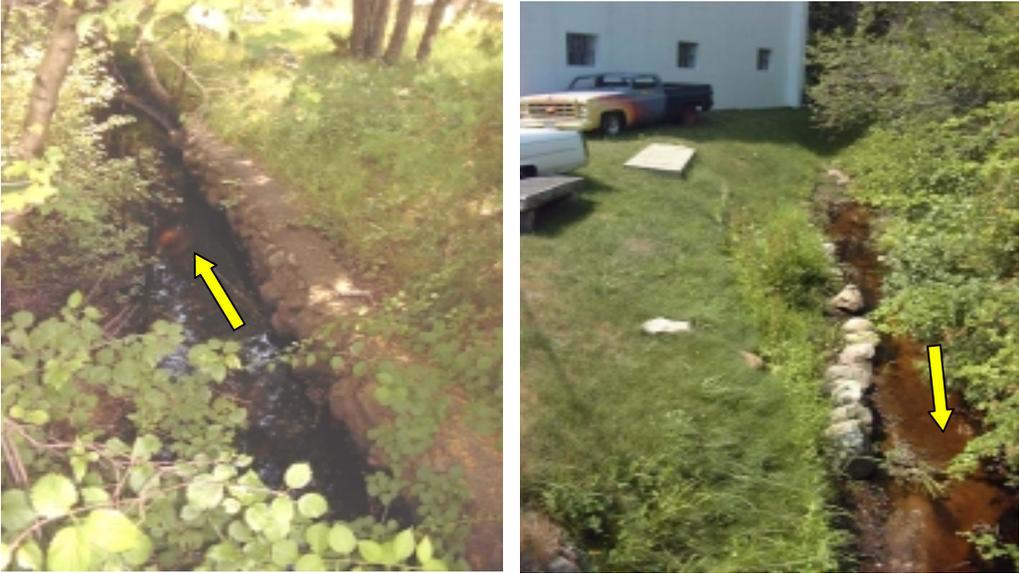
Quad	Site #	Watershed	Wetland Type	Restoration Code	Target Species	Access/Road	Ownership	Waypoint
Q-4	18	Clark Pond	Shrub Swamp	BI, BE	Riverine	Kettle Cove Industrial Park	Private	197
<b>Notes</b>				<b>Photo</b>				
Channelized, artificial bank replaces natural floodplain				<b>A.</b>				
Culvert set at right invert				<b>B.</b>				
~3.5' corrugated culvert

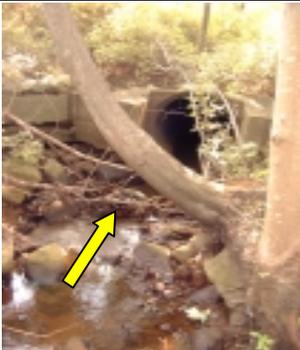
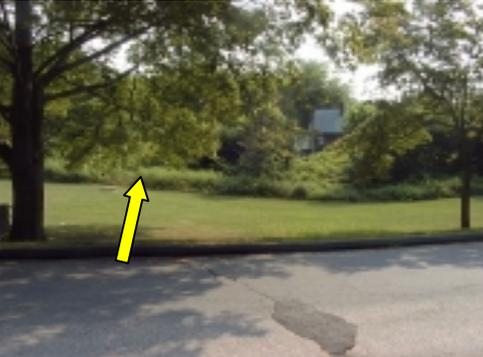
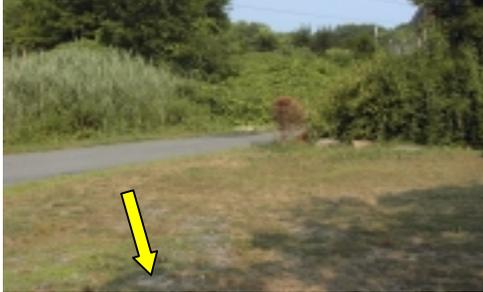
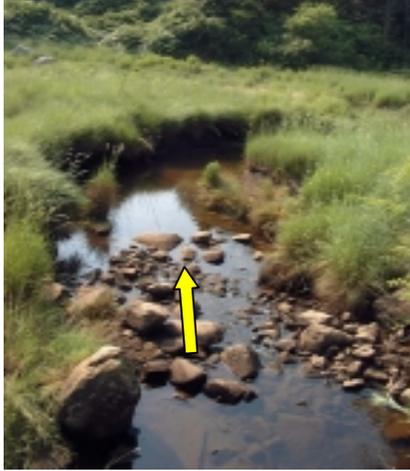
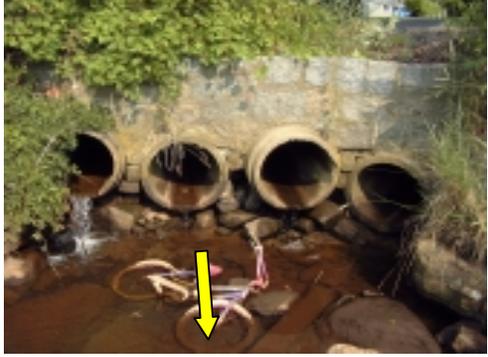
Quad	Site #	Watershed	Wetland Type	Restoration Code	Target Species	Access/Road	Ownership	Waypoint
Q-4	19	Pigery Creek	Brackish Marsh	DL, CU	Riverine/Anadromous	Concord St.	Public/Private	198
<b>Notes</b>				<b>Photo</b>				
Campus of West Parish School				<p><b>A.</b>

</p>				
Upstream 4-5' culvert with perennial stream type flows								
Stream culverted for approx. 100 yards								
Culverted section of stream at natural smelt spawning area								
4 2-2.5' culverts at discharge point, for stream and stormwater								
Stream course not known as it flows under access road to school and discharges to salt marsh								
School has expansion plans that might preclude restoration								
Area is used by schoolchildren								
<b>Sketch</b>

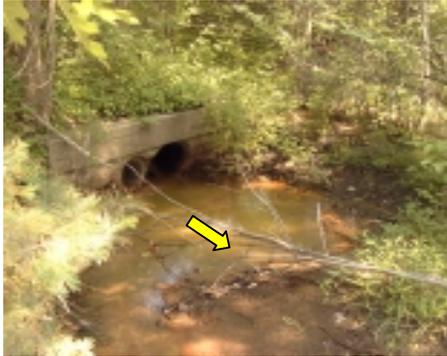
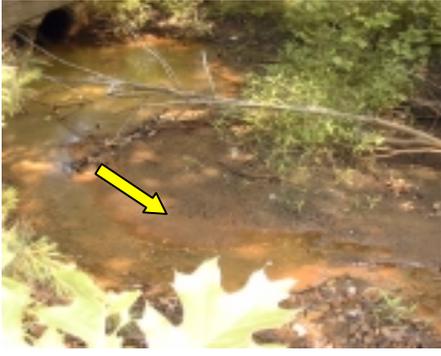
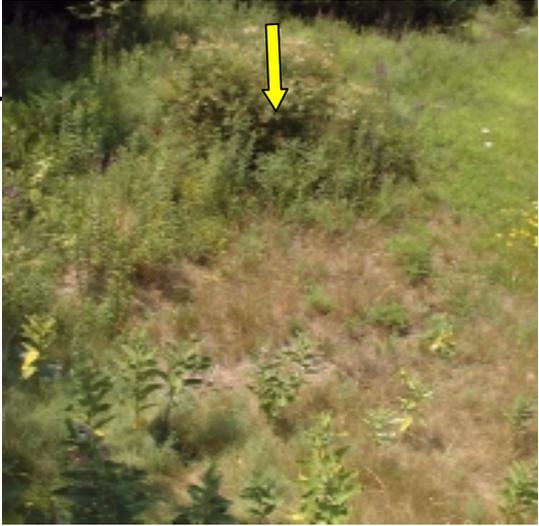
Quad	Site #	Watershed	Wetland Type	Restoration Code	Target Species	Access/Road	Ownership	Waypoint
Q-4	21	Pigery Creek	Shallow Marsh Meadow/Wooded Swamp Deciduous	BMP	Riverine	Rte. 128	Public/Private	200
<b>Notes</b>				<b>Photo</b>				
Sediment build-up in stream from stormwater from Rte.128 offramp				<div style="display: flex; justify-content: space-around;"> <div style="text-align: center;"> <p>A.</p>

</div>				
Potential to install a BMP in offramp median to improve water quality								
<b>Sketch</b>

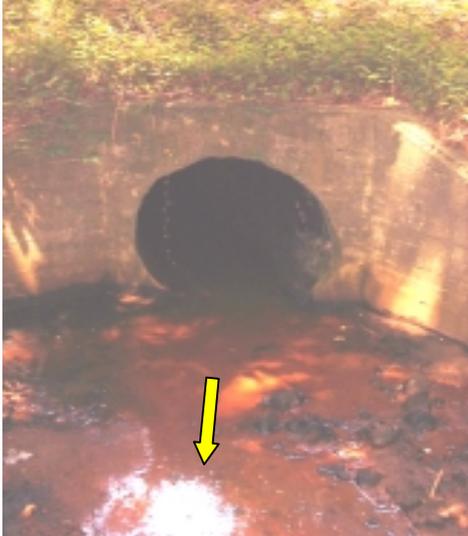
Approx. 100' culvert under Rte. 128								
Upstream pavement to near stream edge, small buffer								
Stone fill to edge of wetlands upstream								
Culvert slightly undersized								
Minimal disturbance								
<b>Sketch</b>				<b>Photo</b> B.

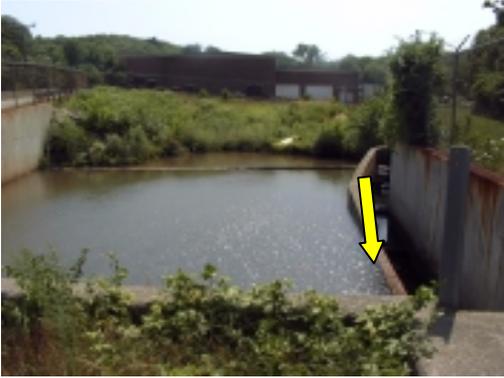
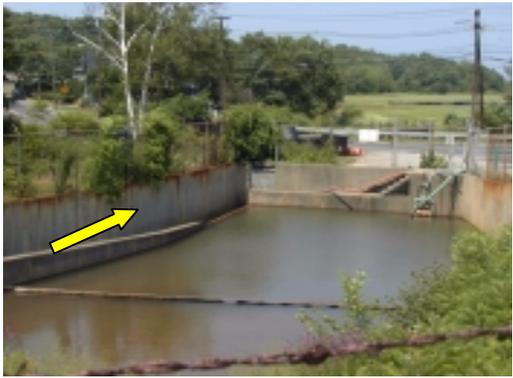
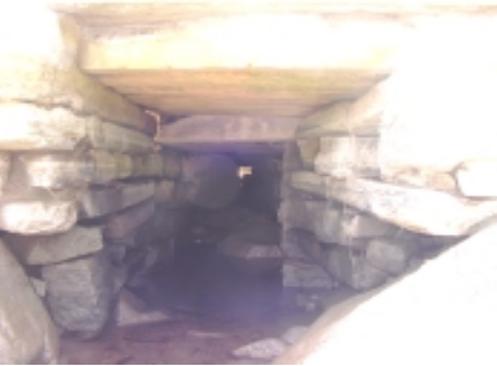
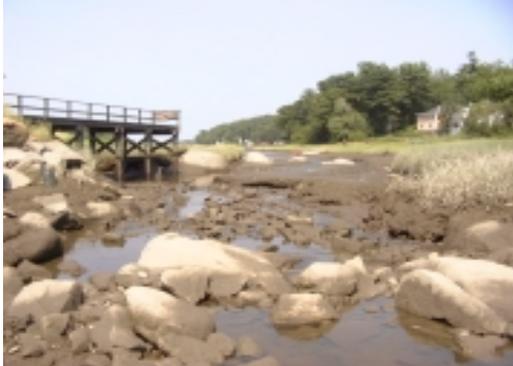
Settling pond not needed as part of filtration plant operations								
Pond could be enhanced for smelt and better integrated into stream flow								
Restoration should be looked at in conjunction with site 24								
<b>Sketch</b>

Quad	Site #	Watershed	Wetland Type	Restoration Code	Target Species	Access/Road	Ownership	Waypoint
Q-4	23	Little River	Brackish Marsh	FR, CR	Anadromous/Estuarine	Magnolia Ave./Essex Ave.	Municipal	204
<b>Notes</b>				<b>Photo</b>				
Settling pond could be integrated with stream system to form resting pool for alewife				<p>A.</p>

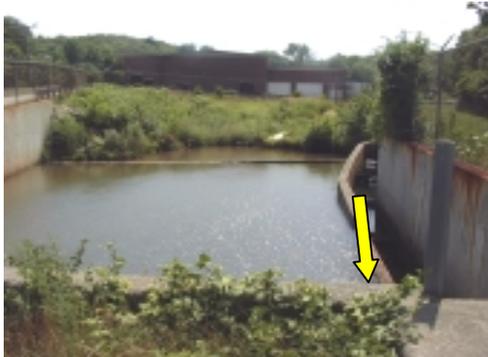
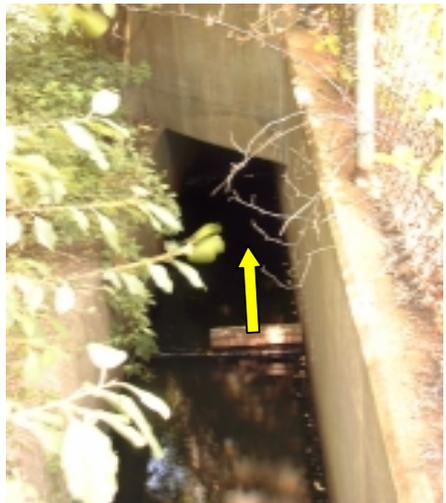
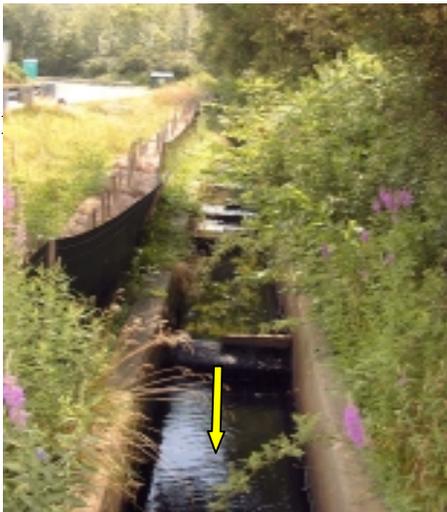
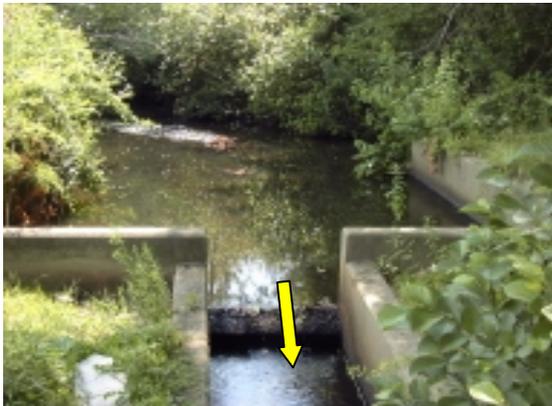
Quad	Site #	Watershed	Wetland Type	Restoration Code	Target Species	Access/Road	Ownership	Waypoint
Q-4	24	Little River	Brackish Marsh	BI, DL	Estuarine/Anadromous	Magnolia Ave./Essex Ave.	Municipal	205
<b>Notes</b>				<b>Photo</b>				
Fish ladder could be replaced with natural stream				A.				
Natural stream may pass fish better and provide flood storage

Natural stream would limit need for long term maintenance of the fish ladder

Natural stream could be integrated with settling pool creation				B.				
Restoration should be looked at in conjunction with site 23				C.

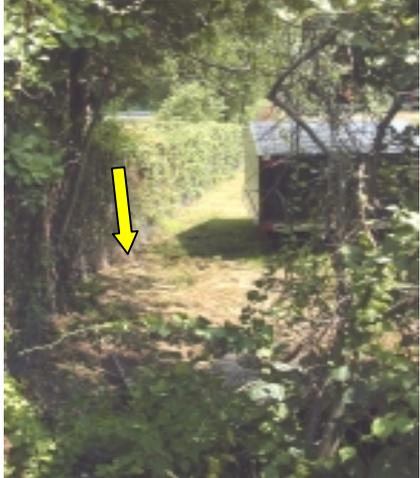
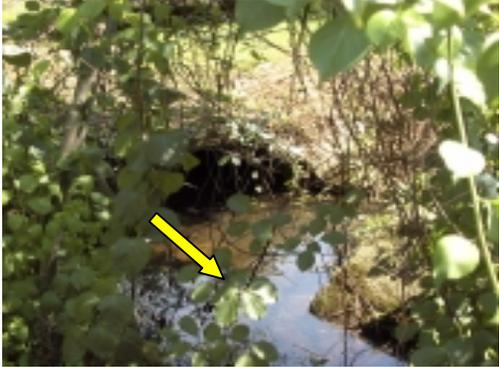
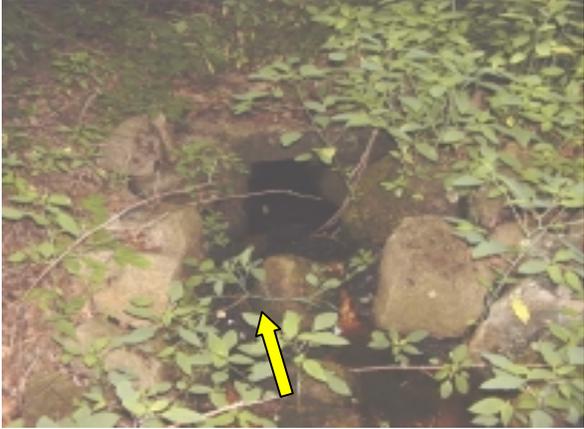
Quad	Site #	Watershed	Wetland Type	Restoration Code	Target Species	Access/Road	Ownership	Waypoint
Q-4	25	Wallace Pond	Shrub Swamp	DL, CU	Riverine/Anadromous	Magnolia Ave.	Municipal	206
<b>Notes</b>				<b>Photo</b>				
Stream culverted for approx. 200'				A.				
Approx. 3' concrete culvert at outlet, granite box culvert at inlet

Alewife potential limited - upstream dam/water supply reservoir				B.				
Historic alewife run according to anecdotal information

Potential to daylight stream to Magnolia Ave.

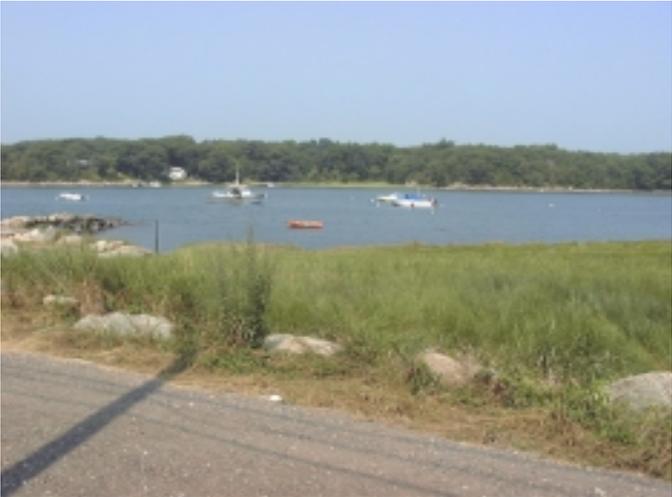
Quad	Site #	Watershed	Wetland Type	Restoration Code	Target Species	Access/Road	Ownership	Waypoint
Q-4	28	Little River	Salt Marsh	FR, CI	Estuarine	Stanwood Ave.	Unknown	209
<b>Notes</b>				<b>Photo</b>				
Potential salt marsh connection severed by Stanwood Point Road				<b>A.</b>				
No culvert found, anecdotal evidence that no connection existed

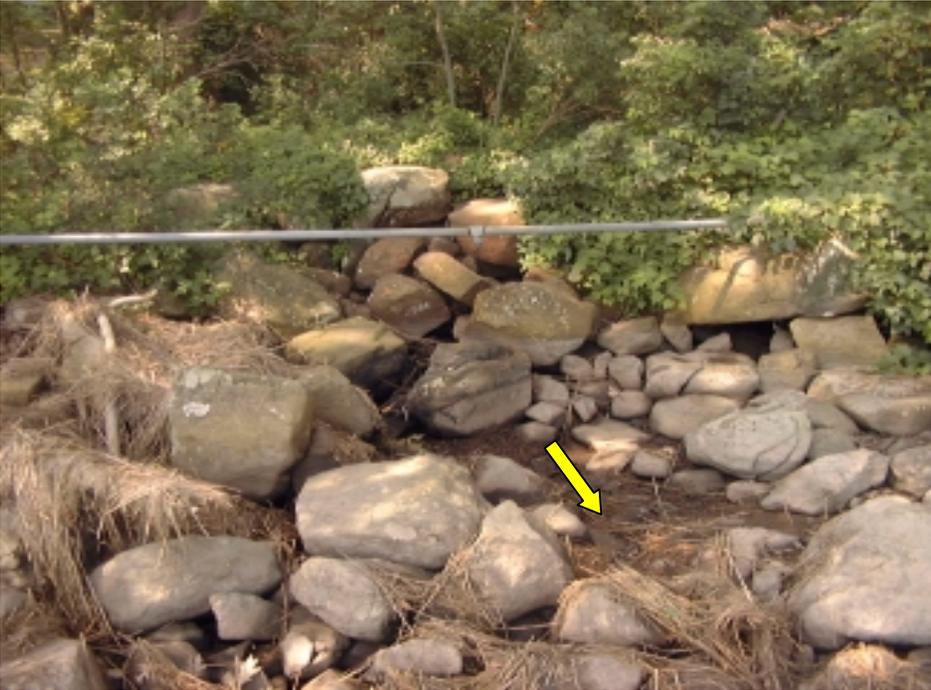
Quad	Site #	Watershed	Wetland Type	Restoration Code	Target Species	Access/Road	Ownership	Waypoint
Q-4	29	Fernwood Lake	Brackish Marsh/Wooded Swamp Deciduous	FR, CR	Anadromous/Estuarine	Winthrop Ave.	Private	210
<b>Notes</b>				<b>Photo</b>				
Re-alignment of stones could encourage smelt spawning				<b>A.</b>

Approx. 50' of smelt run habitat could be created								
New box culvert could help support smelt habitat improvement								
Stones seem to be artificially placed not natural configuration								
Cove is sheltered so stream bed re-alignment would not be adversely impacted by storm action like at Folly Cove								
Stones as configured do not articulate primary stream bed								
<b>Sketch</b>

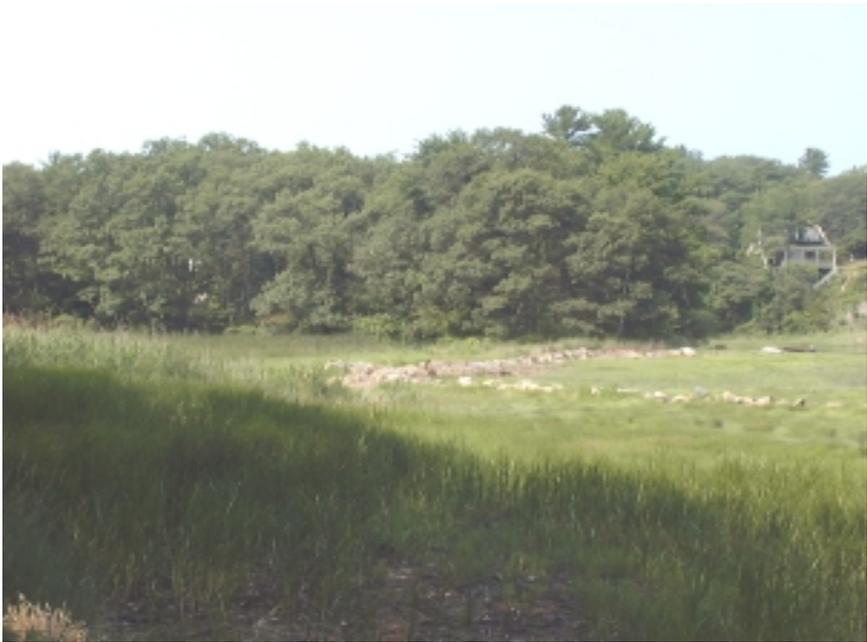
Quad	Site #	Watershed	Wetland Type	Restoration Code	Target Species	Access/Road	Ownership	Waypoint
Q-4	30	Annisquam River	Salt Marsh/Brackish Marsh	FR, IM	Estuarine	Winthrop Ave.	Private	211
<b>Notes</b>				<b>Photo</b>				
Stone wall reduces salt marsh sheet flow potentially encouraging <i>Phragmites australis</i>

Partial removal of the stone wall may reduce <i>Phragmites</i> advance								
Not a clear creek channel to brackish marsh found								
Culvert under Winthrop not found								
<b>Sketch</b>

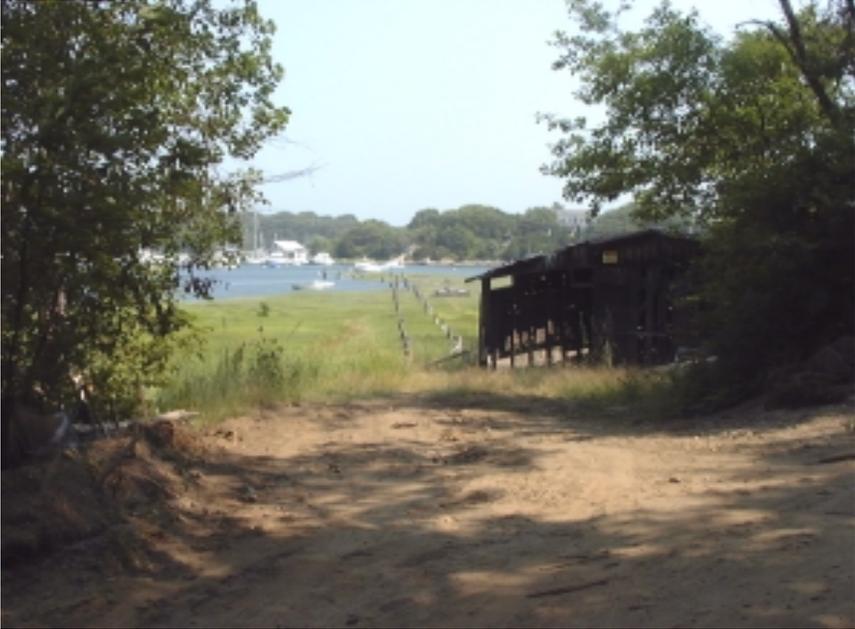
Quad	Site #	Watershed	Wetland Type	Restoration Code	Target Species	Access/Road	Ownership	Waypoint
Q-4	31	Annisquam River	Salt Marsh	FR	Estuarine	Massasoit Rd.	Private	212
<b>Notes</b>				<b>Photo</b>				
Old pier posts in salt marsh				A.				
Present impact limited

Post removal may limit future pier construction which would have a greater resource impact								
<b>Sketch</b>								
Annisquam

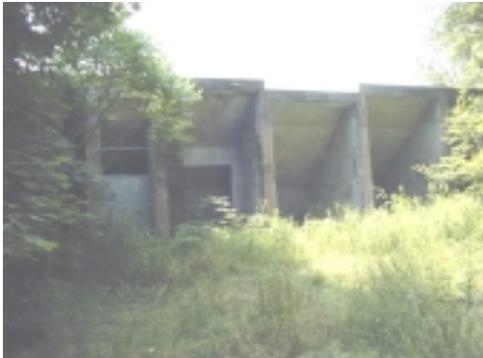
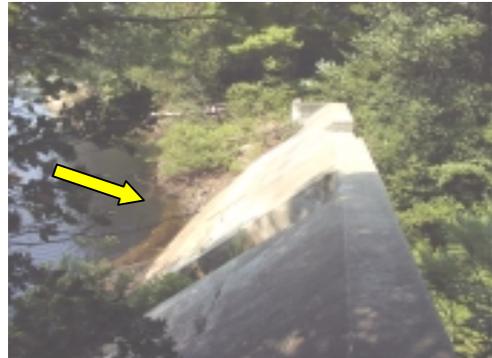
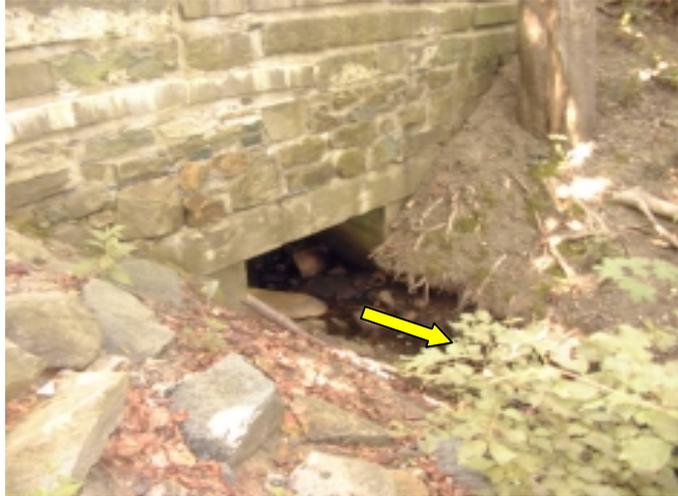
Quad	Site #	Watershed	Wetland Type	Restoration Code	Target Species	Access/Road	Ownership	Waypoint
Q-4	32	Upper Banjo Pond	Open Water	FL	Catadromous	Essex Ave.	Public/Private	213
<b>Notes</b>				<b>Photo</b>				
Dam from lower Banjo Pond to LePage's				<p><b>A.</b></p>

Alewife ladder construction not likely given engineering constraints and lack of continuous water flow								
Increased base flow may encourage eel passage								
Dam is approx. 15' high from base to top of concrete structure								
Box culvert at outlet is approx. 3' x 2'								
Little base stream flow at time of investigation								
<b>Sketch</b>

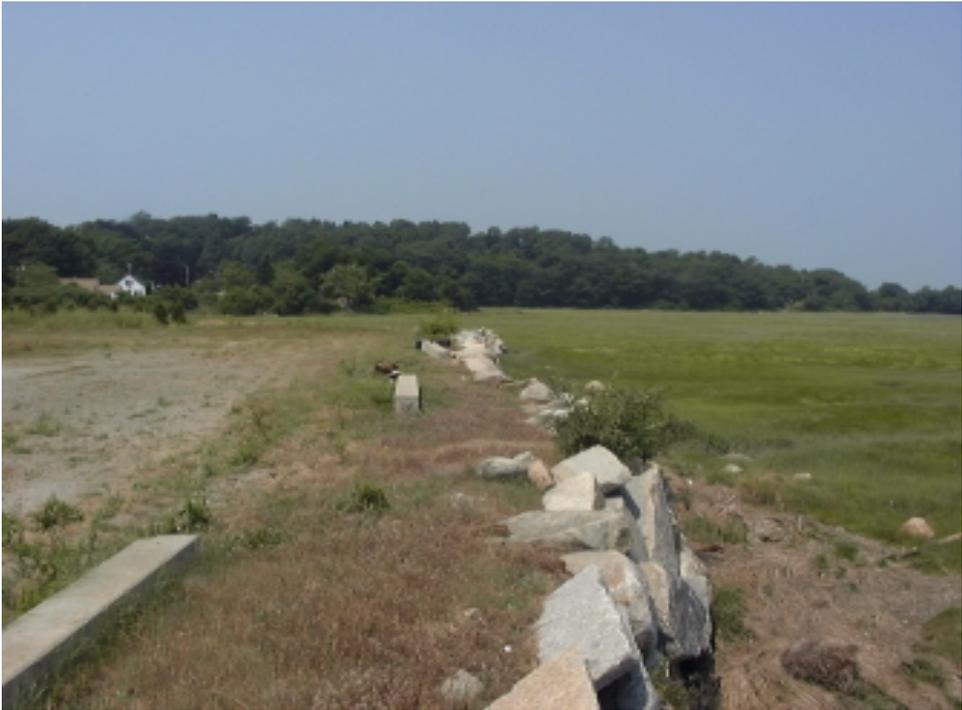
Quad	Site #	Watershed	Wetland Type	Restoration Code	Target Species	Access/Road	Ownership	Waypoint
Q-4	33	Blynman Canal	Salt Marsh	FR	Estuarine	Essex Ave.	Private	214
<b>Notes</b>				<b>Photo</b>				
Section of fill area on presumably historic salt marsh				A.				
Elevation change in fill area would probably result in re-growth of native salt marsh species

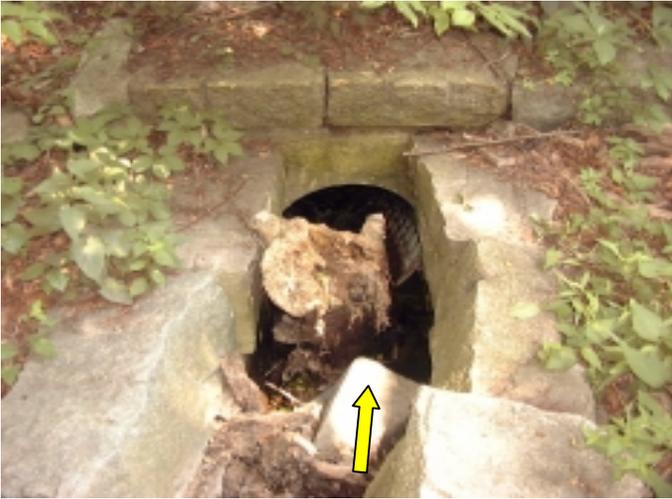
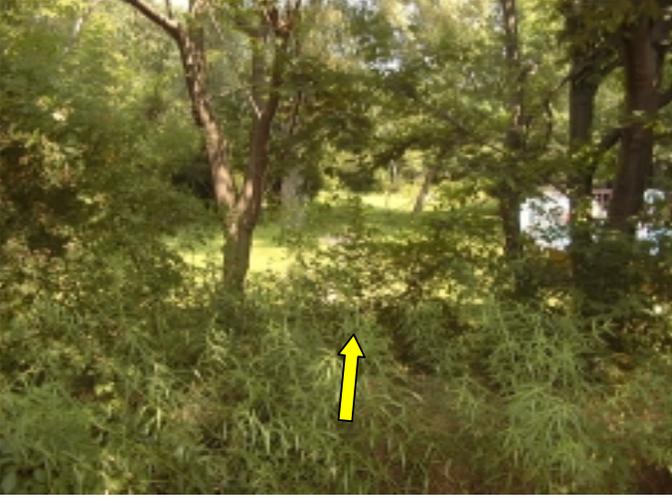
Quad	Site #	Watershed	Wetland Type	Restoration Code	Target Species	Access/Road	Ownership	Waypoint
Q-4	34	Unnamed	Wooded Swamp Deciduous	CU, BE	Riverine	Bond St.	Private	215
<b>Notes</b>				<b>Photo</b>				
Downstream lawn to near stream edge								
Culvert may be slightly undersized								
Stream has low flow								
Stream appears to be straightened out through ditching								
Minor disturbance								
<b>Sketch</b>				<b>A.</b>

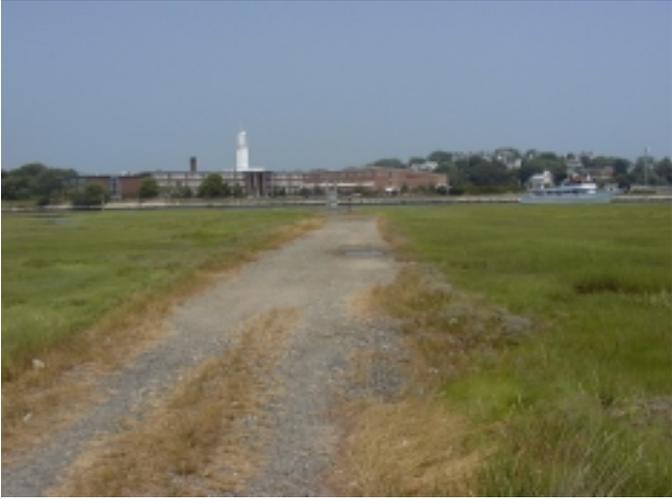
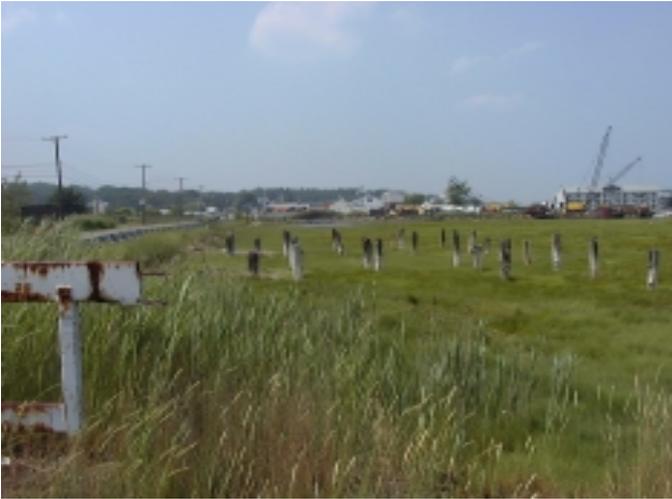
Quad	Site #	Watershed	Wetland Type	Restoration Code	Target Species	Access/Road	Ownership	Waypoint
Q-4	36	Blynman Canal	Salt Marsh	FR	Estuarine	Essex Ave.	Unknown	217
<b>Notes</b>				<b>Photo</b>				
Location of the main sewer discharge pipe				A.

Access needed for utility maintenance								
Road removal would result in increased salt marsh								
Limited potential due to tangible need for road								
Road's low profile reduces habitat impacts and allows for sheet flow								
Area of old posts on marsh presents a fill removal opportunity								
<b>Sketch</b>				B.

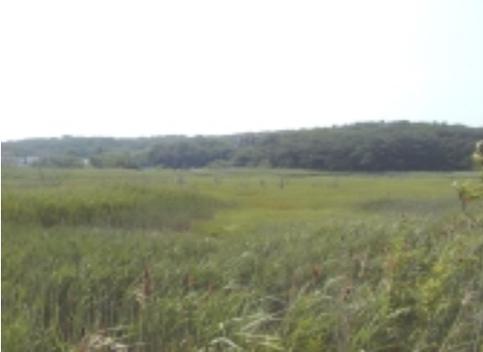
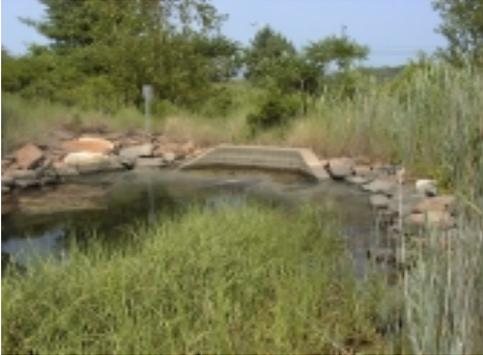
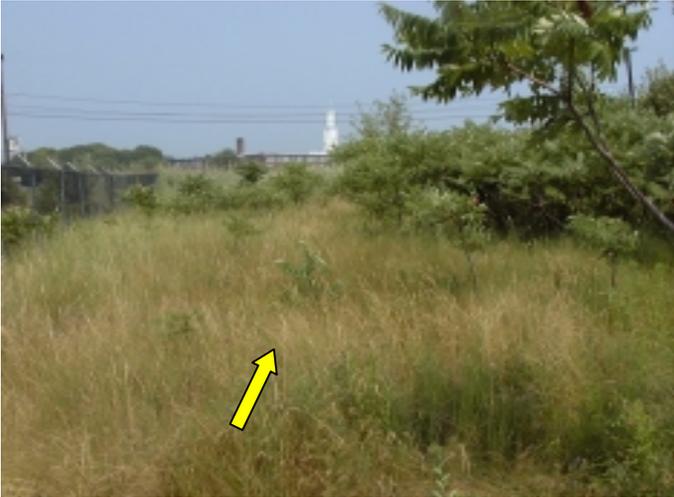
Quad	Site #	Watershed	Wetland Type	Restoration Code	Target Species	Access/Road	Ownership	Waypoint
Q-4	37	Blynman Canal	Salt Marsh	CU, DL	Estuarine	Essex Ave.	Unknown	218
<b>Notes</b>				<b>Photo</b>				
Impounded salt marsh could have increased tidal flushing				<div style="display: flex; justify-content: space-around;"> <div style="text-align: center;"> <p>A.</p>

</div>				
Approx. 10-15 acre marsh area								
Marsh perimeter ringed with <i>Phragmites australis</i>								
Feeder pipe approx. 3.5' concrete culvert								
Main feeder culvert diverted through treatment plant property								
Culverted section of creek could be daylighted for 200' feet to Essex Ave.								
Need to explore additional culverts to drain and flush salt marsh								
Culvert outlet comes from same culvert that feeds movie theater marsh

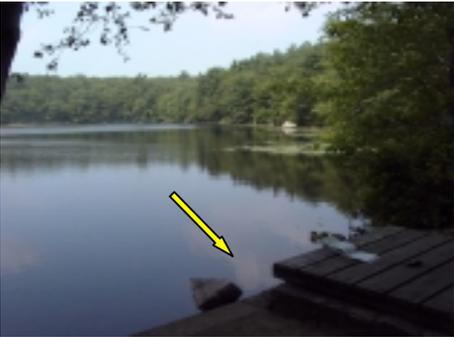
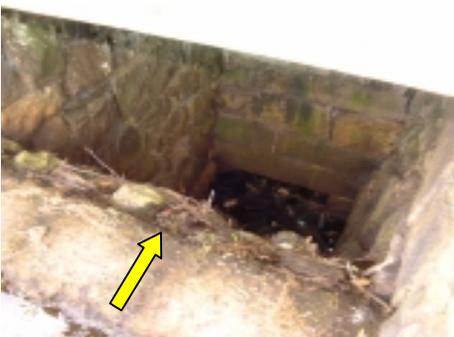
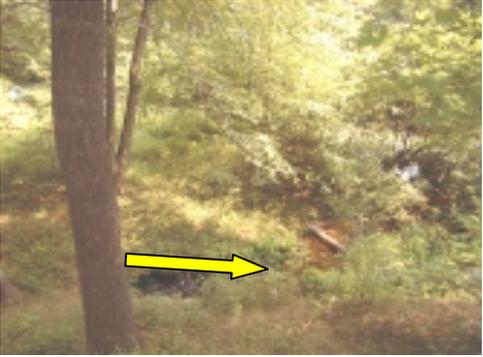
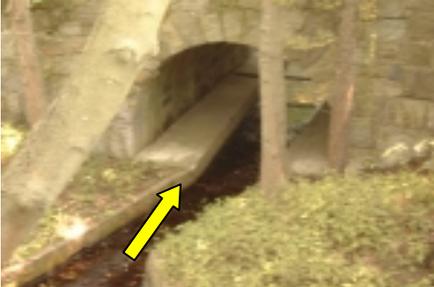
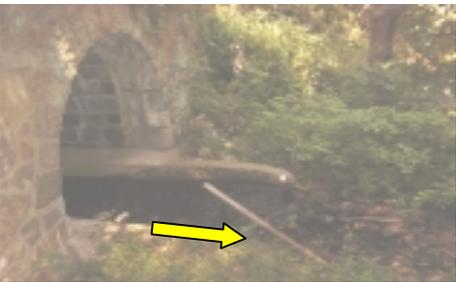
Quad	Site #	Watershed	Wetland Type	Restoration Code	Target Species	Access/Road	Ownership	Waypoint
Q-4	38	Buswell Pond	Open Water	FL	Anadromous/Catadromous	Western Ave.	Public/Private	219
<b>Notes</b>				<b>A.</b>				
Approx. 10' drop from pond level to stream base (Photo B)

Pond may be too small for alewife								
Large elevation drop from pond to sea level in relatively short span								
Stream is channelized in masonry stream bed near bridge								
Approx. 50' of buried culvert under Western Ave.								
<b>Sketch</b>				<b>B.</b>

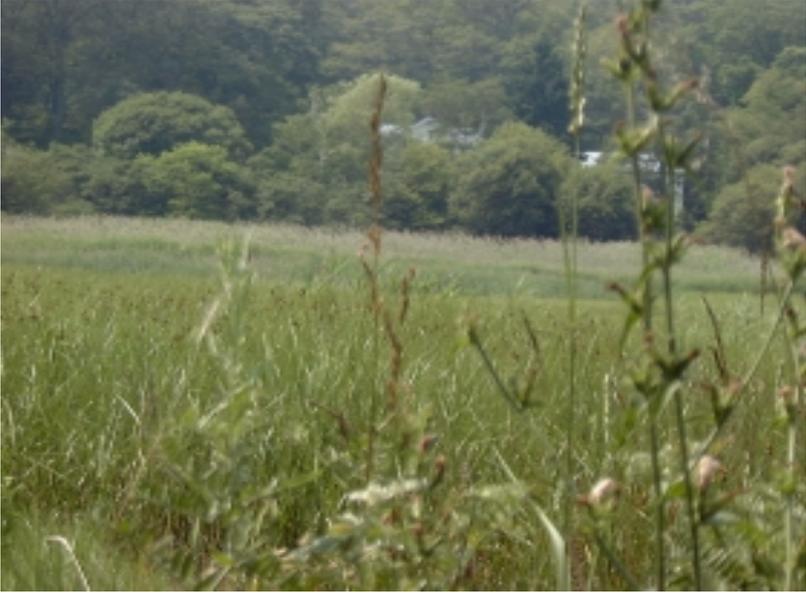
Quad	Site #	Watershed	Wetland Type	Restoration Code	Target Species	Access/Road	Ownership	Waypoint
Q-4	39	Freshwater Cove	Salt Marsh	IM	Estuarine	Dollivers Neck	Private	220
<b>Notes</b>				<b>Photo</b>				
End of Freshwater Cove				A.				
Typical transition zone <i>Phragmites australis</i> growth

No clear channel definition in salt marsh								
<b>Sketch</b>
