# City of Gloucester Comprehensive River and Stream Habitat Restoration Report

2003

Tim Purinton

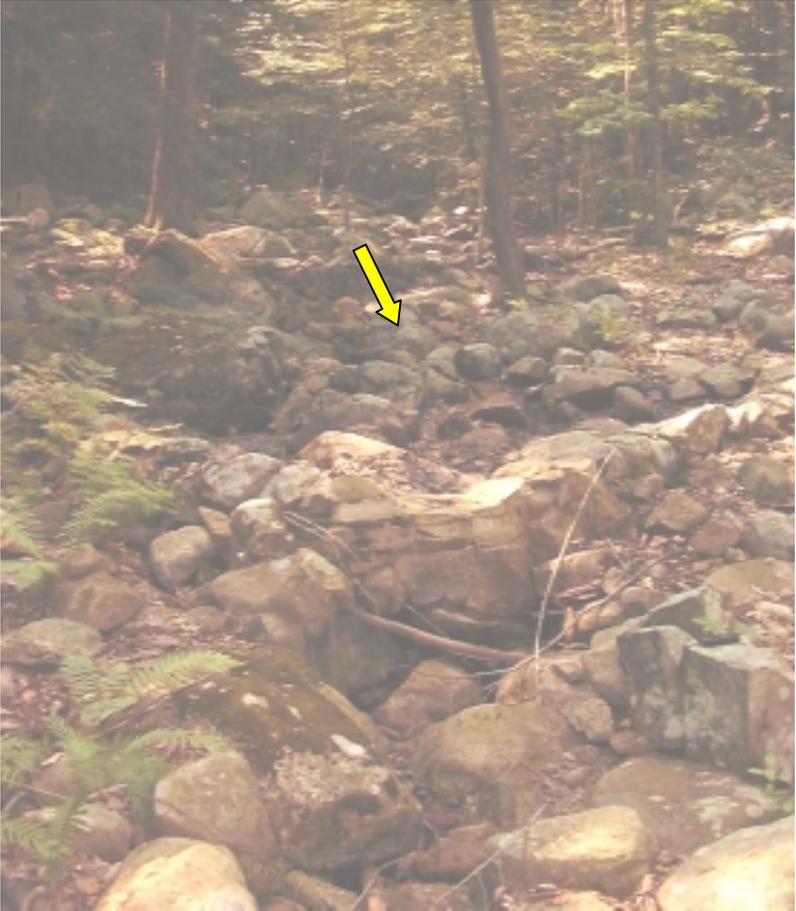
Quad	Site #	Watershed	Wetland Type	Restoration Code	Target Species	Access/Road	Ownership	Waypoint
Q-4	40	Buswell Pond	Wooded Swamp Deciduous	FR	Riverine	Western Ave.	Private	221
<b>Notes</b>				<b>Photo</b>				
2 small stone dams in stream course				A.				
Minimal impact

Dams create deep water habitat but retard natural flow								
Stream not an anadromous fish run nor potential run								
Stream drops considerably in elevation prior to entry into pond								
<b>Sketch</b>

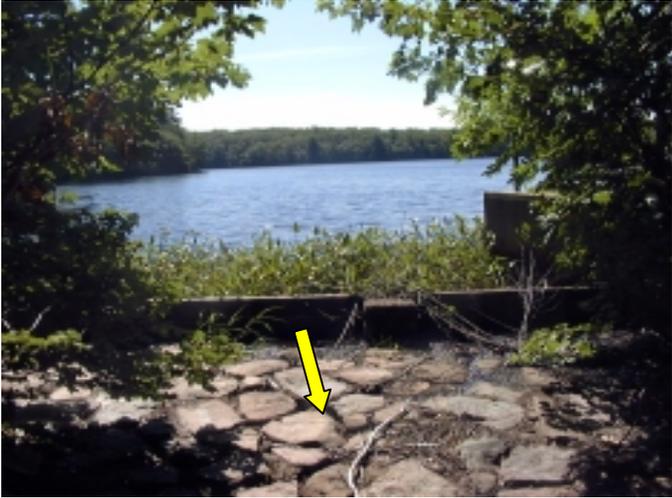
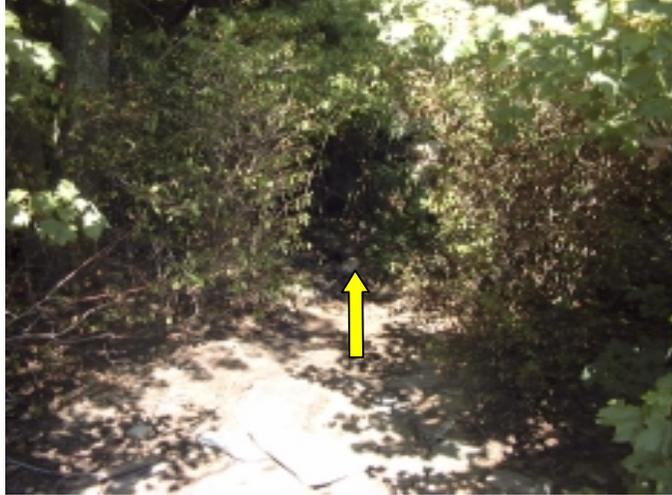
Quad	Site #	Watershed	Wetland Type	Restoration Code	Target Species	Access/Road	Ownership	Waypoint
Q-4	42	Fernwood Lake	Open Water	FL	Anadromous/Catadromous	Fernwood Ave.	Private	229
<b>Notes</b>				<b>Photo</b>				
Main spillway from Fernwood Lake				<b>A.</b>

16" weir boards control flow								
Dam extends along edge of lake								
Elevation drop from dam to stream below Essex Ave. is significant								
Spring flows are quite rapid, fish ladder would need to dissipate actual flow								
Landowner supportive of fish passage improvements								
<b>Sketch</b>				<b>B.</b>

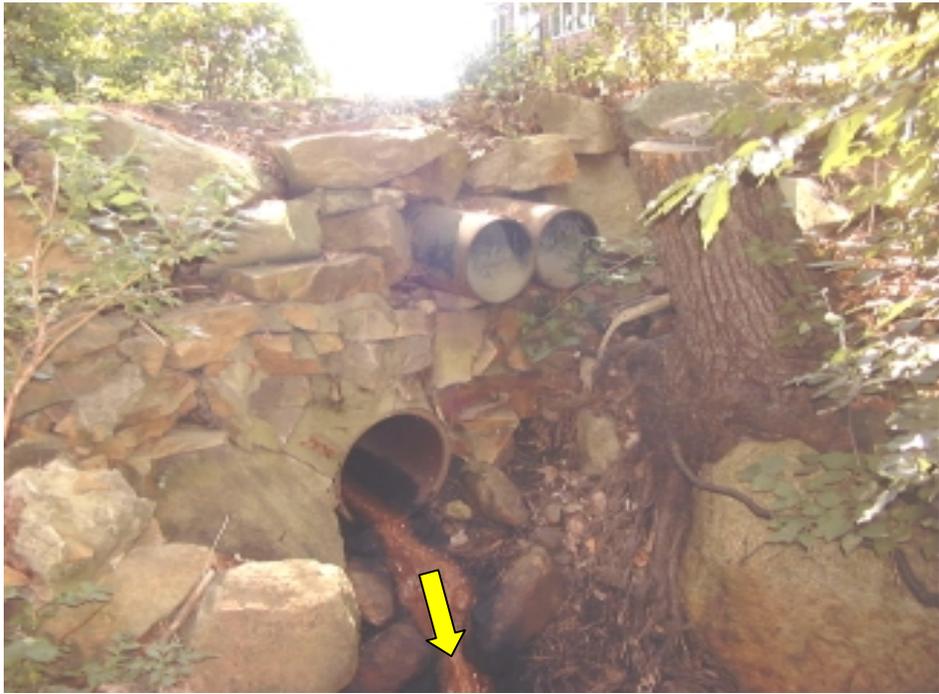
Quad	Site #	Watershed	Wetland Type	Restoration Code	Target Species	Access/Road	Ownership	Waypoint
Q-4	43	Fernwood Lake	Wooded Swamp Deciduous	CU, FL	Anadromous/Catadromous	Fernwood Ave.	Private	230
<b>Notes</b>				<b>Photo</b>				
Culverts below dam spillway				A.				
Culverts need to be removed to facilitate fish passage

Culvert set to high								
2 Culverts near road surface presumably handle high flows								
2 - ~12" culverts								
1 - ~16" culvert								
Site linked to sites 42, 44 and 29								
<b>Sketch</b>

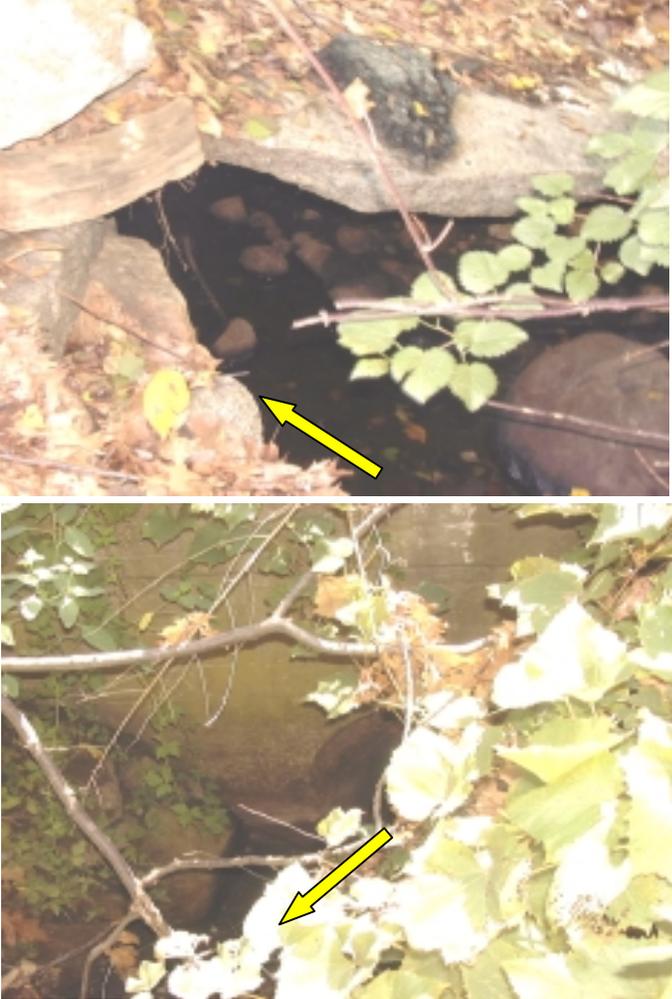
Quad	Site #	Watershed	Wetland Type	Restoration Code	Target Species	Access/Road	Ownership	Waypoint
Q-4	44	Fernwood Lake	Shrub Swamp	CU, FL, DL	Anadromous/Catadromous	Essex Ave.	Municipal	231
<b>Notes</b>				<b>Photo</b>				
Approx. 3' culvert under Essex Ave.				A.				
An effort to provide alewife fish passage to Fernwood Lake would probably require culvert improvements

Section of 50' of buried stream along Essex Ave.								
<b>Sketch</b>				B.

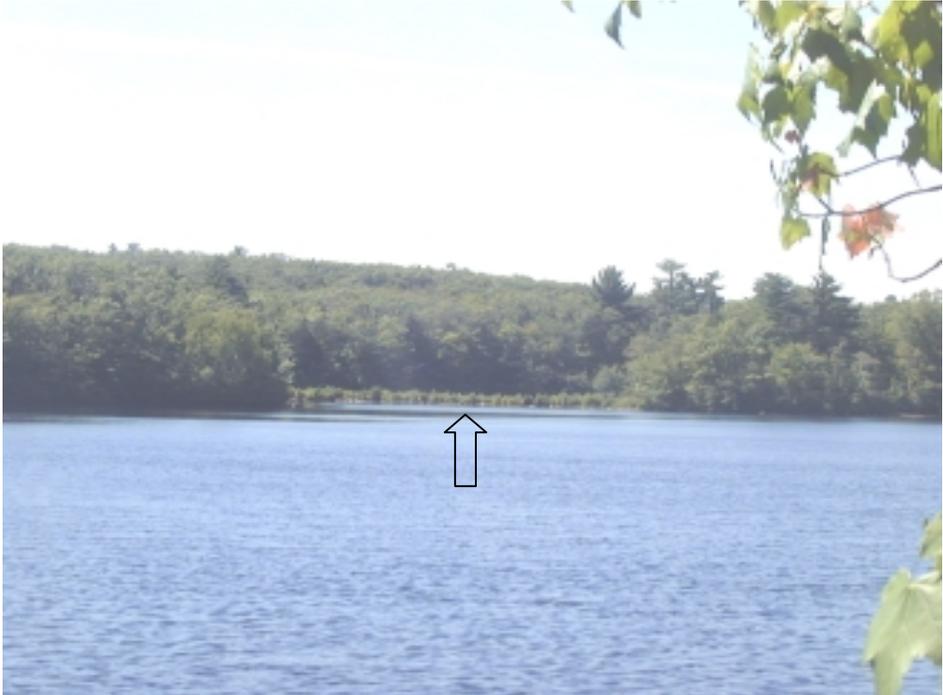
Quad	Site #	Watershed	Wetland Type	Restoration Code	Target Species	Access/Road	Ownership	Waypoint
Q-4	45	Fernwood Lake	Shrub Swamp/Open Water	FR	Anadromous/Catadromous	Essex Ave.	Unknown	NA
<b>Notes</b>				<b>Photo</b>				
Berm placed across lake to segment water bodies				<p>A.</p>

Area of potential fill removal								
Area behind berm more vegetated, less deep water habitat								
Disturbance not site investigated								
Removal of berm may increase spawning habitat for alewives if passage improvements are possible								
Berm is vegetated								
<b>Sketch</b>

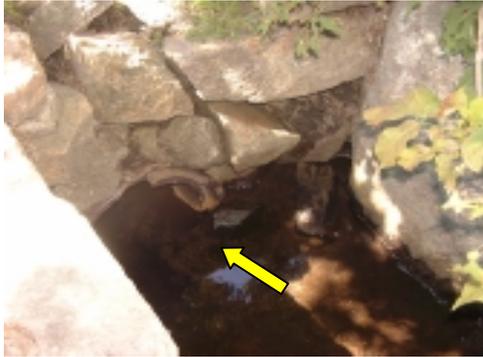
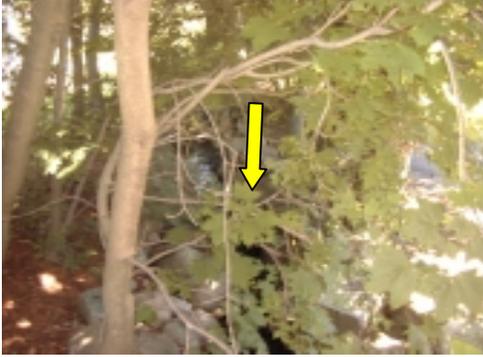
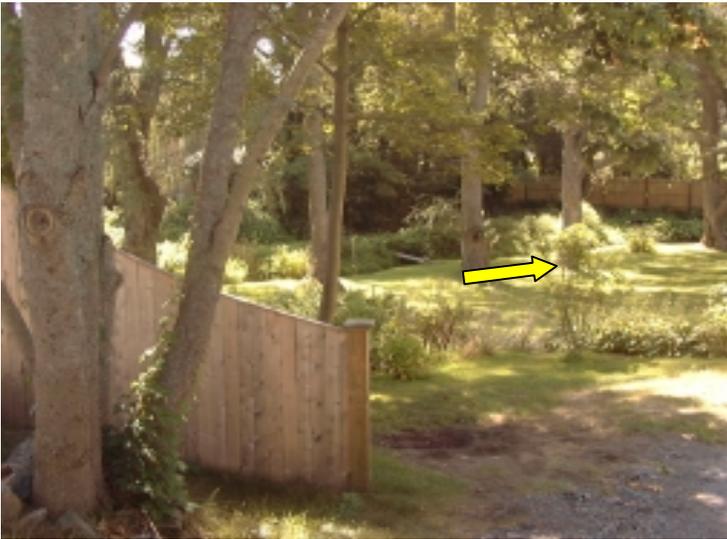
Quad	Site #	Watershed	Wetland Type	Restoration Code	Target Species	Access/Road	Ownership	Waypoint
Q-4	46	Clark Pond	Wooded Swamp Deciduo	BE, BI	Anadromous/Catadromous	Magnolia Ave.	Private	232
<b>Notes</b>				<b>Photo</b>				
Minor disturbance				A.				
Stream downstream could benefit with greater vegetated buffer				B.				
Stream artificially channelized upstream for approx. 20' either side

Culvert slightly undersized

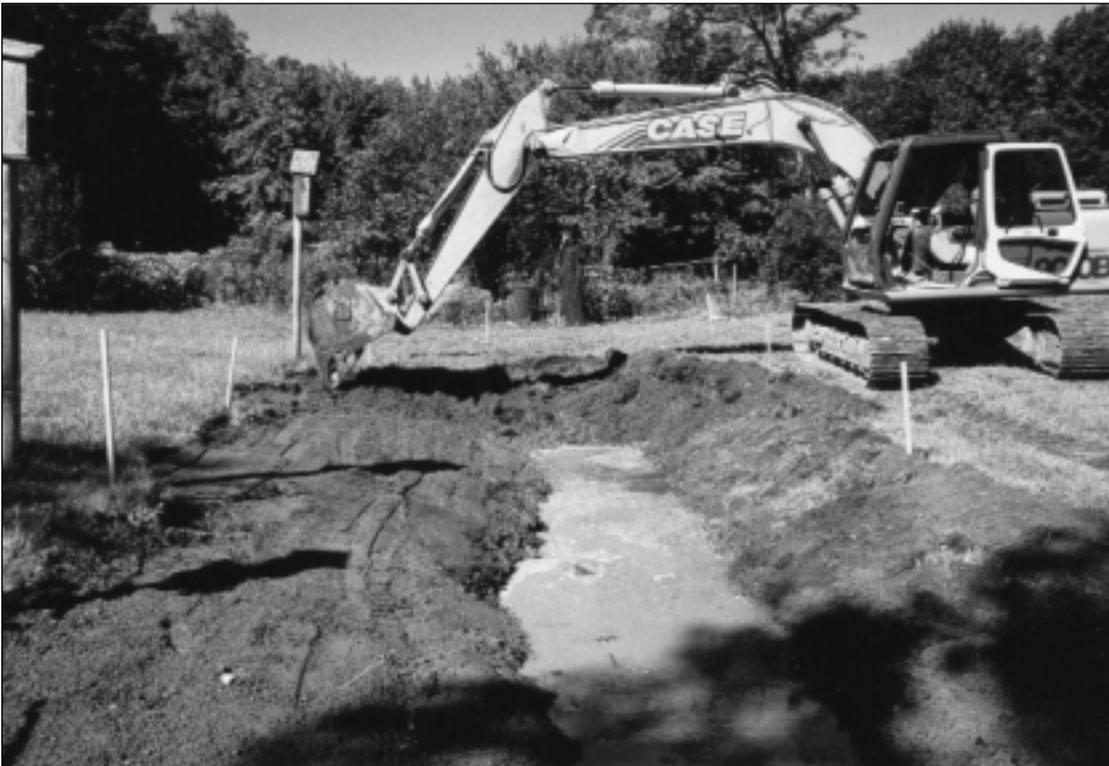
*A backhoe halfway through removing a culvert and grading the banks of West Ox Pasture Brook in a Rowley, Massachusetts backyard. Courtesy of Rowley Conservation Commission.*
