**FIRE SERVICE  
AFTER ACTION REPORT (AAR)  
LORRAINE APARTMENT BUILDING  
CITY OF GLOUCESTER, MA  
FINAL REPORT  
FEBRUARY 2009**

**Lorraine Apartment Building  
80 Middle Street  
Gloucester, Massachusetts**

**Date of Incident  
December 14, 2007**

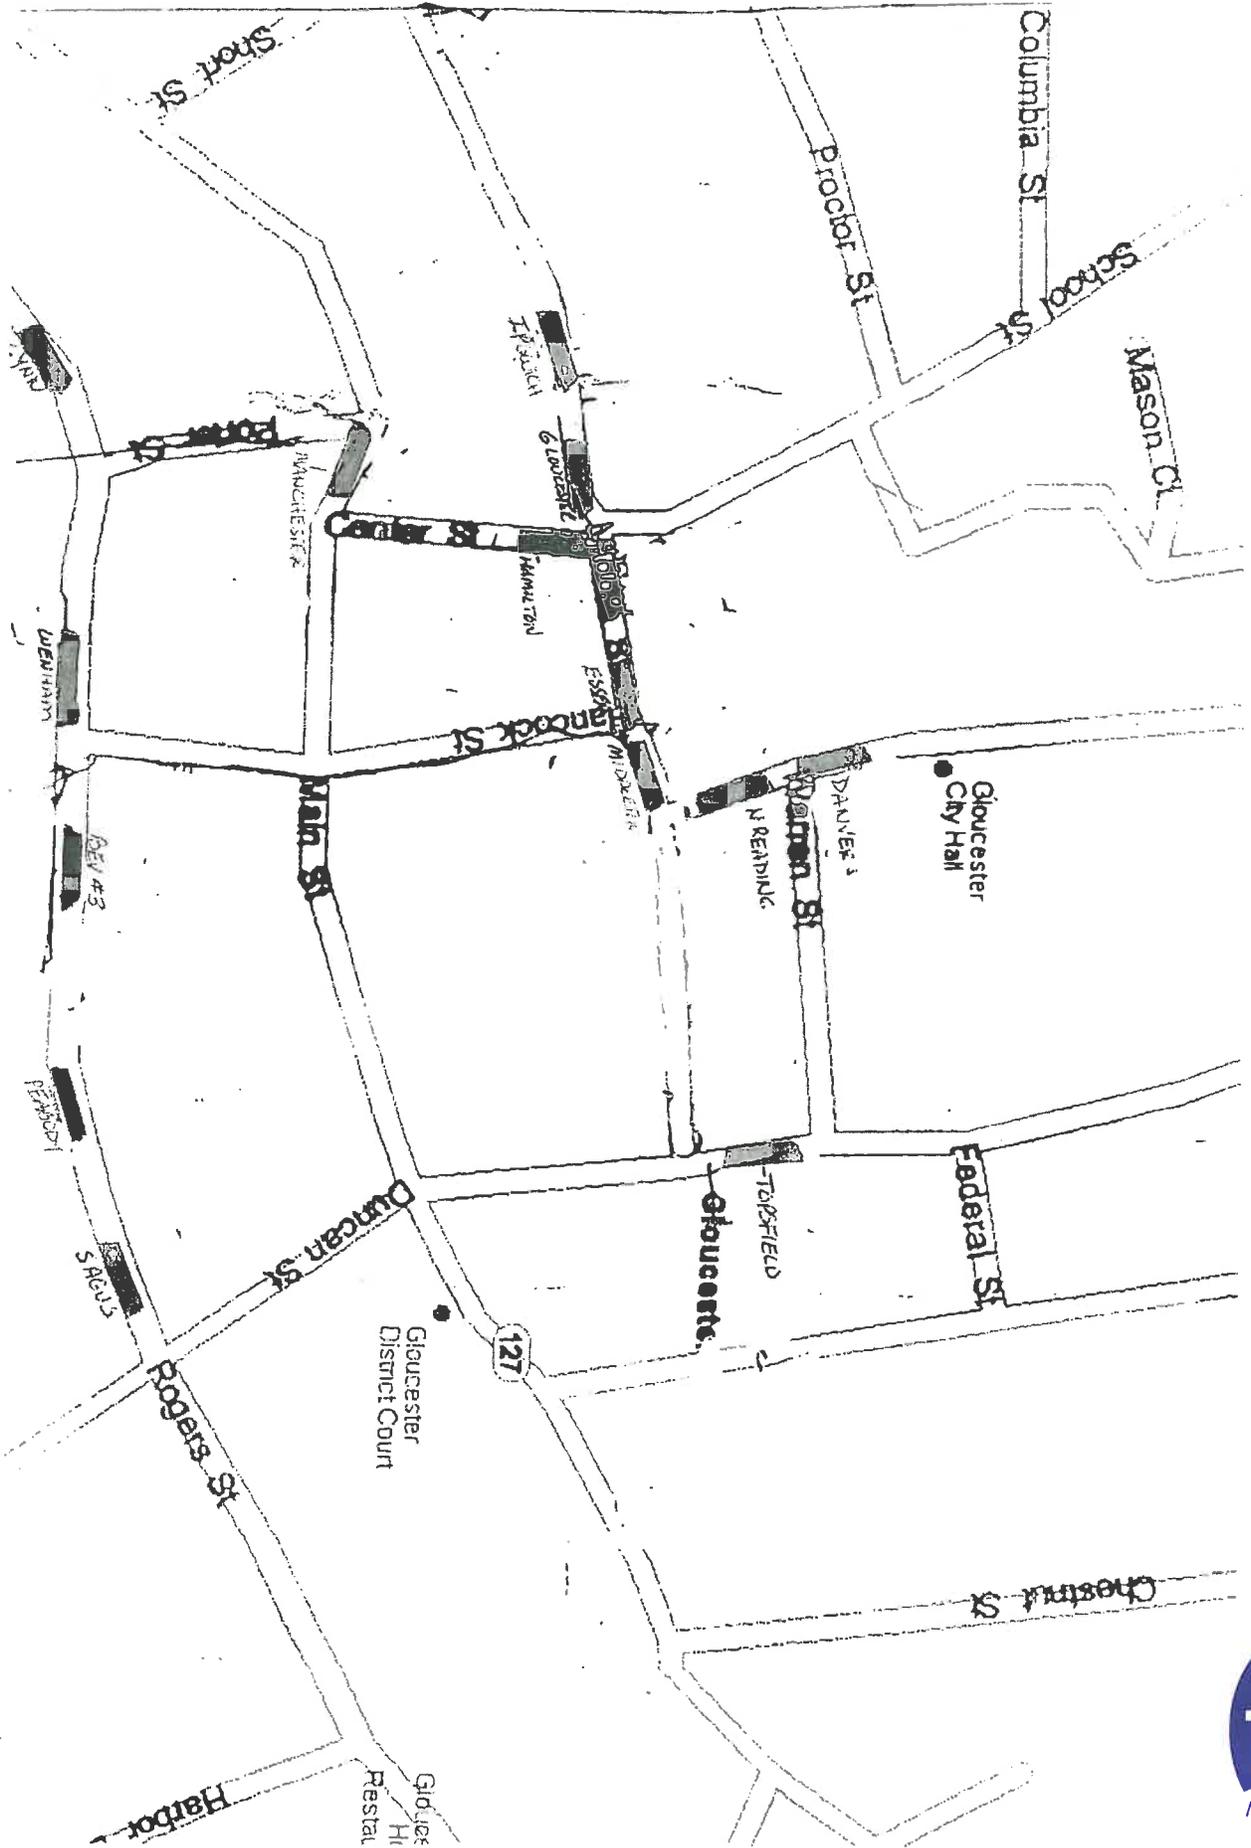
- North Reading's engine, located on Dale Street, was being fed from Topsfield, located on Pleasant Street. Danvers also had a line into North Reading.

It was determined that there had been a significant water main infrastructure problem at the time of the incident. Weeks after the fire it was discovered the main water valves in both Maplewood Avenue and Prospect Street were closed. This was determined by Mike Hale of the Gloucester Public Works Water Division.
